# Arborist Report

1901 Alton Road

Miami Beach

9/13/2023

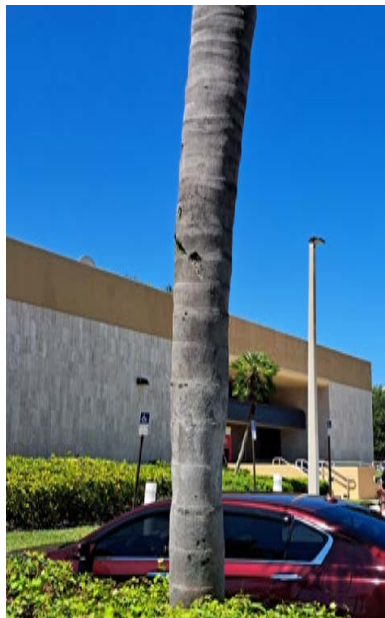
## Tree #32

Tree #32 is a Queen Palm located in the existing parking lot. It is in poor condition with a trunk constriction and a thin, chlorotic canopy.
