## Arborist Report

Miller Legg Project No.  
25-00062

## City of Miami Beach North Beach Log Cabin

**North Beach Oceanside Park Log Cabin**  
**Arborist Review**

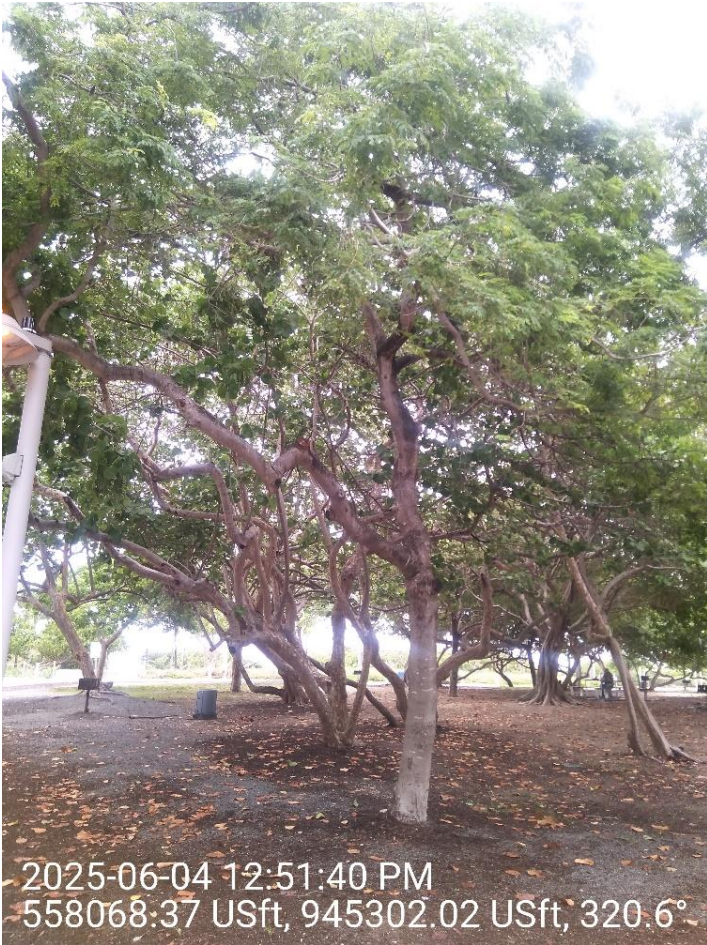
| Tree Details | | Photos |
|---|---|---|
| Tree ID | 1 | |

| Tree Details | | Photos |
|---|---|---|
| Observed Conditions | Bent Trunk, Limb Damage – Minor, Lopsided | |
| Overall Condition | Fair | |
| Condition % | 50% | |

| Tree Details | | Photos |
|---|---|---|
| Disposition | Remain | |

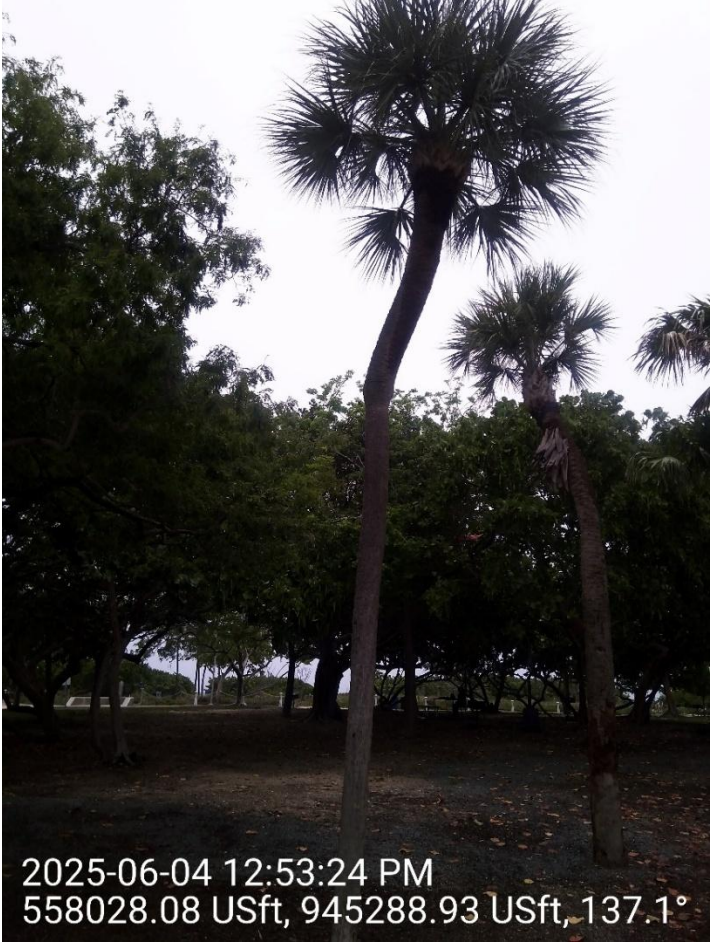
| Tree Details | | Photos |
|---|---|---|
| Tree ID | 3 | |

| Tree Details | | Photos |
|---|---|---|
| Overall Condition | Fair | |
| Condition % | 55% | |

| Tree Details | | Photos |
|---|---|---|
| Disposition | Remain | |

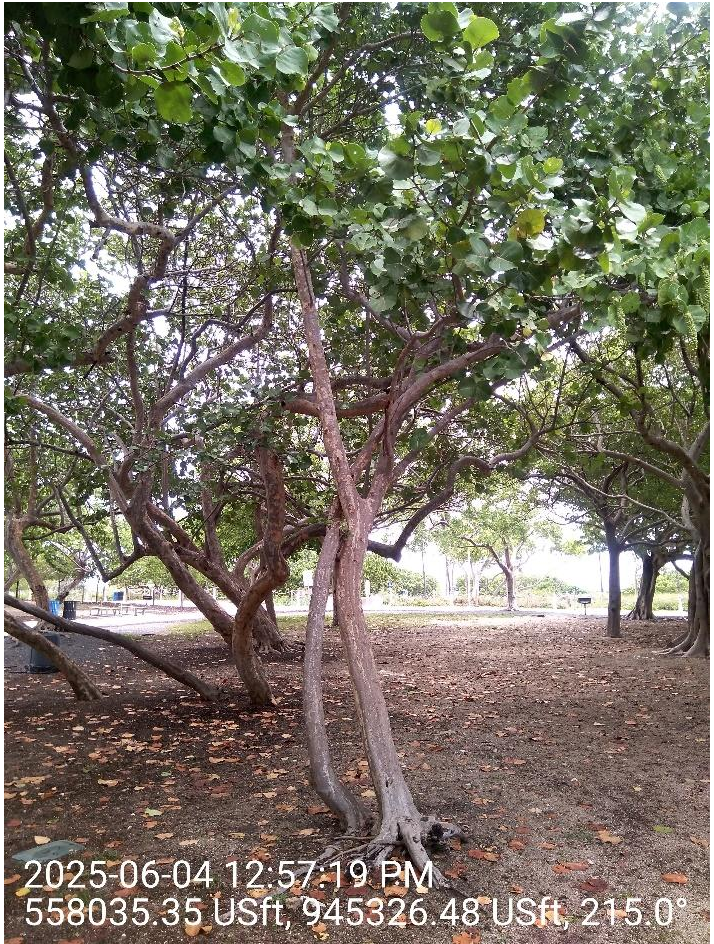
| Tree Details | | Photos |
|---|---|---|
| Tree ID | 8 | |

| Tree Details | | Photos |
|---|---|---|
| Observed Conditions | Bent Trunk, Co-Dominant Leaders | |
| Overall Condition | Fair | |
| Condition % | 50% | |

| Tree Details | | Photos |
|---|---|---|
| Disposition | Relocate | |

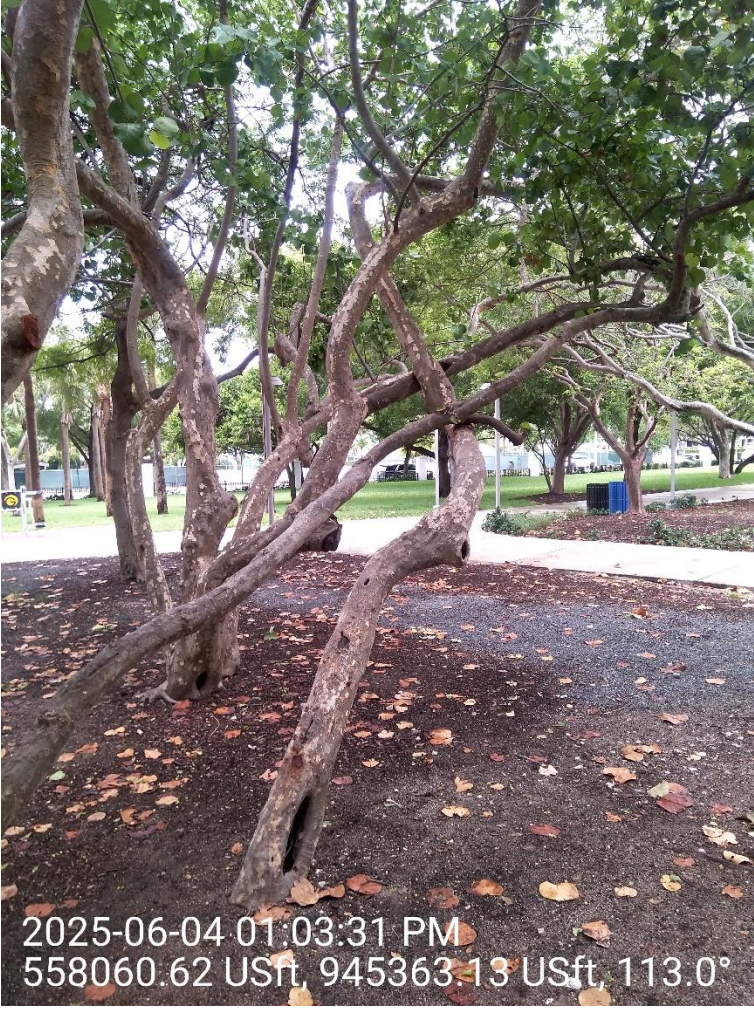
| Tree Details | | Photos |
|---|---|---|
| Tree ID | 14 | |

| Tree Details | | Photos |
|---|---|---|
| Observed Conditions | Bent Trunk, Limb Damage - Minor | |
| Overall Condition | Fair | |
| Condition % | 45% | |

| Tree Details | | Photos |
|---|---|---|
| Disposition | Relocate | |

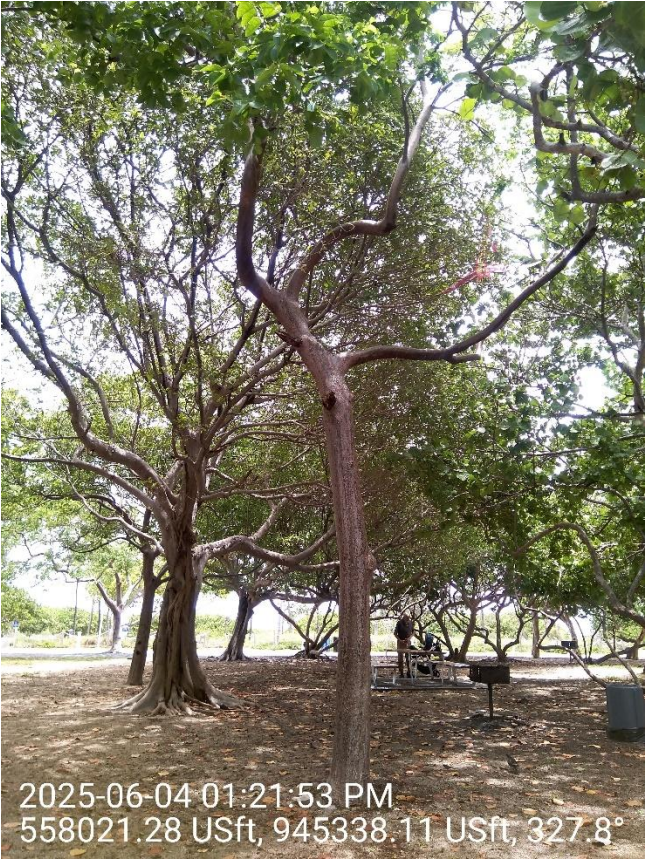
| Tree Details | | Photos |
|---|---|---|
| Tree ID | 26 | |

| Tree Details | | Photos |
|---|---|---|
| Observed Conditions | Bent Trunk, Limb Damage – Minor, Lopsided | |
| Overall Condition | Fair | |
| Condition % | 60% | |

| Tree Details | | Photos |
|---|---|---|
| Disposition | Relocate | |
