# **HISTORIC CHARACTER AND DESIGN ANALYSIS**

7418 Harding Avenue  
Miami Beach, Florida

**7418 Harding Avenue**  
Historic Character and Design Assessment

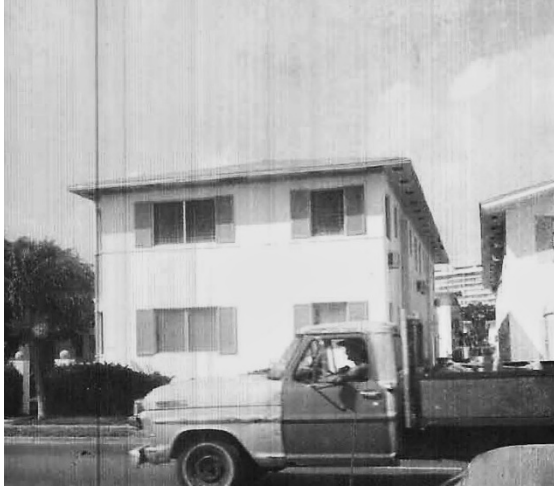
*Fig. 5. View of the north building from Harding Ave, January 1963 (Office of the Property Appraiser, Miami-Dade County).*

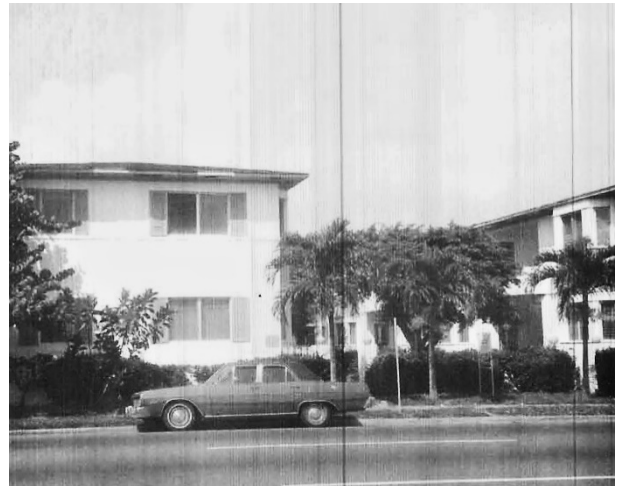
*Fig. 6. View of the south and north buildings from Harding Ave, January 1963 (Office of the Property Appraiser, Miami-Dade County).*

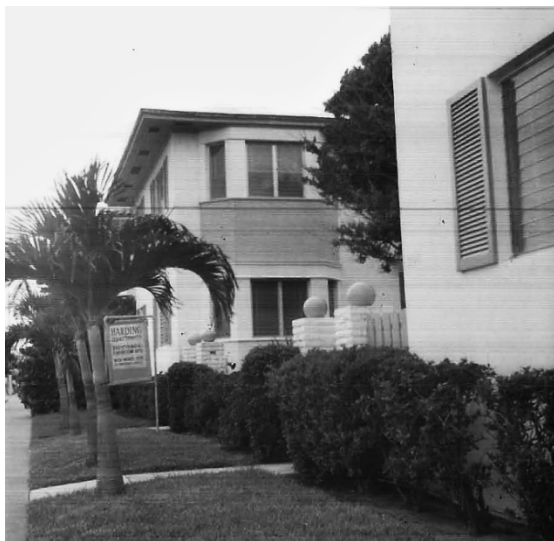
*Fig. 7. View of the south and north buildings from sidewalk, January 1963 (Office of the Property Appraiser, Miami-Dade County).*

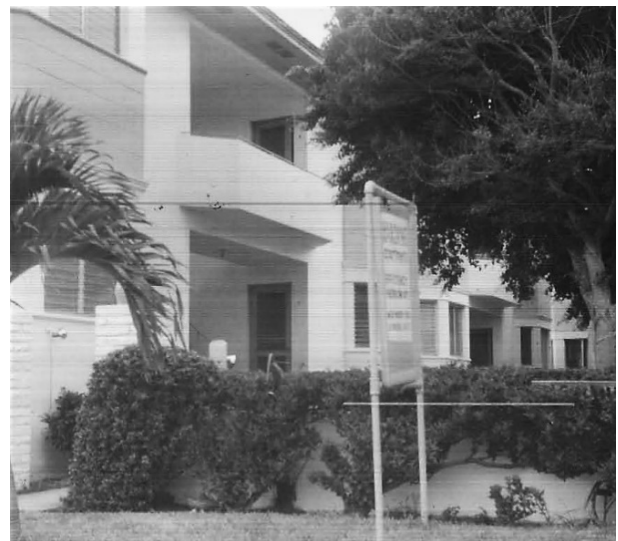
*Fig. 8. View of the south building entrance from courtyard, January 1963 (Office of the Property Appraiser, Miami-Dade County).*

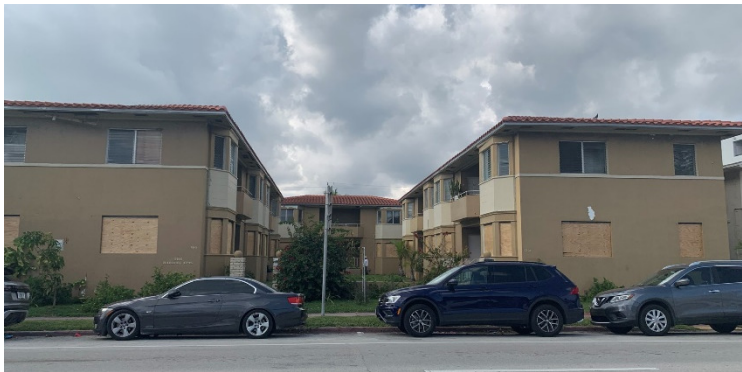
*Fig. 24. View of the site looking east from Harding Avenue, January 2022.*

Three free-standing structures are located on the site. The east buildings (N and S bars) are on Harding Avenue and are clearly visible from the street (Fig. 24 & 25). They are fronted by a sidewalk and are accessed via the Harding Avenue. The west building is situated near the rear lot line and is only slightly visible from Harding Avenue. The property is accessed from the ally and the open front area.

The primary historic structures are the 2-story buildings facing Harding Av. (Fig. 24 & 26) The main buildings are parallel and face an open grass area. The building is constructed with concrete block clad with stucco and features simple post war style. The structure has a low sloped clay tiled roof with slightly overhangs (Fig. 35).

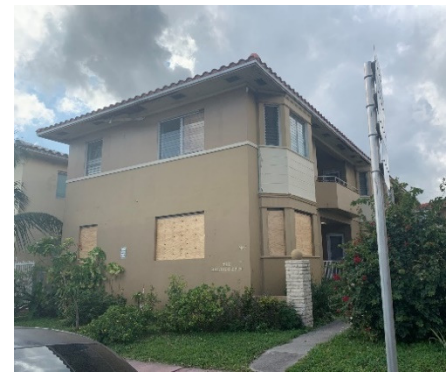
*Fig. 25. View of the south building looking east from Harding Avenue, January 2022.*

The south building is a secondary historic structure. It is 2 stories and closes off the courtyard space. It has similar features to the two front buildings, with one entry space in its center. (Fig. 24 & 25)

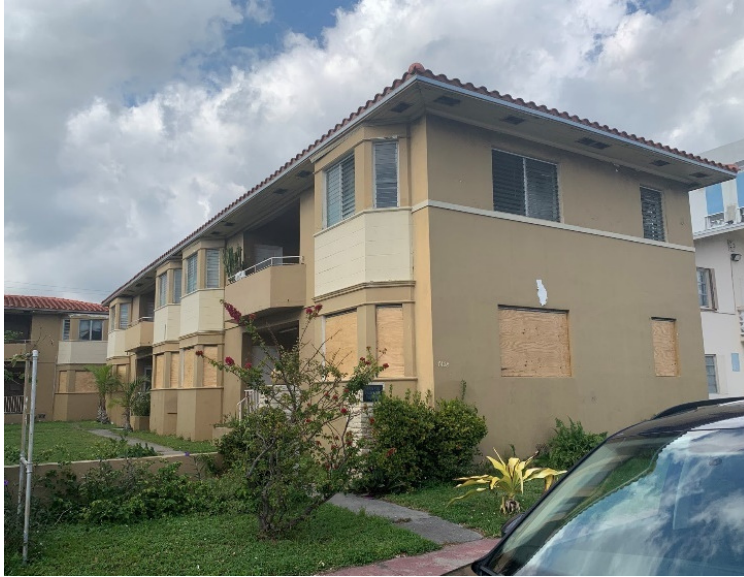
*Fig. 26. View of the north building looking east from Harding Avenue, January 2022.*

At the front facade, the buildings are simple, and each have 2 windows per floor. The windows are not original to the building (Fig 26). The door is accessed from a stoop covered with non-original square gray tile. The stoop appears to be larger than the original and the handrail configuration is blocking part of the window on the north side. (Fig. 32).

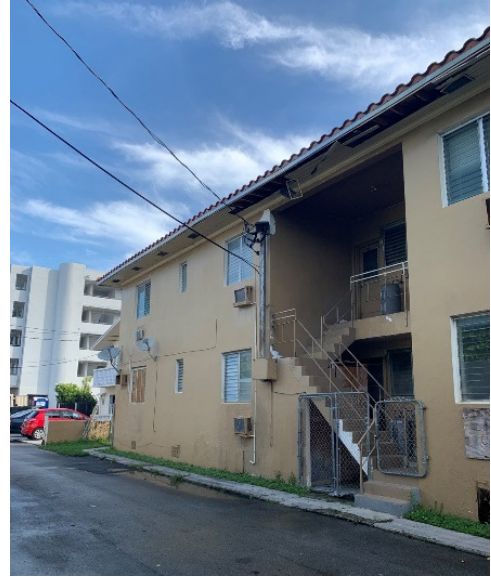
*Fig. 27. View of the East building from back alley, January 2022.*

The rear (west) elevation features a secondary exterior stair with stucco walls and non-original handrail that gives an access to the back alley. (Fig. 27)

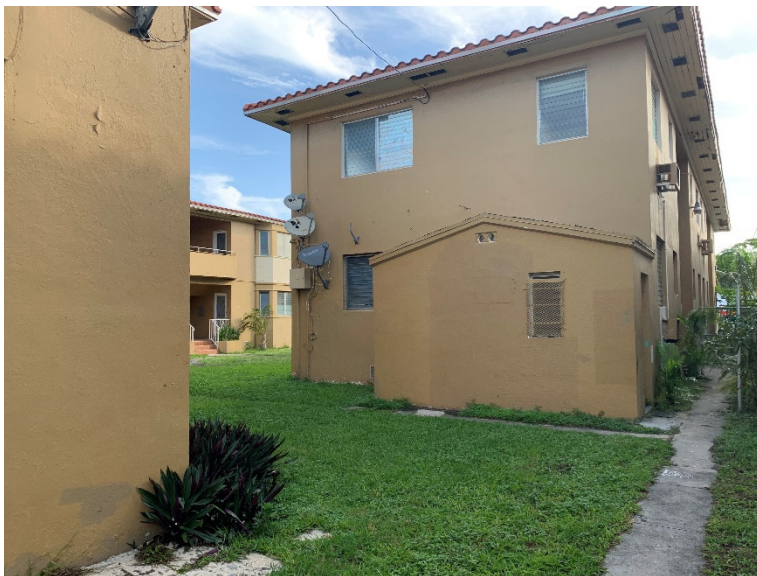
*Fig. 28. View of the south building from its rear side, January 2022.*

The west elevations of the North and South Buildings are not visible from the street and have 1 story sheds attached. (Fig. 28)

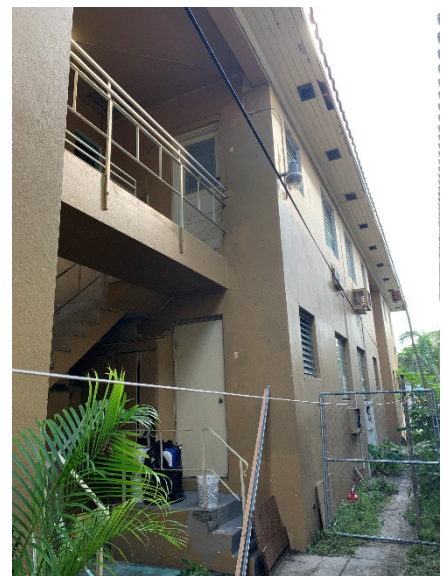
*Fig. 29. View of the rear side of the south building, January 2022.*

The rear (north/south) elevation features a secondary exterior stair with stucco walls and non-original handrail. (Fig. 29) The door hood at the 2<sup>nd</sup> Level is the same type as at the other doors. The stair has a non-original notched opening at the 1<sup>st</sup> Level that provides access to a small stoop with the same paving as at the front entrance. A door at the 1<sup>st</sup> Level is directly below the door at the 2<sup>nd</sup> Level. The secondary exterior stairs are partially hidden behind the building and are partially visible from the street.

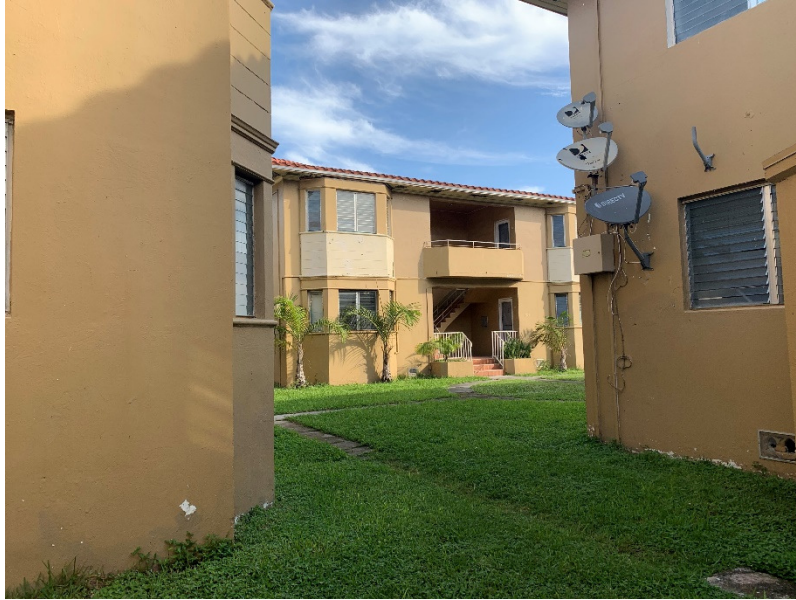
*Fig. 30. View of the open area side of the north building, January 2022.*

Each residential unit has exterior access from the central open area. The ground floor units have entry's directly from a stoop covered in tile. The exposed stair goes up to a landing balcony between two additional units. (Fig. 34) This elevation is composed of repeating bay windows (Fig. 33) and is duplicated once more along a central axis (Fig. 30).

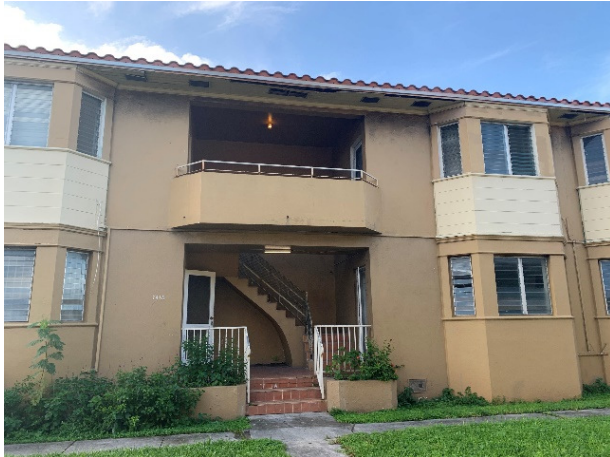
*Fig. 31. North façade of south site building,  
January 2022.*

At the front facade, the building is identical to the open area elevations of the north & south buildings, with repeating bay windows & exposed staircases. (Fig. 31 & 32)

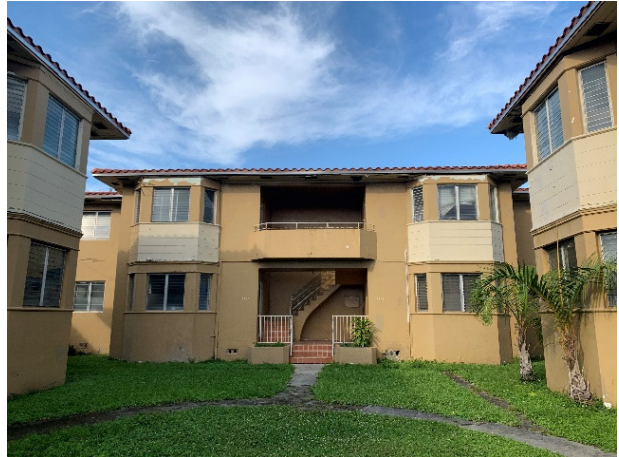
*Fig. 32. East façade of West site building,  
January 2022.*

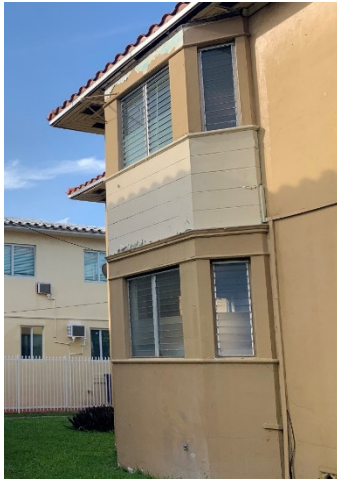
*Fig 33. Detail of bay window/jalousie window*

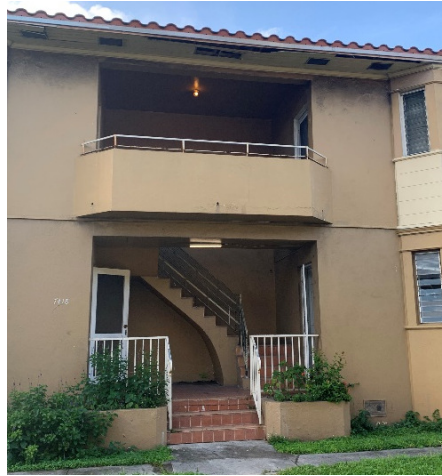
*Fig. 34. Detail of outdoor staircases with inset balcony.*
