# SKETCH OF BOUNDARY SURVEY

**PROPERTY ADDRESS:**  
7801 Atlantic Way  
Miami Beach, Florida 33141-2120

**LEGAL DESCRIPTION:**  
Lot 6, Block 5, of Corrected Plat Altos Del Mar No. 1, according to the Plat thereof, as recorded in Plat Book 31, Page 40, of the Public Records of Miami-Dade County, Florida.  
Lot 6 bounded as follows: Bounded on the North by the dividing line between Lots 5 and 6; Bounded on the South by the Southerly line of Lot 6, said Southerly line also being the Northerly line of 78th Street; Bounded on the West by the Westerly line of Lot 6, said Westerly line also being the Easterly line of Atlantic Way; Bounded on the East by the Erosion Control Line of the Atlantic Ocean, as recorded in Plat Book 105, at Page 62, of the Public Records of Miami-Dade County, Florida.

SHEET:  
**1** OF 3

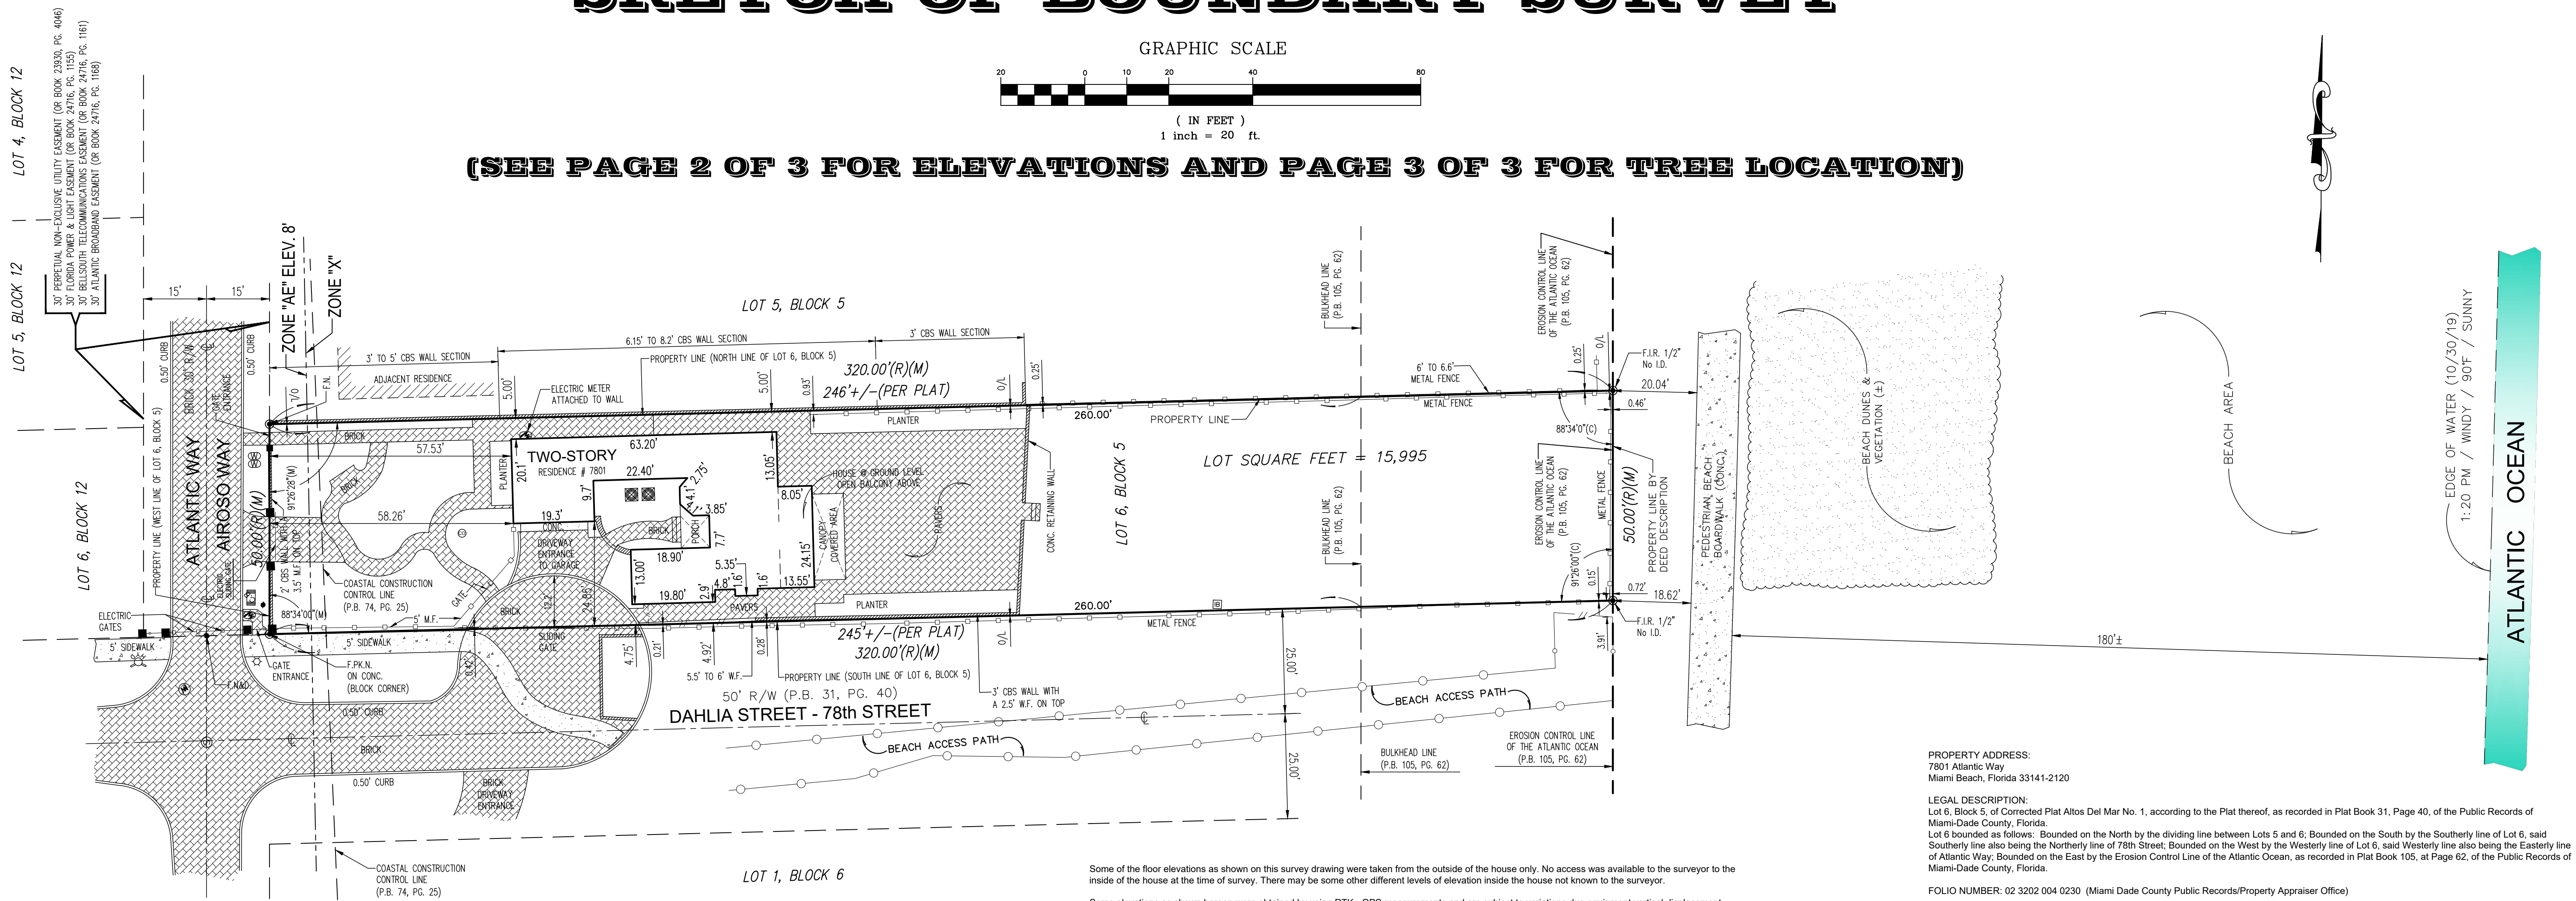
(SEE PAGE 2 OF 3 FOR ELEVATIONS AND PAGE 3 OF 3 FOR TREE LOCATION)

Survey done by occupation, physical evidence, the recovery of existing property corners, field measurements, calculations, adjacent plats and legal description provided to the surveyor and also from the Miami-Dade County Public Records/ Property Appraiser Office and no claims as to ownership are made or implied.

The legal ownership of the fences and/or walls as shown hereon was not determined, and the locations as shown are based on the recovered boundary monumentation and calculations.

Distances from property lines to fences or walls may slightly varies due to their irregularity, width and composition. Fences or walls not always travel on a straight line and in most cases meander through trees, hedges, vines and heavy landscaping usually located along boundary lines, therefore the resultant said dimensions as shown hereon may vary slightly within 0.30' to 0.50' of a foot more or less.

Obstructed property corners are witnessed by improvements.

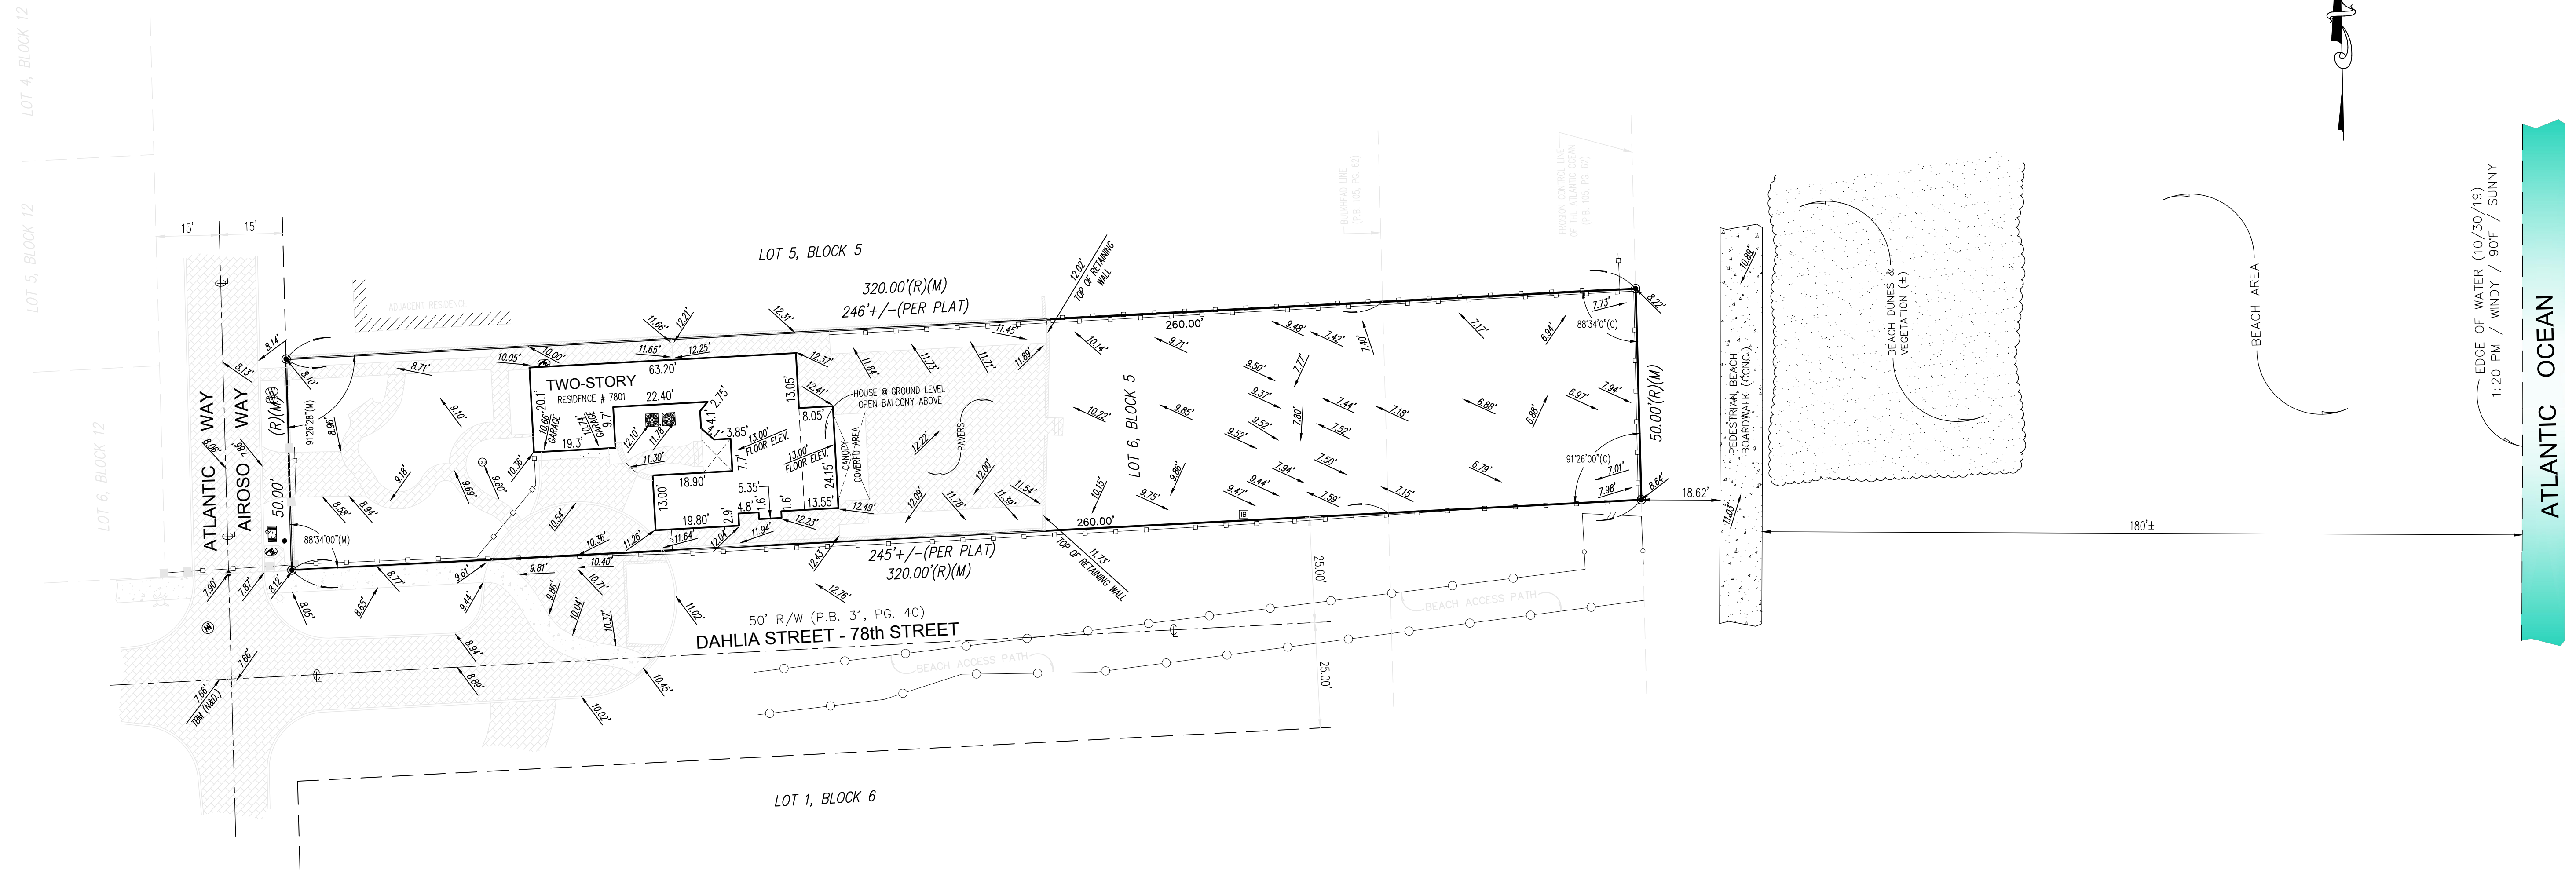
SHEET:  
**2** OF 3

Some of the floor elevations as shown on this survey drawing were taken from the outside of the house only. No access was available to the surveyor to the inside of the house at the time of survey. There may be some other different levels of elevation inside the house not known to the surveyor.

Some elevations as shown hereon were obtained by using RTK - GPS measurements and are subject to variations due equipment vertical displacement. Elevations taken in the sand area of the subject property can fluctuate due to erosion, weather elements like rain, wind, etc.

All elevations as shown on this Survey drawing are referred to the National Geodetic Vertical Datum, 1929 (NGVD).

(SEE PAGE 1 OF 3 FOR BOUNDARY INFORMATION AND PAGE 3 OF 3 FOR TREE LOCATION)

**BENCHMARK REFERENCES:**  
Benchmark: CMB 78-01  
Elevation: 2.71 feet (NAVD 1988) / 4.25 feet (NGVD 1929) by GPS conversion factor.  
Location: NE INTX 78TH ST & ABBOTT AVE  
Status: Survey  
GPS: N  
Painted: N  
Description: PK NAIL & WASHER ON TOP OF CURB  
Benchmark: CMB 80-11  
Elevation: 2.43 feet (NAVD 1988) / 3.97 feet (NGVD 1929) by GPS conversion factor.  
Location: NE INTX ABBOTT AVE & 80 ST  
Status: Survey  
GPS: N  
Painted: N  
Description: PK N&W ON TOP OF CURB

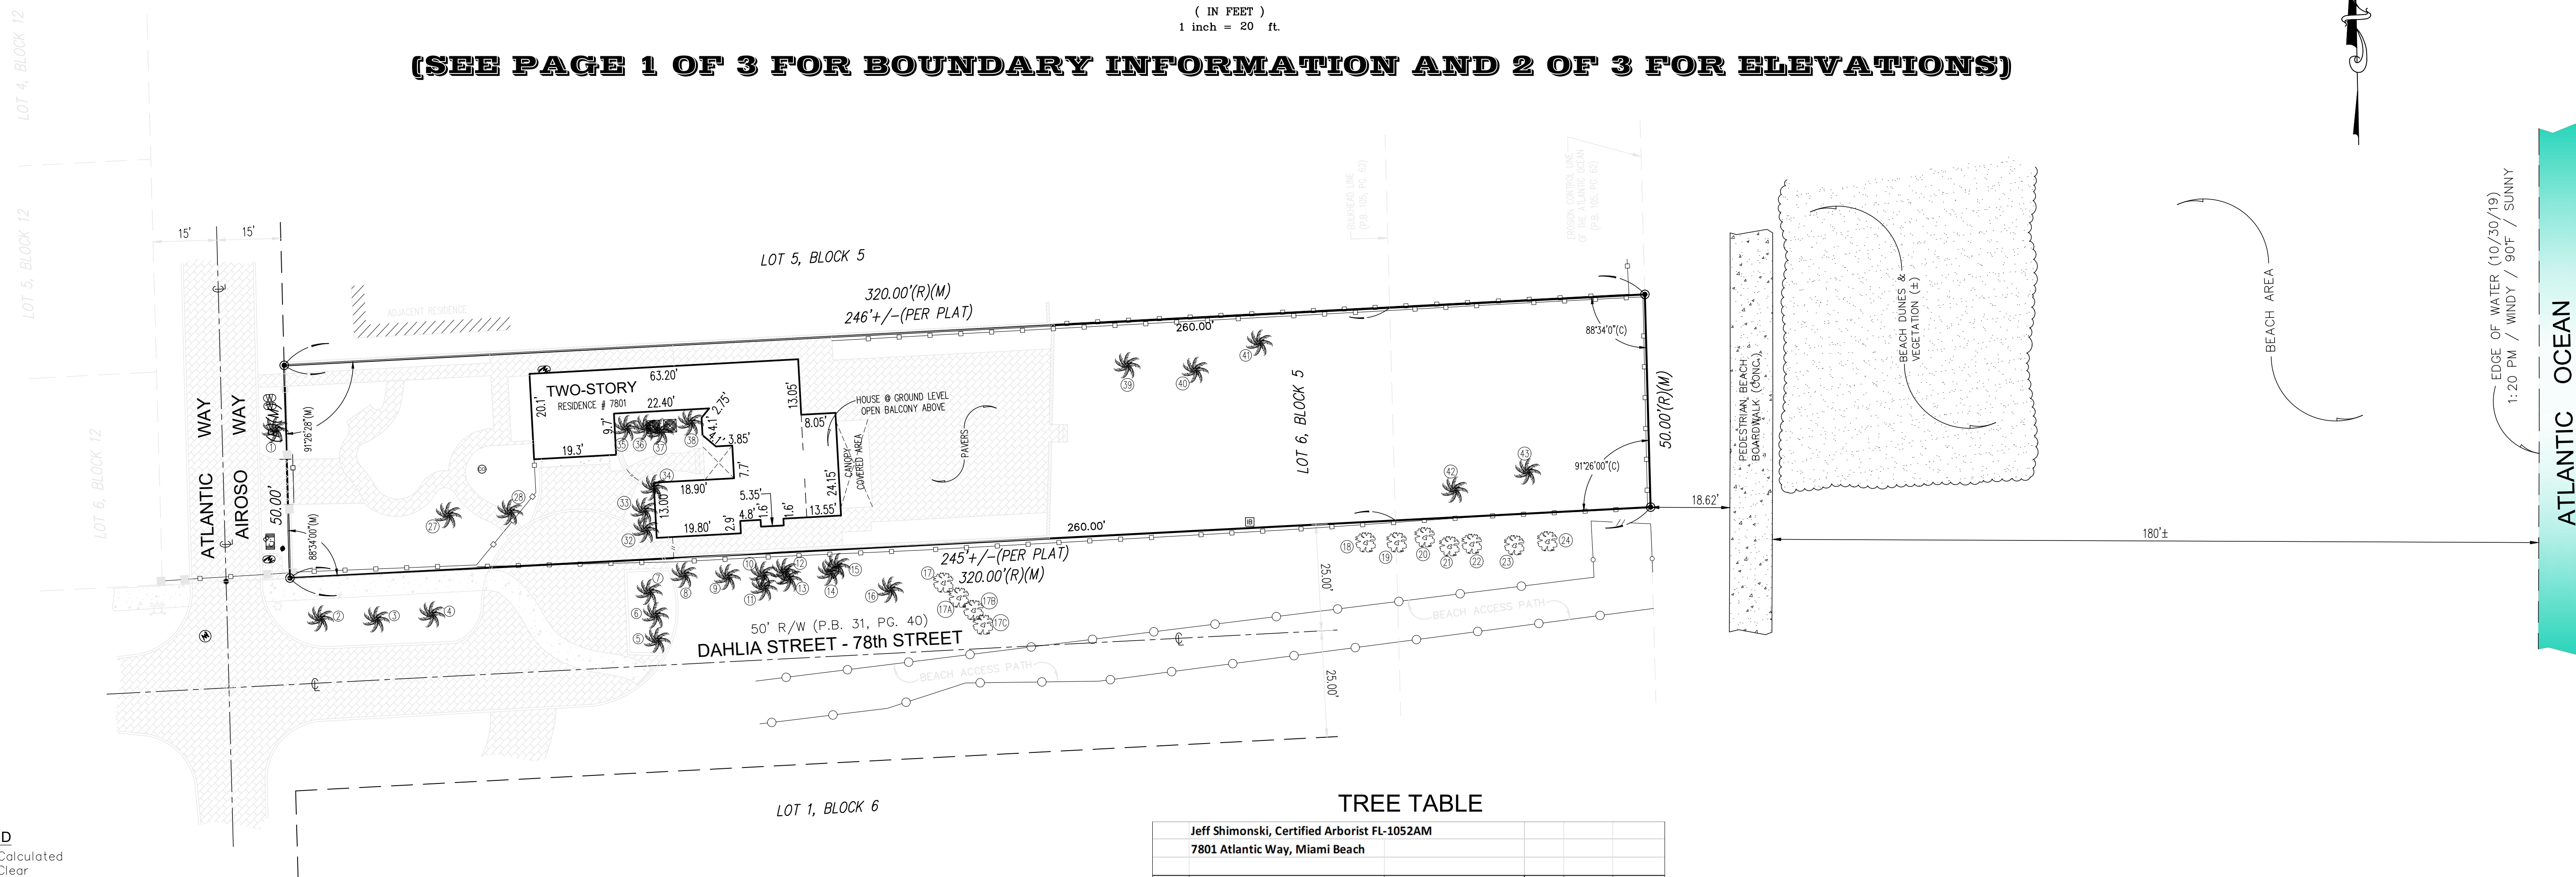
SHEET:  
**3** OF 3

(SEE PAGE 1 OF 3 FOR BOUNDARY INFORMATION AND 2 OF 3 FOR ELEVATIONS)

The location of the trees as shown on this survey drawing are compiled from such field surveys deemed necessary by Jorge L. Cabrera, PSM, therefore the resultant of said dimensions shown hereon could vary slightly within 1 to 2 feet more or less.

The Tree Table as shown hereon was prepared by certified Arborist Jeff Shimonski, information below:

Only the trees inside the subject property were revised at the time of the updated survey on May 23rd, 2022 under Job Number 19-5113D. Trees outside the subject property were not updated and was not part of the scope of work provided to the client.
