Executive Summary for the Removal of Lattice Profiles in the AMAN Residence Design

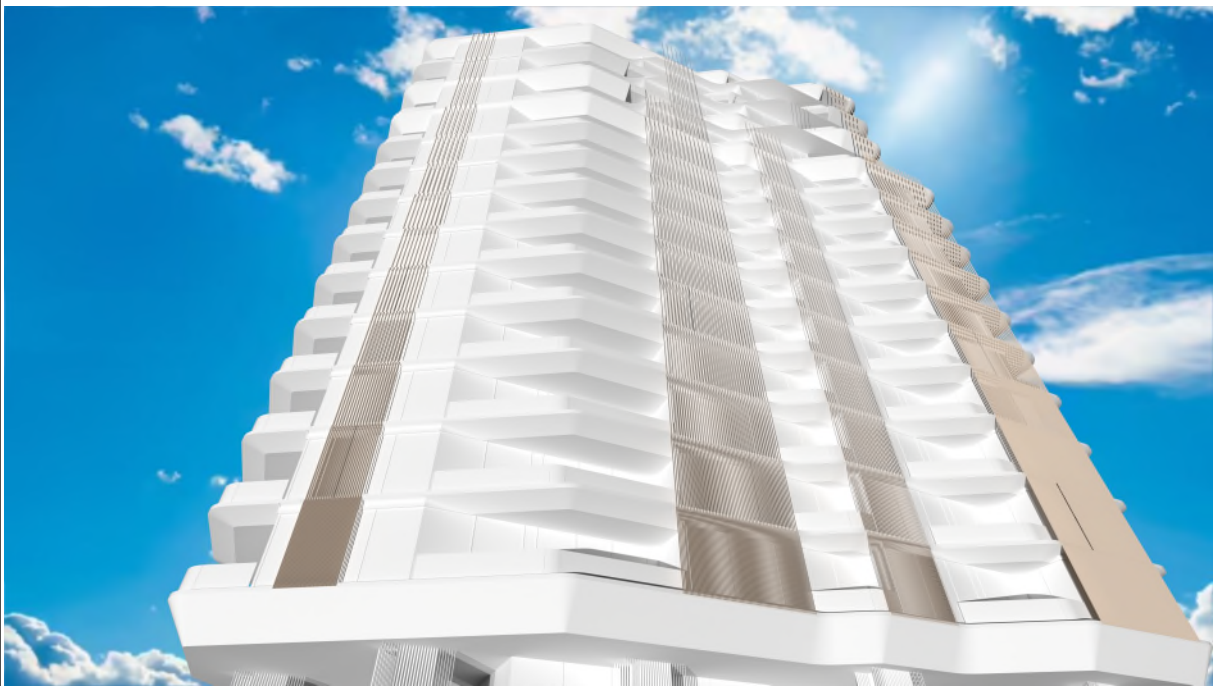
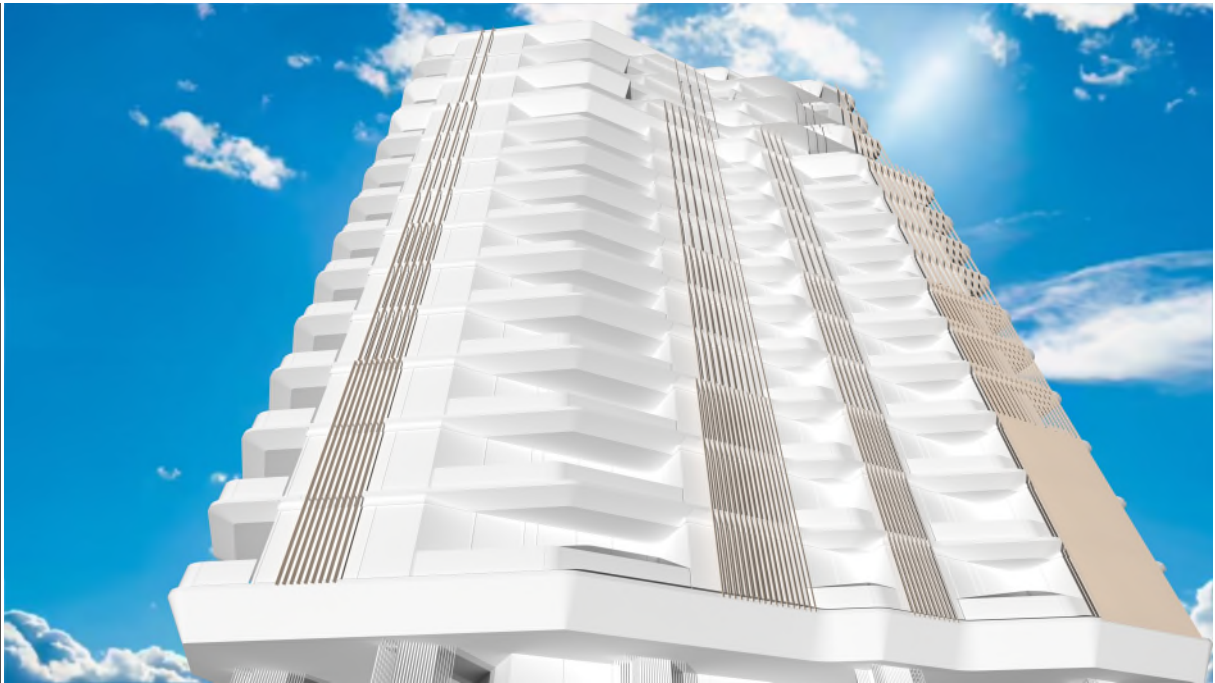
The initial conceptualization featured thinner, more numerous lattice profiles intended to complement the building's aesthetic. However, engineering analyses revealed that these profiles, constructed from aluminum, presented significant structural challenges. The slender design threatened to bend or even break under environmental stresses such as wind loads. This deformation risk was heightened by the proximity of the lattice to the facade glass, posing potential contact and damage — scenarios unacceptable by structural integrity standards. Additionally, compensatory design adjustments necessitated the profiles' thickening, deviating from the architectural intent and introducing further complications.

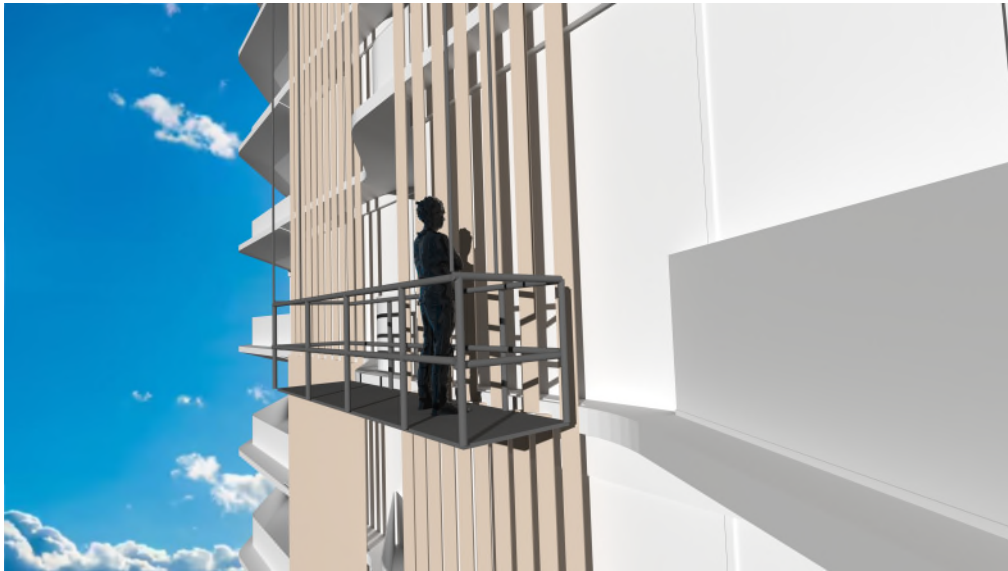
The lattice profiles, in their original and modified forms, severely obstructed access to the building's glazing for routine cleaning and maintenance. This obstruction not only raises operational costs but also diminishes the building's sustainability by increasing the difficulty of maintaining the glass surfaces in prime condition. The lattice thus emerges as a prohibitive factor against maintaining the building's aesthetic and functional longevity, contrary to initial design objectives that prioritize ease of maintenance and operations.

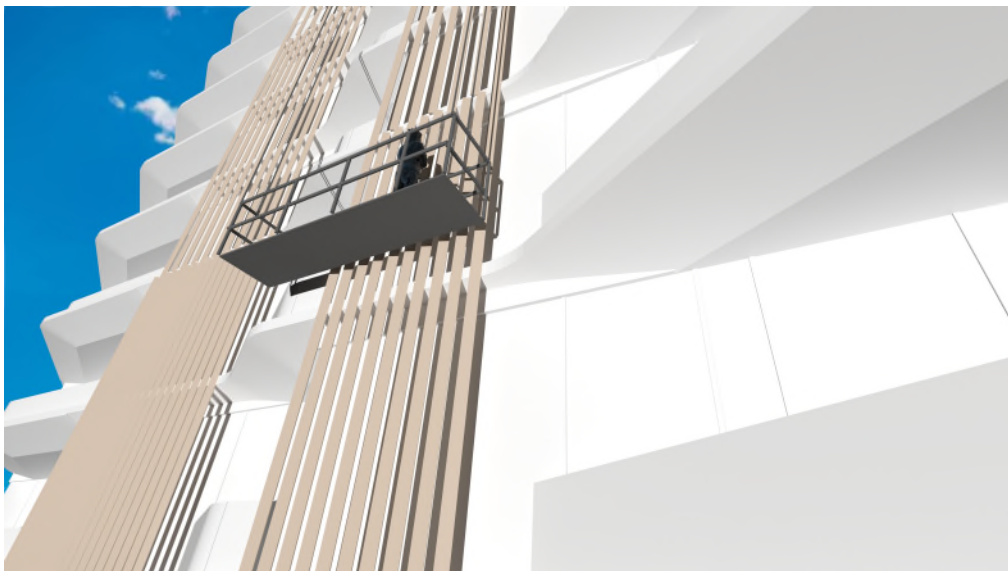
Incorporating the lattice profiles induces potential hazards for maintenance personnel tasked with facade cleaning. The presence of these architectural elements introduces collision risks that could compromise safety during cleaning operations. Furthermore, any accidental impact with these profiles during maintenance activities could lead to facade damage or personnel injury, warranting significant concern and revision.

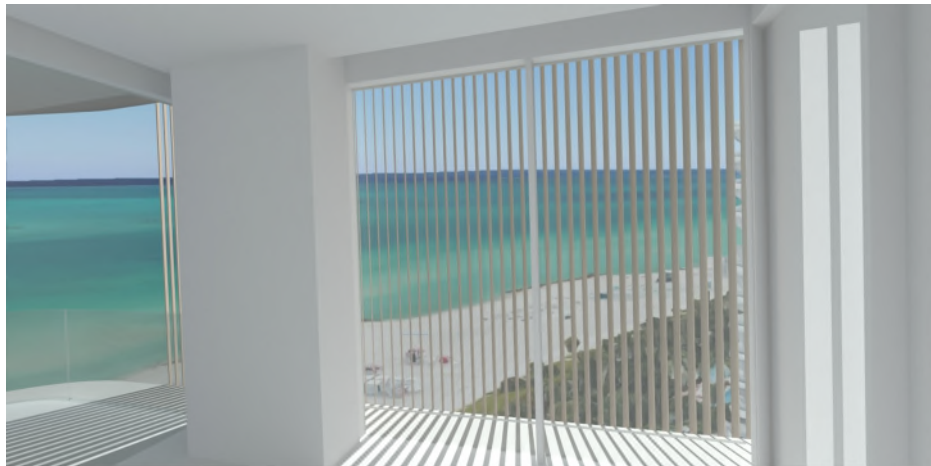
Original Design

The transition to thicker lattice profiles not only results in visual clutter but has engendered discontent among residents, whose views have been obstructed significantly. This alteration diminishes the living experience and aesthetic value perceived by apartment owners, which were intrinsic selling points of the development. The broader and denser profiles compromise the transparency and openness initially promised, leading to legitimate grievances from current and prospective residents.
