# SKETCH OF BOUNDARY SURVEY

PROPERTY ADDRESS:  
7801 Atlantic Way  
Miami Beach, Florida 33141-2120

**LEGAL DESCRIPTION:**  
Lot 6, Block 5, of Corrected Plat Altos Del Mar No. 1, according to the Plat thereof, as recorded in Plat Book 31, Page 40, of the Public Records of Miami-Dade County, Florida.  
Lot 6 bounded as follows: Bounded on the North by the dividing line between Lots 5 and 6; Bounded on the South by the Southerly line of Lot 6, said Southerly line also being the Northerly line of 78th Street; Bounded on the West by the Westerly line of Lot 6, said Westerly line also being the Easterly line of Atlantic Way; Bounded on the East by the Erosion Control Line of the Atlantic Ocean, as recorded in Plat Book 105, at Page 62, of the Public Records of Miami-Dade County, Florida.

| SHEET: | 1 OF 3 |

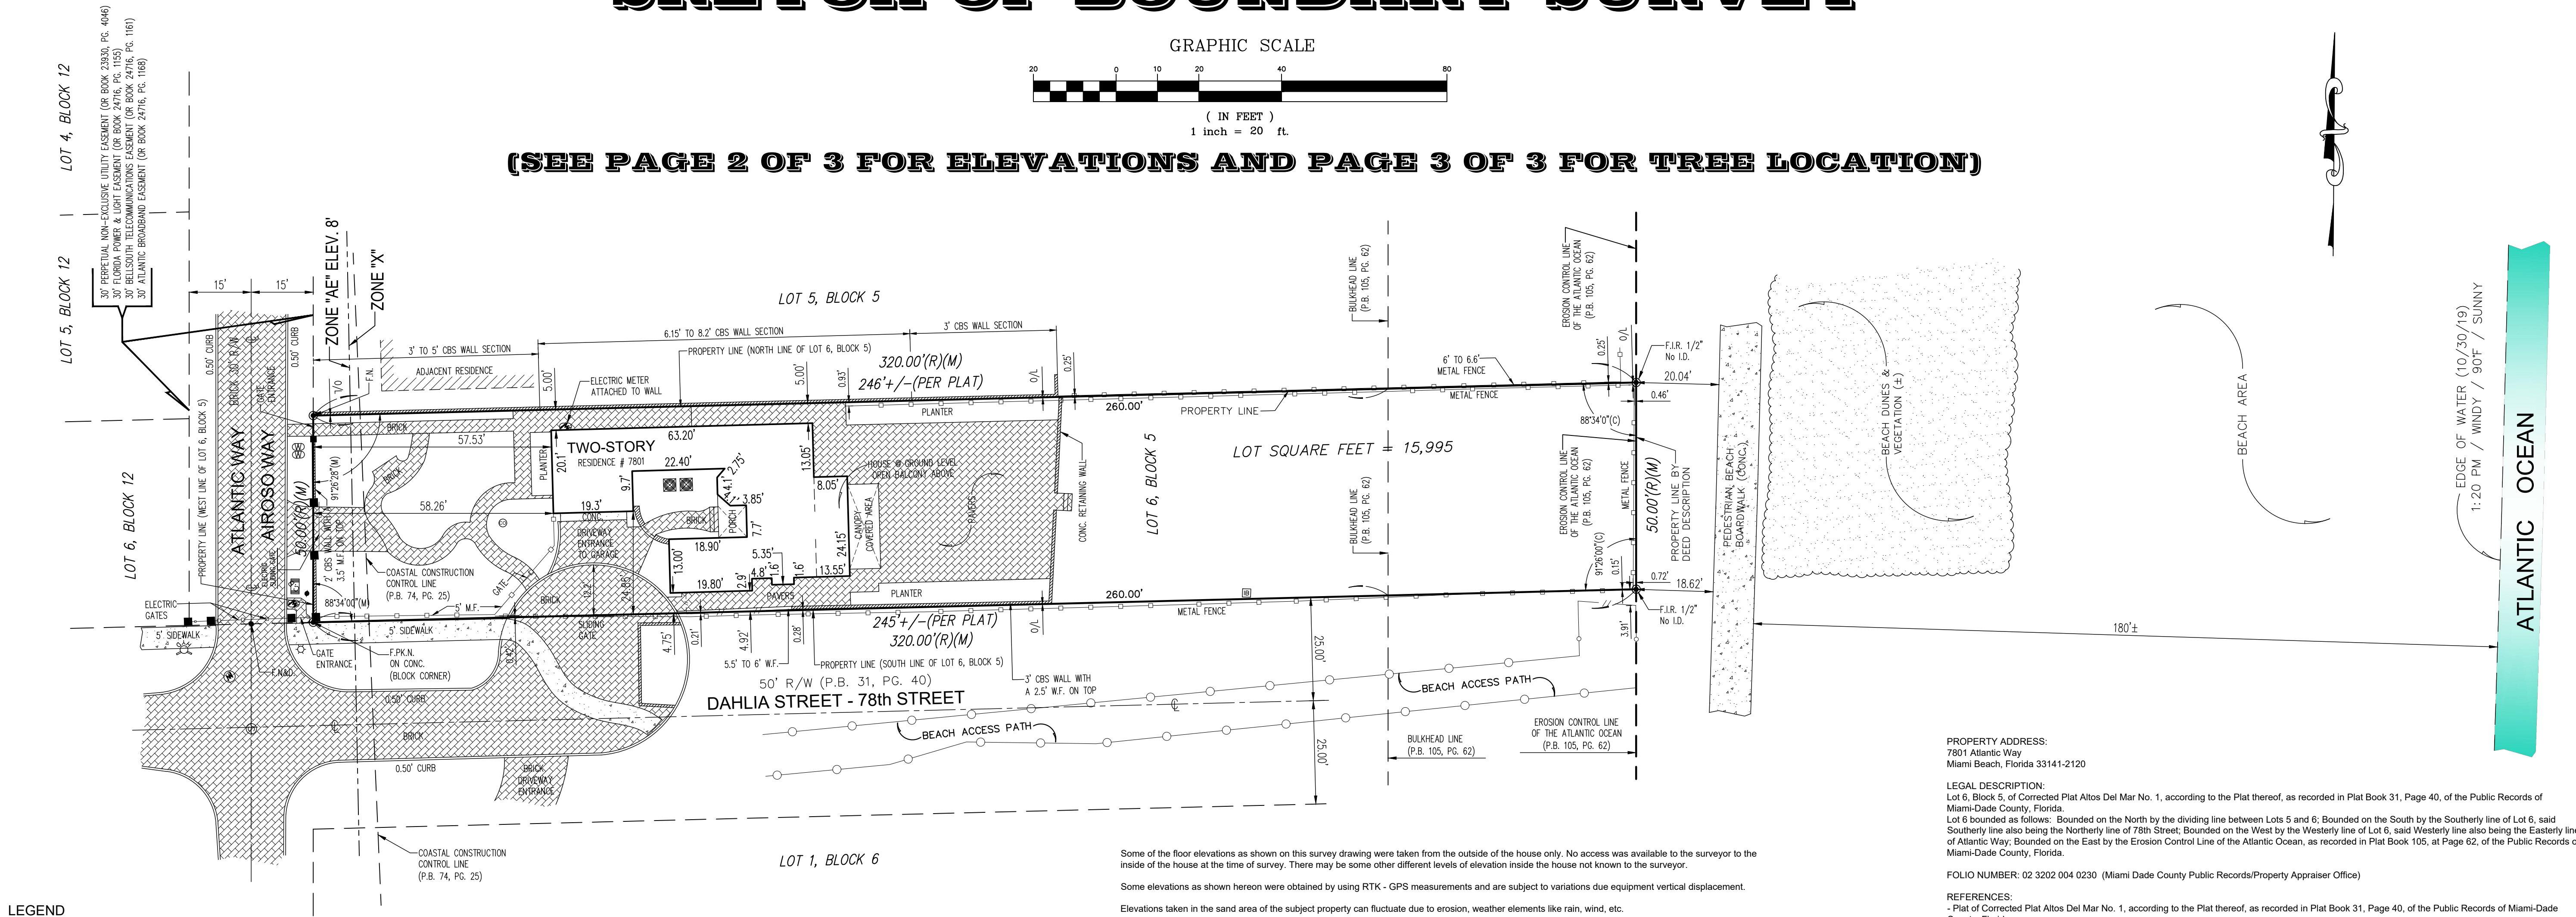
(SEE PAGE 2 OF 3 FOR ELEVATIONS AND PAGE 3 OF 3 FOR TREE LOCATION)

Survey done by occupation, physical evidence, the recovery of existing property corners, field measurements, calculations, adjacent plats and legal description provided to the surveyor and also from the Miami-Dade County Public Records/Property Appraiser Office and no claims as to ownership are made or implied.

Distances from property lines to fences or walls may slightly varies due to their irregularity, width and composition. Fences or walls not always travel on a straight line and in most cases meander through trees, hedges, vines and heavy landscaping usually located along boundary lines, therefore the resultant of said dimensions as shown hereon may vary slightly within 0.30' to 0.50' of a foot more or less.

In some instances graphic representations have been exaggerated to more clearly illustrate the relationship between physical improvements and/or lot lines. In all cases dimensions shall control the location of the improvements over scaled positions.

The dimensions and directions shown hereon are in substantial agreement with the legal description and calculated values unless otherwise noted.

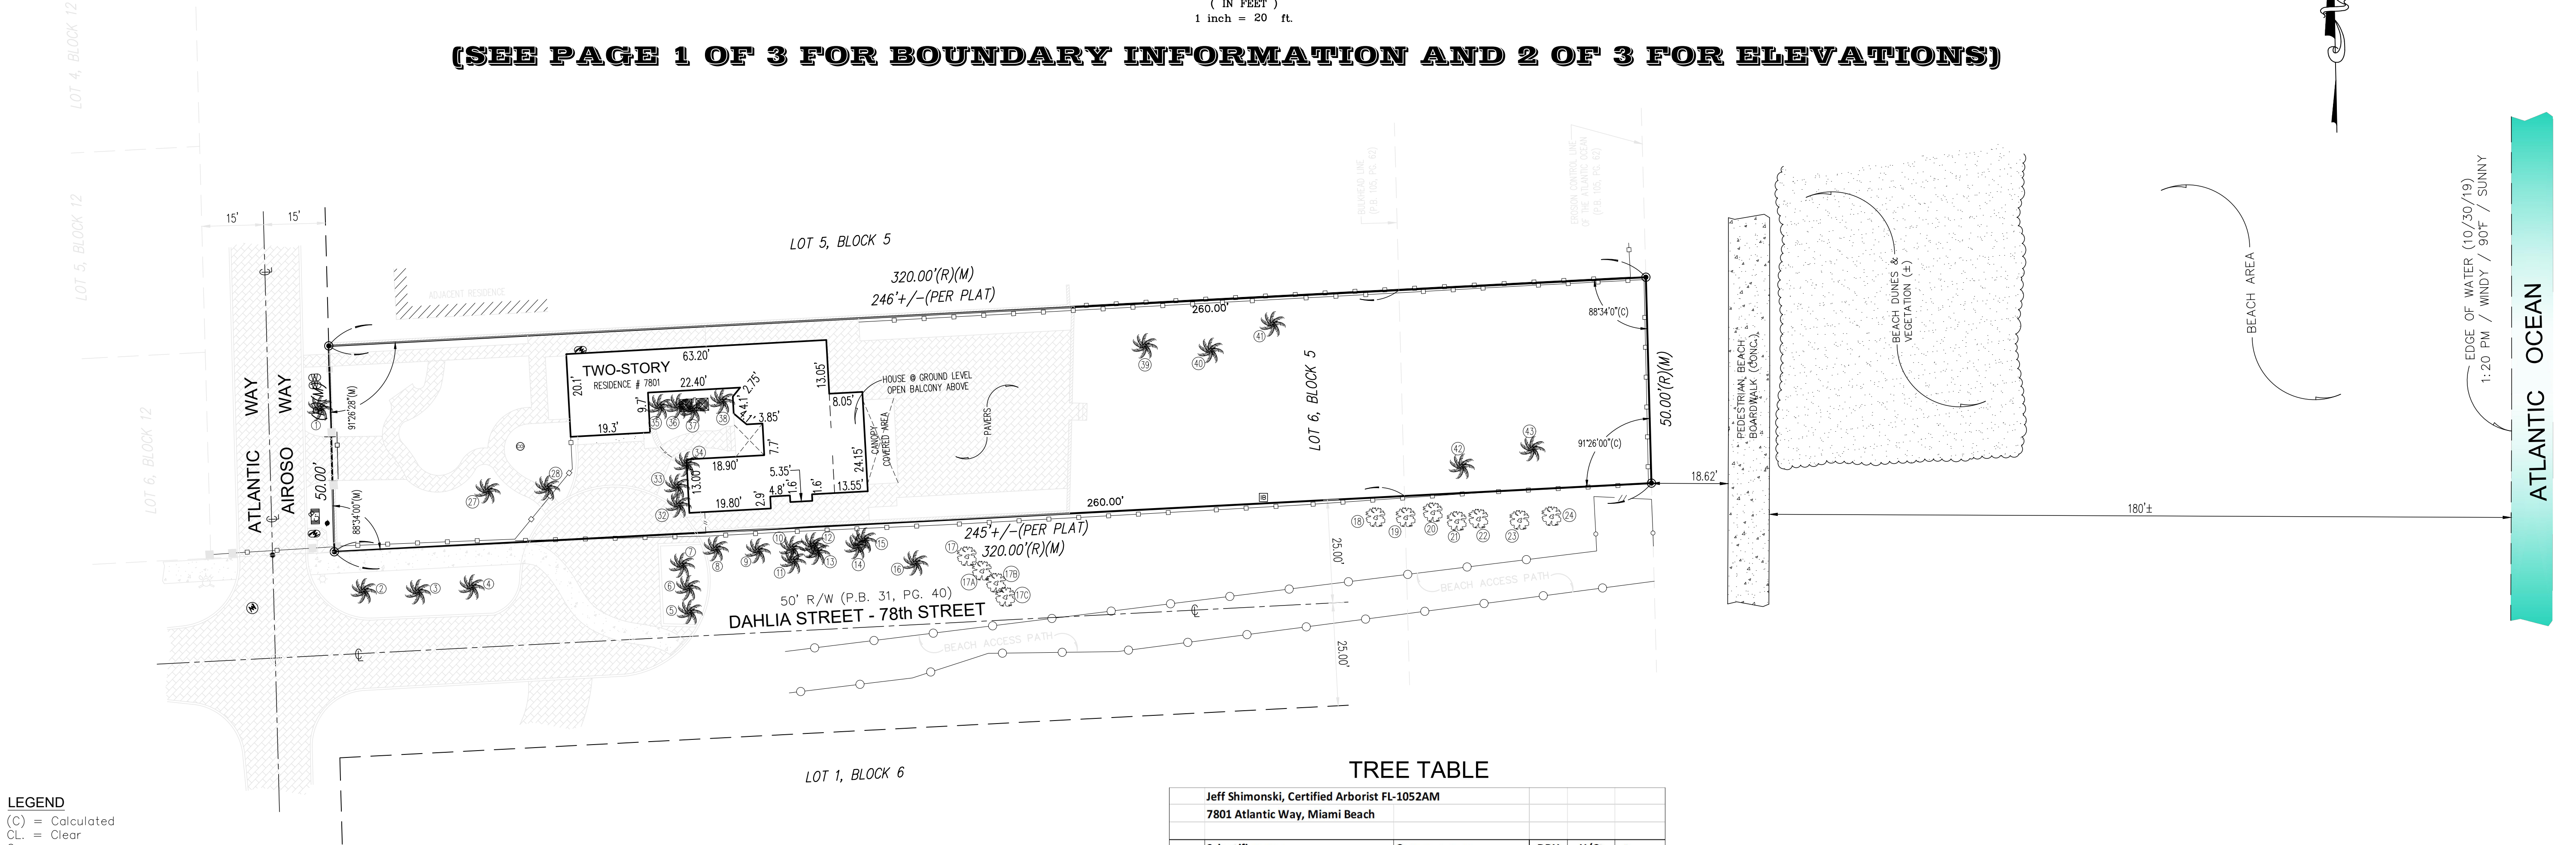
SHEET:  
**3** OF 3

Only the trees inside the subject property were revised at the time of the updated survey on May 23rd, 2022 under Job Number 19-5113D. Trees outside the subject property were not updated and was not part of the scope of work provided to the client.

(SEE PAGE 1 OF 3 FOR BOUNDARY INFORMATION AND 2 OF 3 FOR ELEVATIONS)

The location of the trees as shown on this survey drawing are compiled from such field surveys deemed necessary by Jorge L. Cabrera, PSM, therefore the resultant of said dimensions shown hereon could vary slightly within 1 to 2 feet more or less.
