# 235 Washington Avenue

HPB25-0645

Historic Preservation Board

March 17, 2026

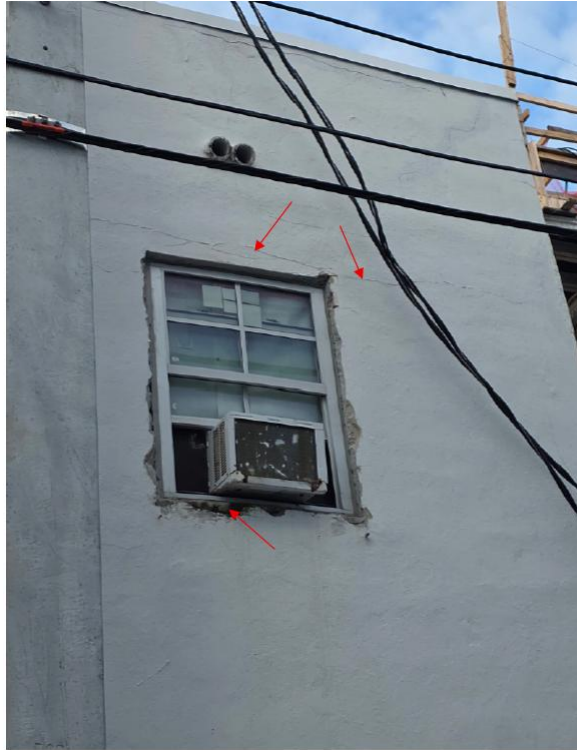
Spall and delaminated stucco and concrete present

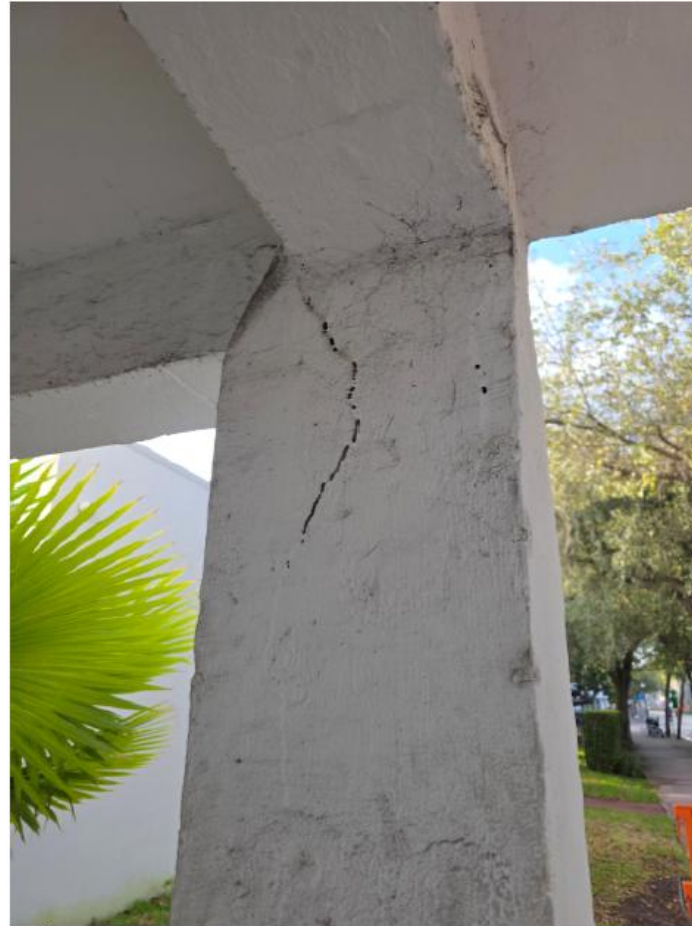
Spall and delaminated stucco and concrete present

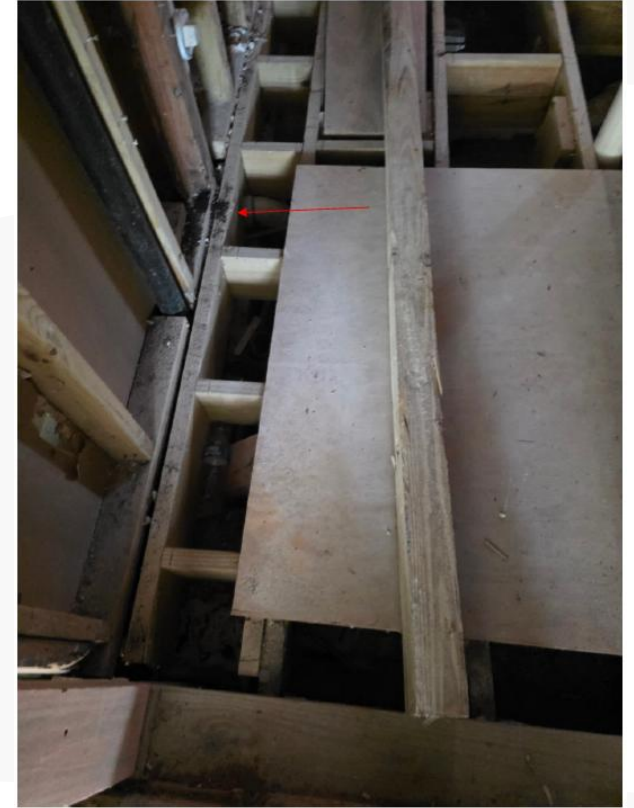
Termite dropping and stud damage

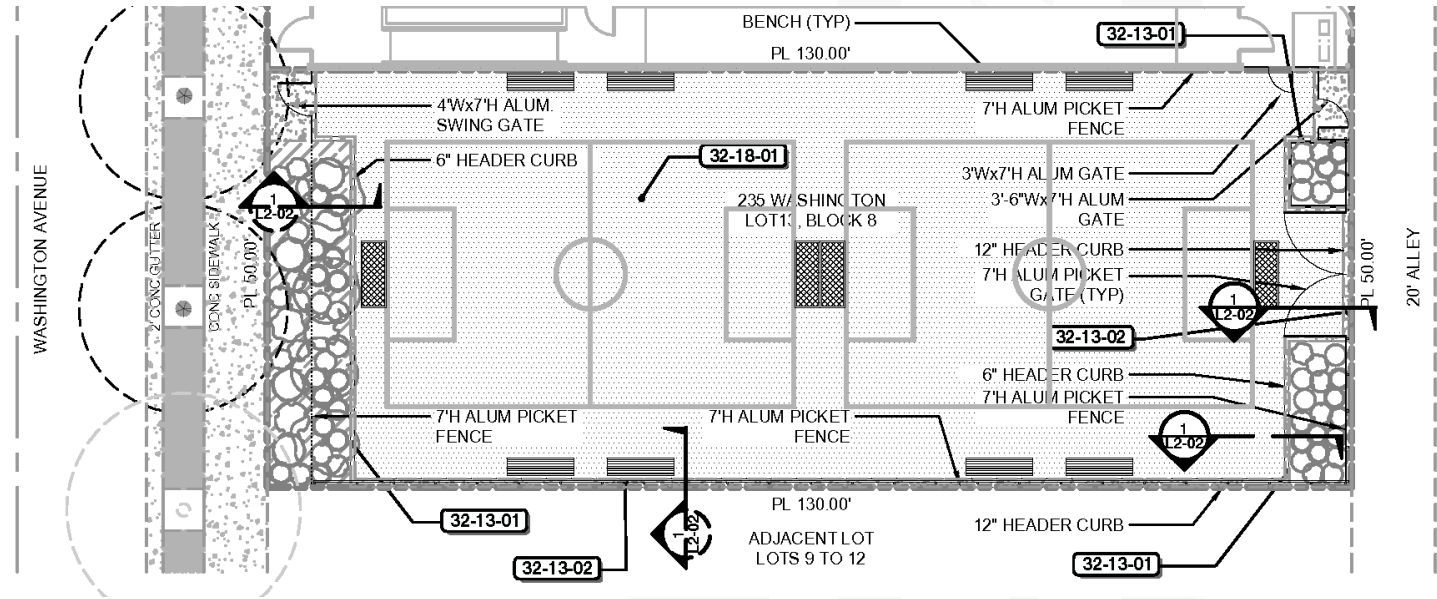
32-18-01	TURF	5,648 sf	1.75" Tall	Tiger Turf	Everglade Spring Pro

- **Product:** TigerTurf Everglade Spring Pro — a permeable synthetic turf with a drainage rate of 30+ inches per hour per square yard.
- **Performance & Application:** Engineered for high-traffic environments and continuous youth recreation, providing superior shock absorption and long-term durability.

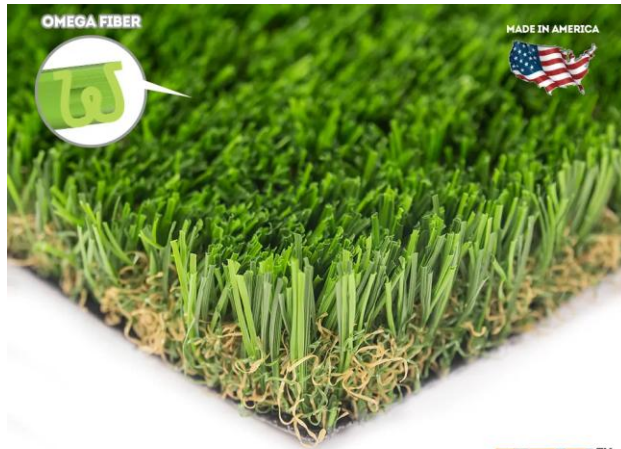
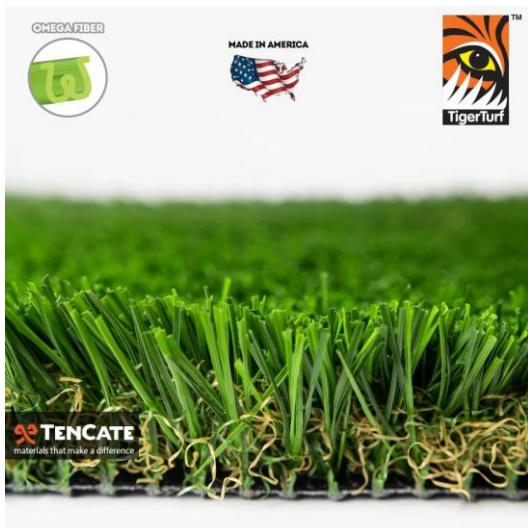
# TigerTurf Everglade Spring Pro

- Multi-tone blend of field and lime green fibers with a brown thatch layer creates a natural grass appearance that integrates seamlessly into the campus environment
- Maintains a uniform and visually consistent open-space surface despite intensive daily student use, avoiding the deterioration and patchiness typical of natural sod in high-traffic school settings
- Permeable system supports on-site drainage and prevents standing water, ensuring the recreation area remains functional without creating runoff or maintenance concerns

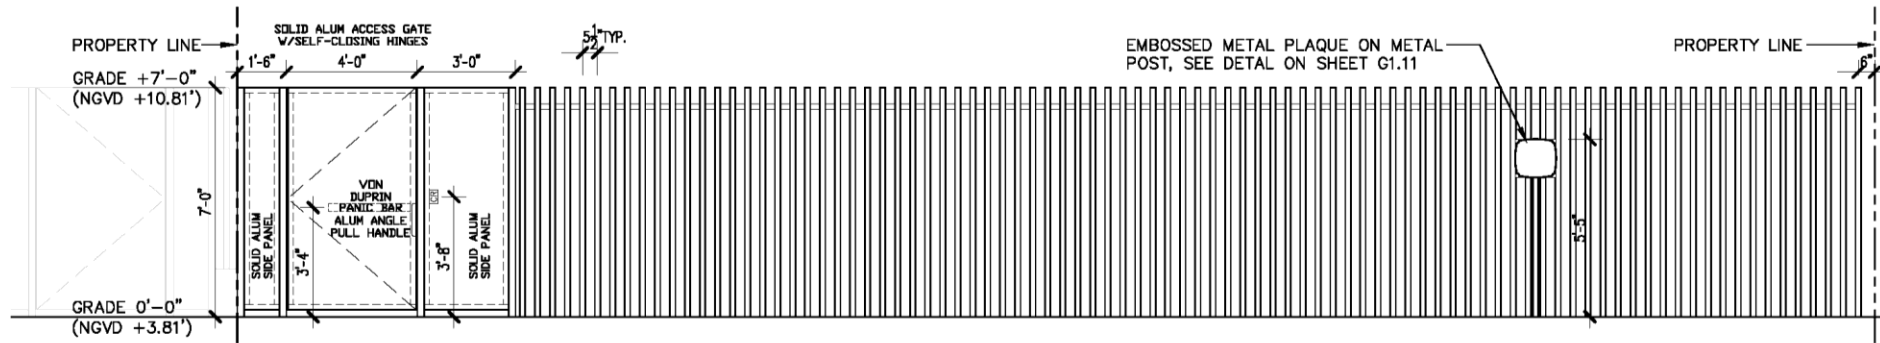
1 West Elevation (Washington) 1/4" = 1'-0"  
G1.12 7' High Aluminum Fence & Gate

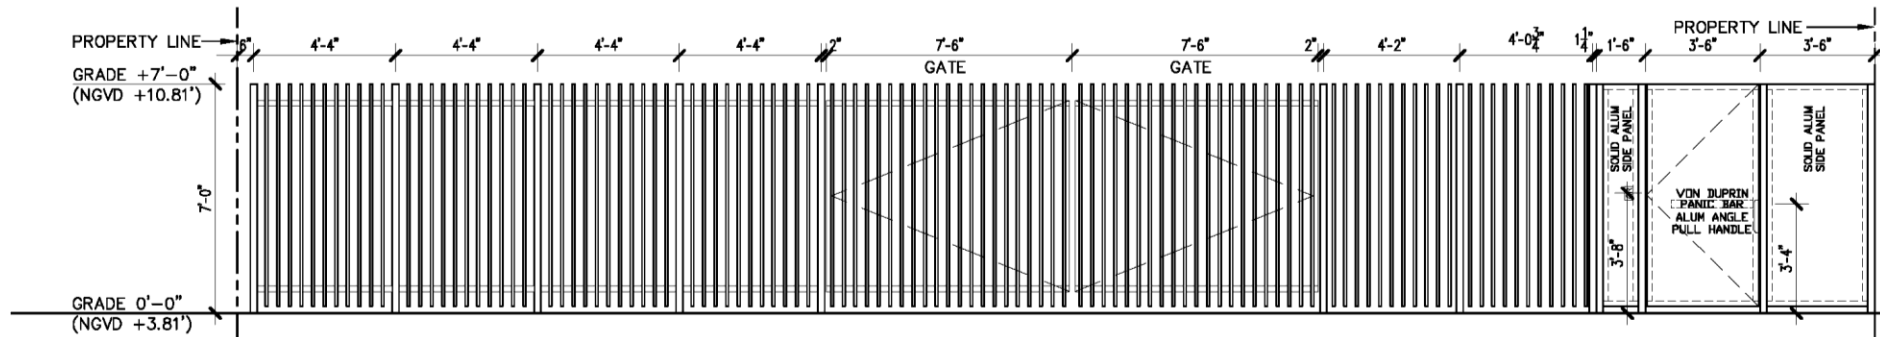
2 East Elevation (Alley) 1/4" = 1'-0"  
G1.12 7' High Aluminum Fence & Gates

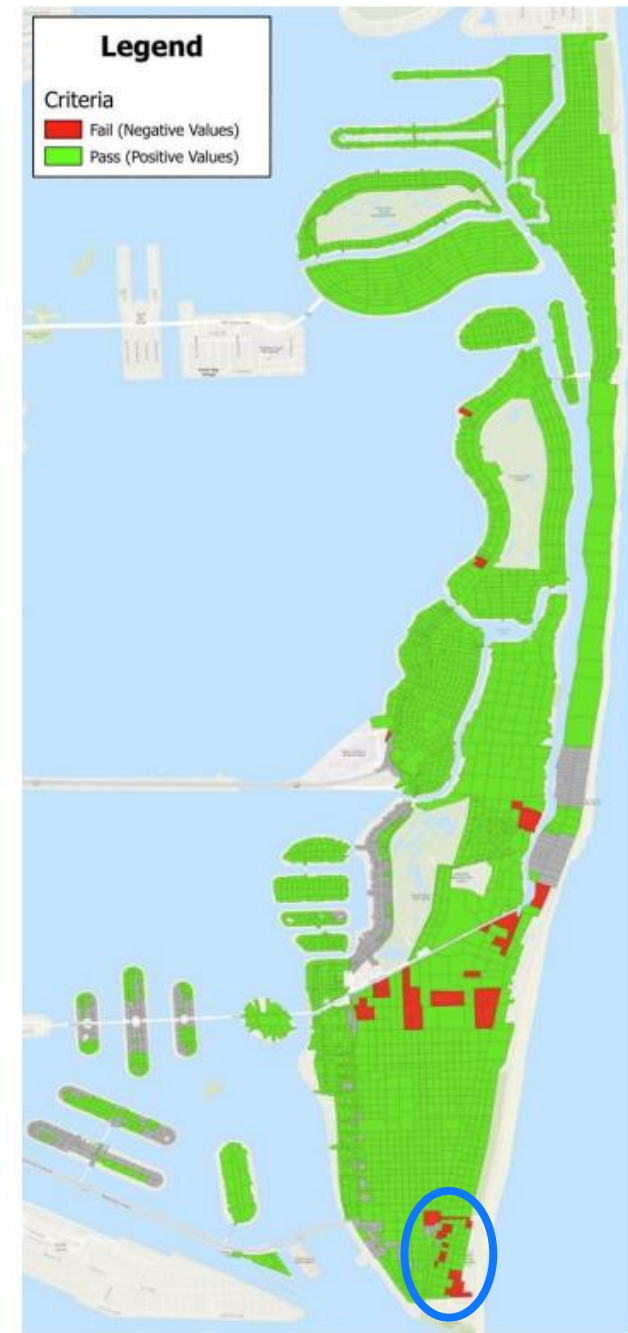
Figure 10, 2024 SWMP LOS Compliance Map

Figure 10 of the City's 2024 Stormwater Master Plan (LOS Compliance Map) indicates that the subject property is located in close proximity to areas identified as failing the adopted stormwater Level of Service standard, reflecting limited available capacity within the surrounding public drainage system during design storm events.

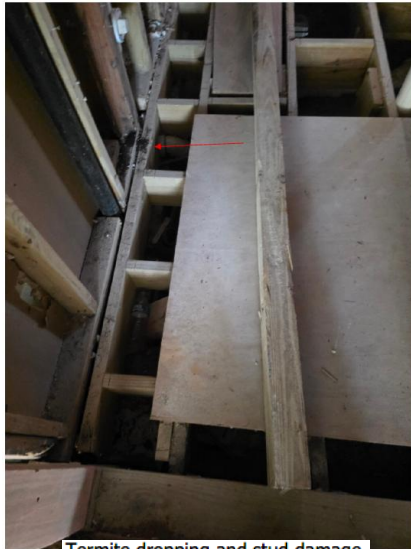
Termite dropping and stud damage

1. Roof structure failures leading to water intrusion and wood members sagging, rotting, failing, and total collapse in multiple areas
2. Concrete columns and beams exhibit spalling affecting approximately 40% of their surface area, with cracking evident throughout the building
3. Evidence of prior repair areas re-cracking
4. Presence of mold and water intrusion on interior walls and ceilings exhibit varying levels of failure

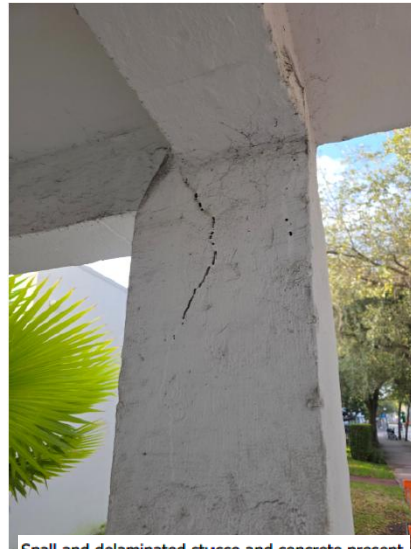
Spall and delaminated stucco and concrete present

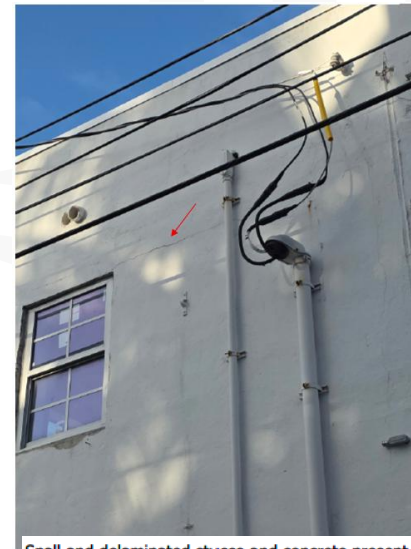
Spall and delaminated stucco and concrete present

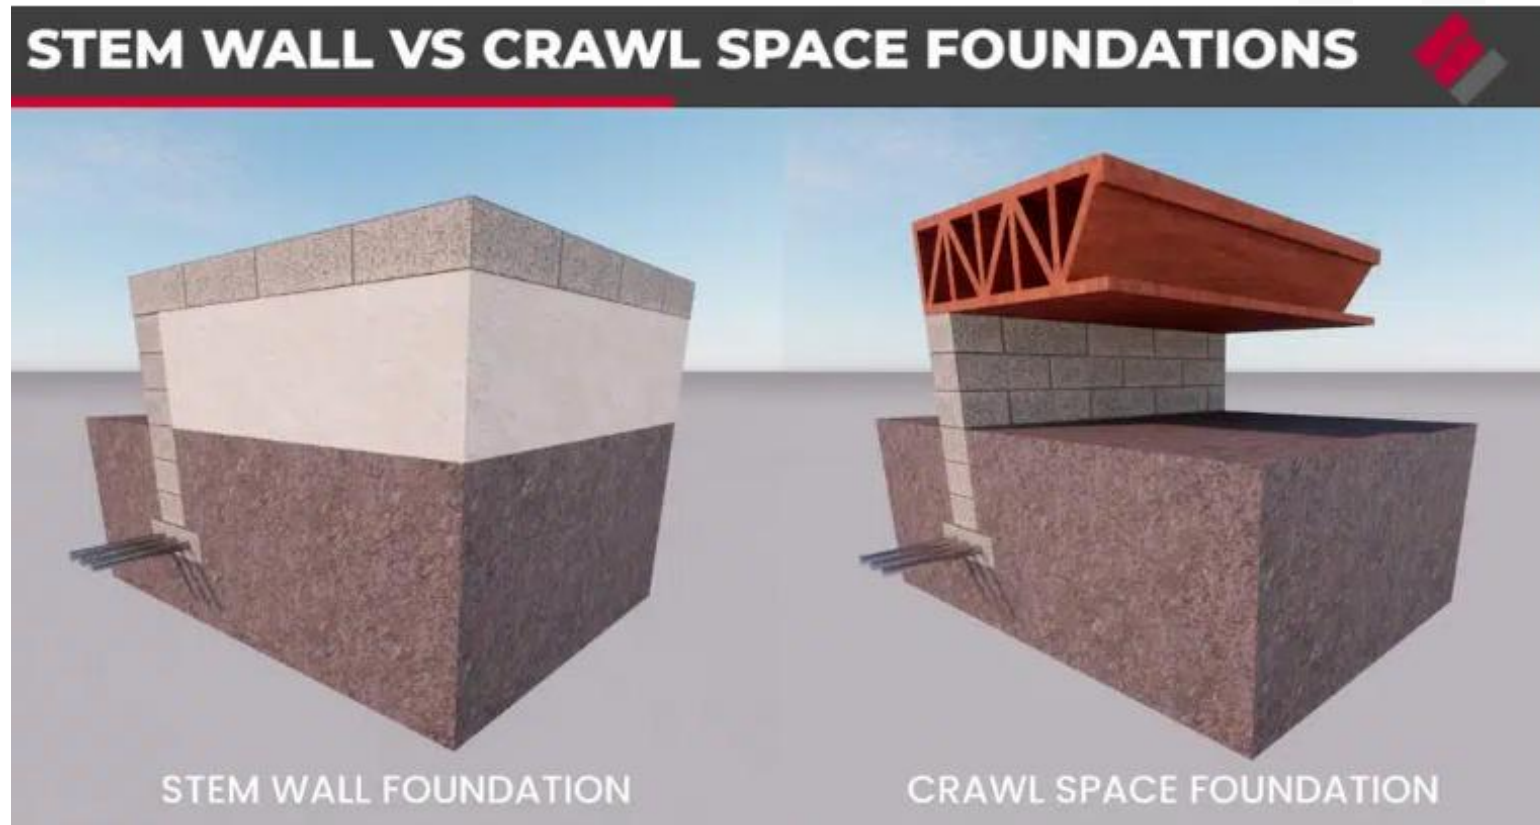
- Slab on grade
- Shallow foundation supporting concrete stem walls
- Foundation has to be strengthened to resist lateral loads

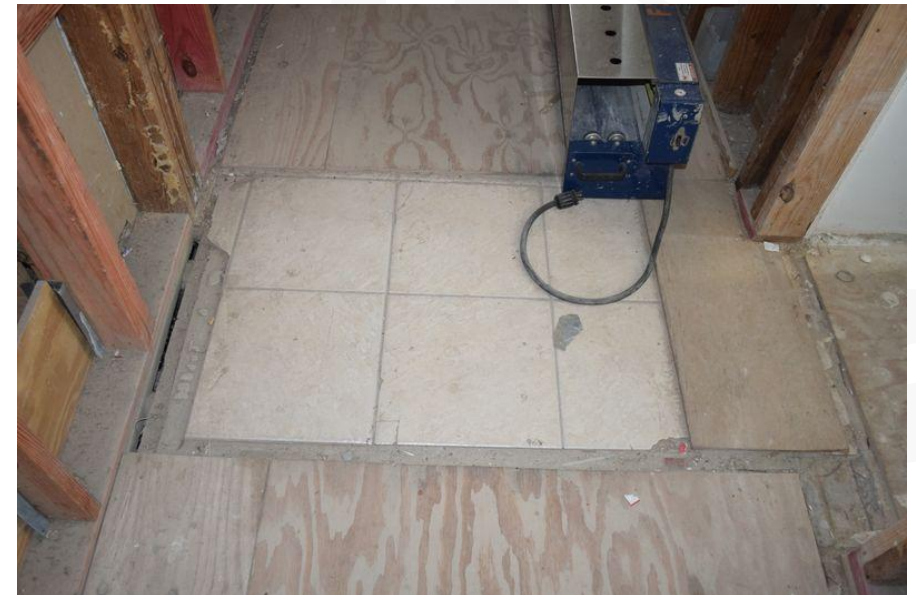
Figure 13-20 Wood and heavy timber beams were often “fire-cut” so that a fire-damaged, sagging floor would simply slide out of the wall pocket in order to preserve the wall.

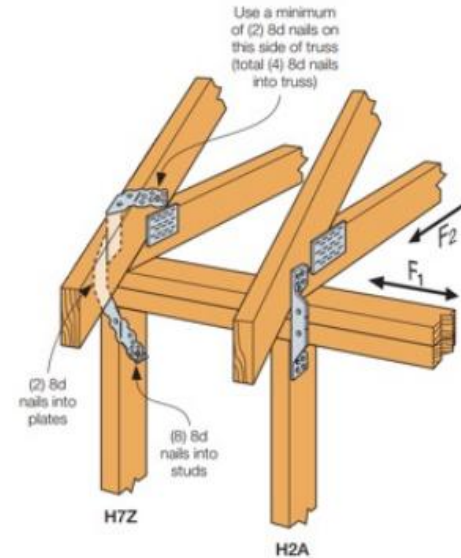
Figure 9. Roof-Framing-to-Stud Connection with Single Hurricane Tie

- Roof waterproofing has failed in multiple locations
- Connections for wind uplift forces and wind lateral resistance are non-existent
- Requires roof connection tie-downs be installed to strengthen the roof for Florida Building Code compliance

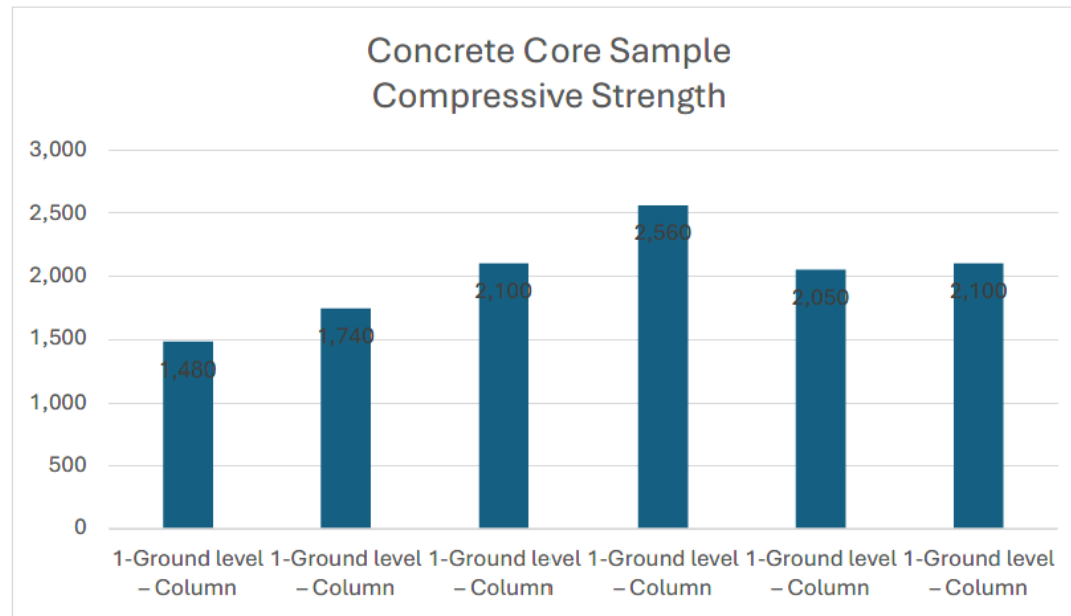
The Concrete compressive strength ranged from 1,480 to 2,560 PSI. Per Florida Building Code the concrete strength should be 5,000 PSI.

- Ability to withstand pressure before breaks or fails
- Low compressive strength concrete is more prone to cracking and spalling
- Can lead to structural failure and compromised stability

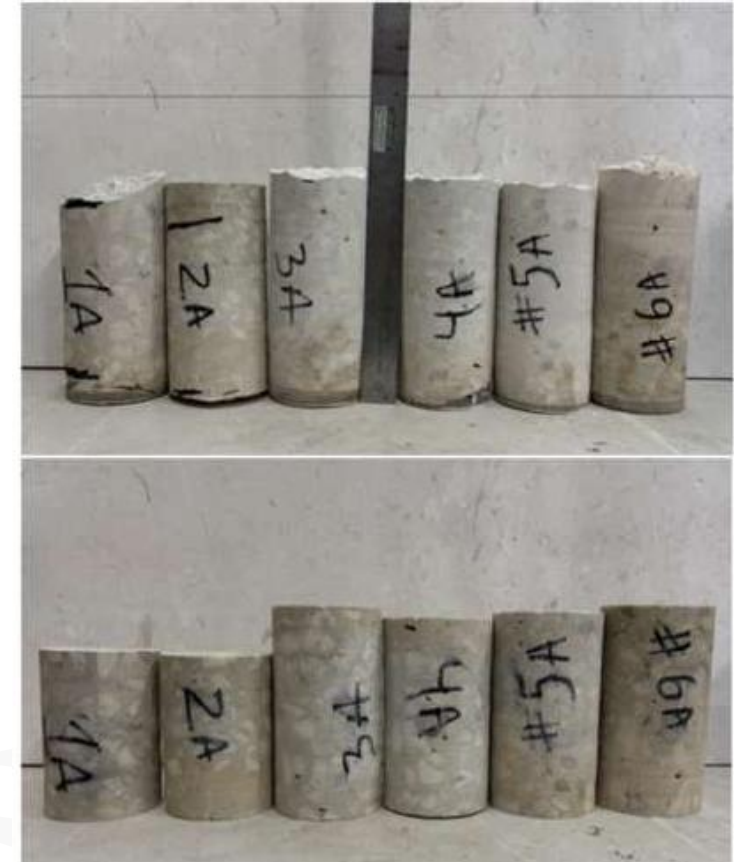
- Extracted core samples confirm a low-density, deteriorated concrete matrix, consistent with **compressive strengths well below** the Florida Building Code–required 5,000 PSI.

The Concrete compressive strength ranged from 1,480 to 2,560 PSI. Per Florida Building Code the concrete strength should be 5,000 PSI.

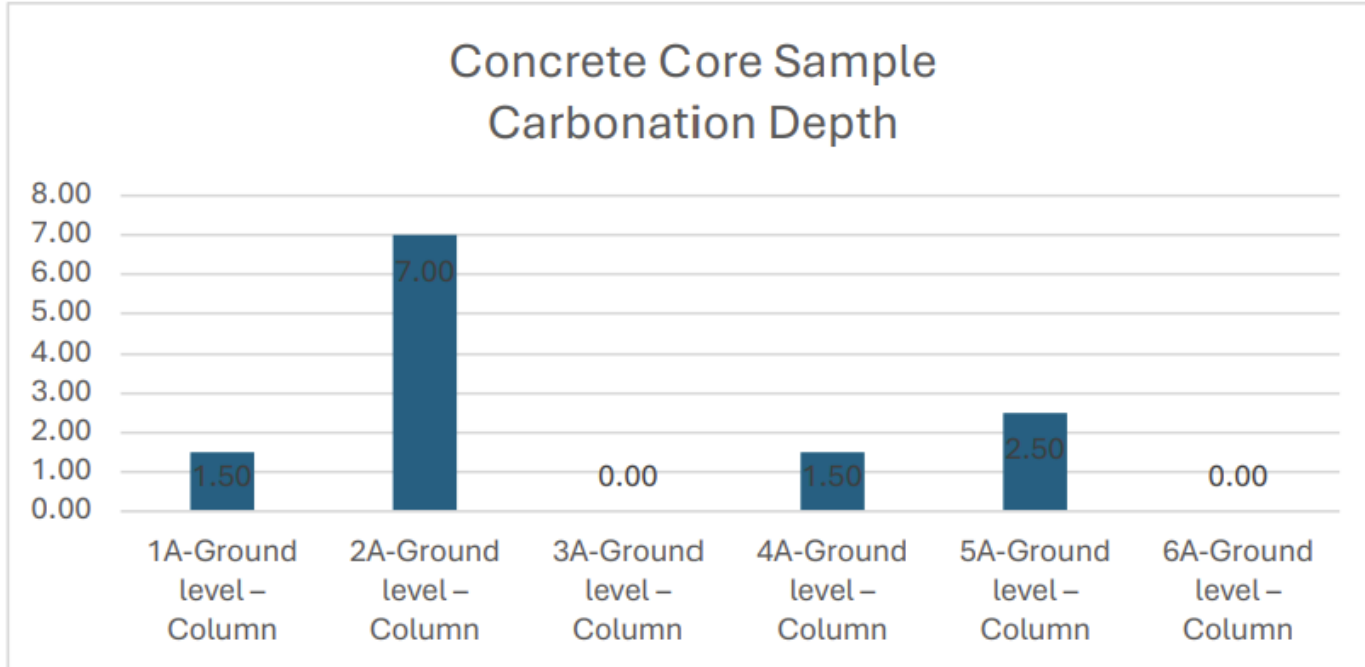
- Depth of carbonation is measured from the surface of the concrete
- Carbonation exposes the rebars to corrosion
- Carbonation is extensive and is as high as 7.00"

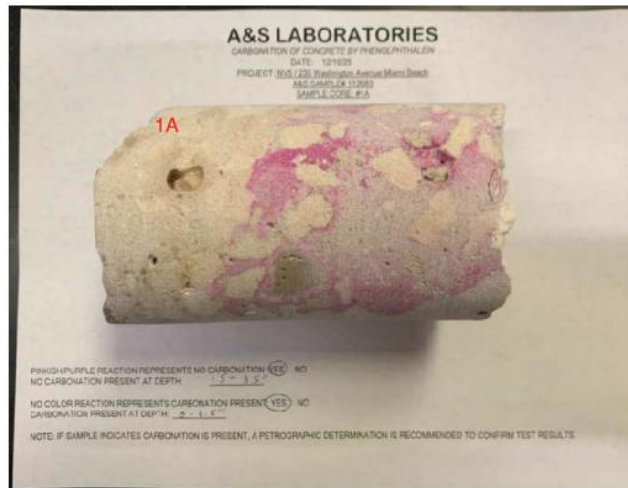
- One-third of samples show carbonation extending beyond the typical depth of reinforcing steel in concrete (>2 inches)
- Another one-third of samples are at or approaching the depth where reinforcing steel is located ( $\approx 1.5$  inches)
- This indicates that much of the structure has lost or is losing protection against steel corrosion, as **carbonation has reached or passed the reinforcing steel**

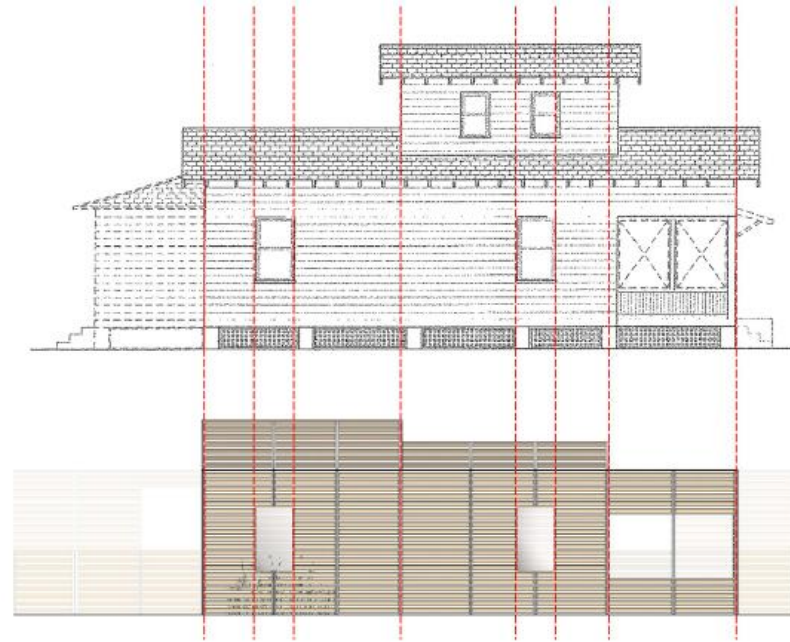
1 COTTAGE PAVILION  
A-2.03 SCALE: N15

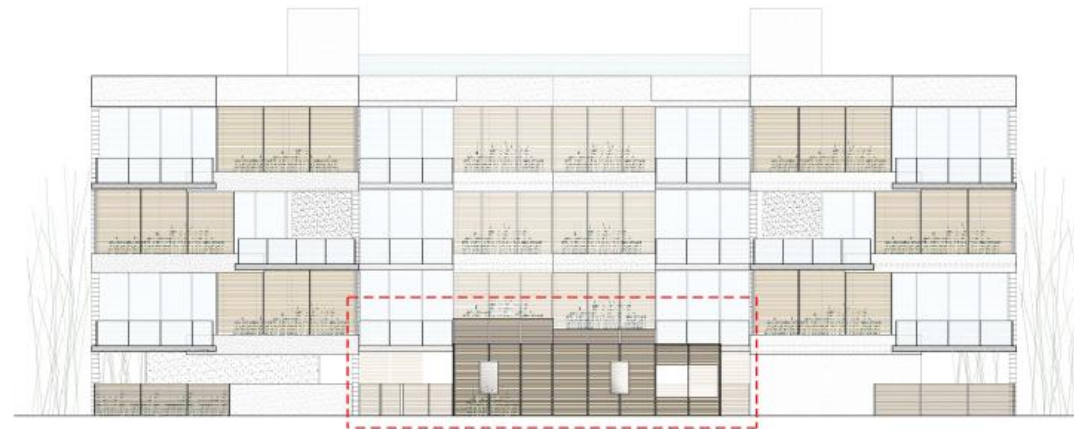
2 COTTAGE PAVILION  
A-2.03 SCALE: N15

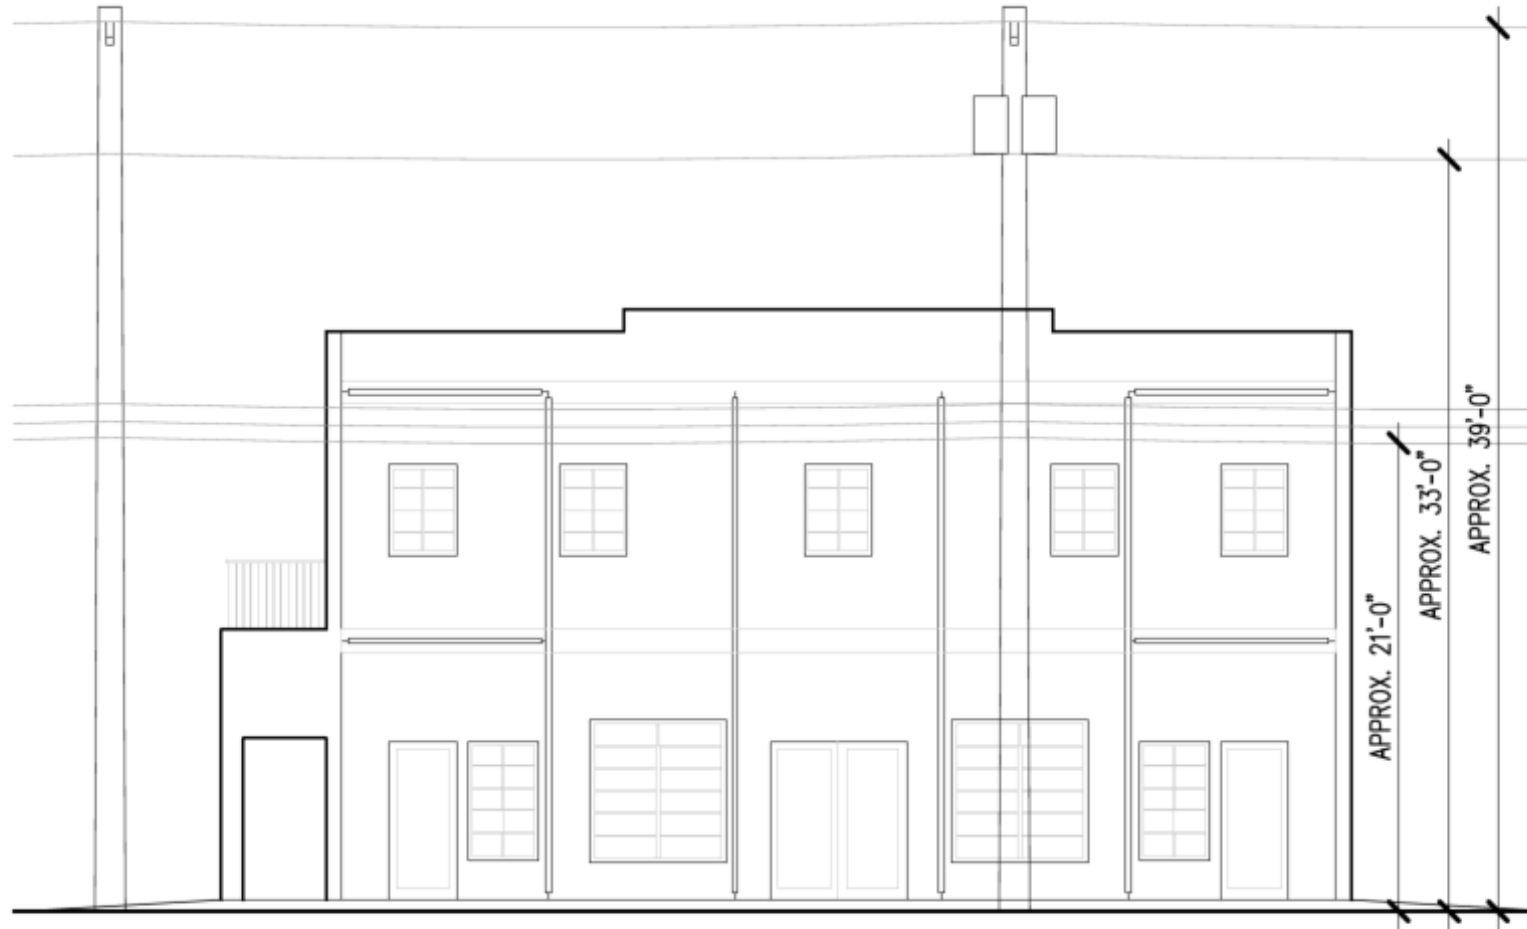
Site Elevation (West)

# Power Line Safety Requirements Restrict Rear Demolition
