STOREFRONT ANALYSIS
716-720 Lincoln Road
Miami Beach, Florida

April 20, 2026

720 Lincoln Partners LLC (the Client) has commissioned Heritage Architectural Associates (HAA) to provide a Storefront Assessment for the property at 716-720 Lincoln Road, Miami Beach, Florida. This report presents a general history of storefronts, the evolution of storefronts on Lincoln Road, a description of the property at 716-720 Lincoln Road, and the evolution of that property from construction to the current day. Additionally, this report presents a description and an analysis of the proposed modifications in context of the evolution of the storefront and historic preservation standards and guidelines.

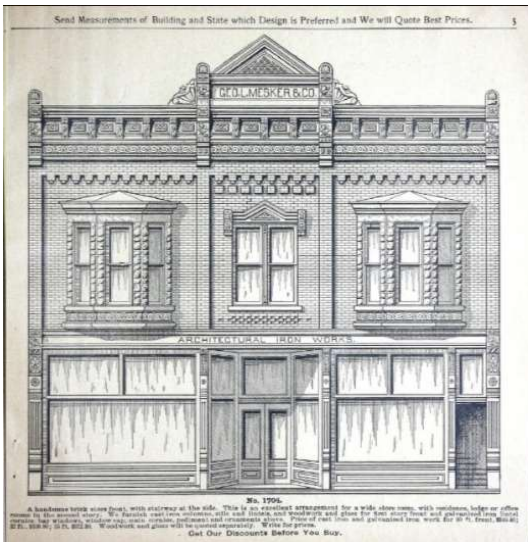
Cast storefronts featured iron columns and lintels at the ground floor and cornices at the top. (Figure 2) Sometimes, the storefront extended from the ground floor to the cornice. (Figure 3) The iron storefront became part of the advertising of the business, and sometimes the name of the business was integrated into the storefront. Storefronts were also manufactured with wood components. Due to the availability of individual elements and moldings, wood storefronts could be as elaborately detailed as those fabricated of cast metal. In the 19th century, iron storefronts were sometimes added to existing buildings to modernize the building's appearance.

Figure 2. Catalog page depicting galvanized iron storefront and cornice, 1900. (George L. Mesker & Co., p. 5)

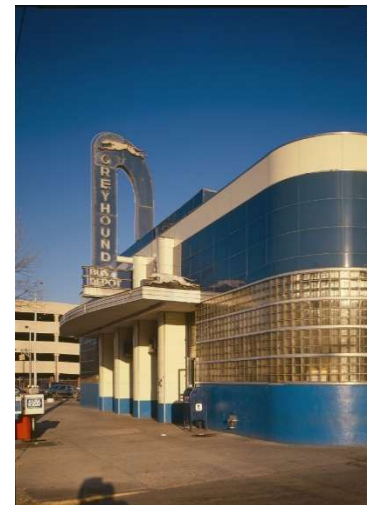
Further innovations in glass production in the early 20th century provided new types of glass materials that altered storefront design. The new technology allowed for larger panes of glass to be produced. Other new uses of glass include prismatic glass lights in transom windows, pigmented structural glass, such as Carrara and Vitrolite, glass block and tinted glass. (Figure 4) Aluminum and stainless steel allowed for less visible framing. The use of electricity, including neon lights, enhanced the visibility of the business establishment. Storefront designs evolved along with the current architectural styles, with many featuring Art Deco and Streamline Moderne features and ornamentation. As in the past, stores often modernized by installing new storefronts to draw attention to the business.

Figure 4. Modern glass materials at Greyhound Bus Station, Columbia, SC, 1986. (Historic American Buildings Survey)

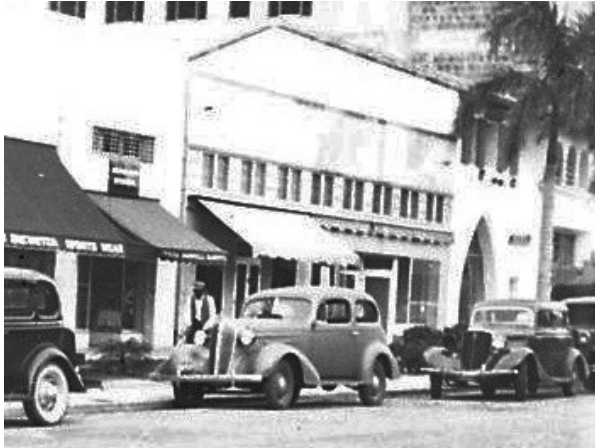
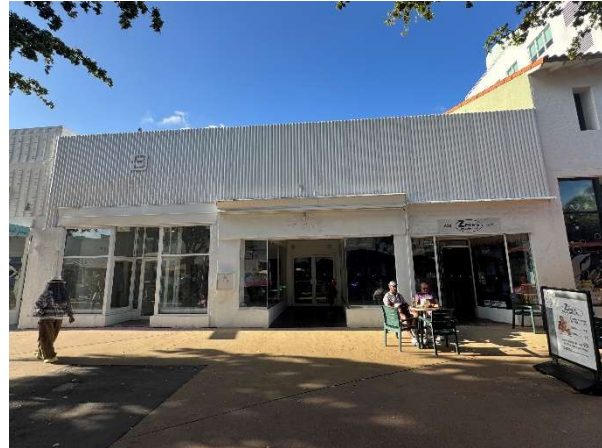
Although 625-631 Lincoln Road retains its original recessed storefronts, the windows and the entire upper façade of this one-story building have been completely covered. (Figure 5, Figure 6)

*Figure 5. 625-631 Lincoln Road, c. 1936
(Phillip Pessar, Flickr)*

Figure 6. 625-631 Lincoln Road, April 2026.

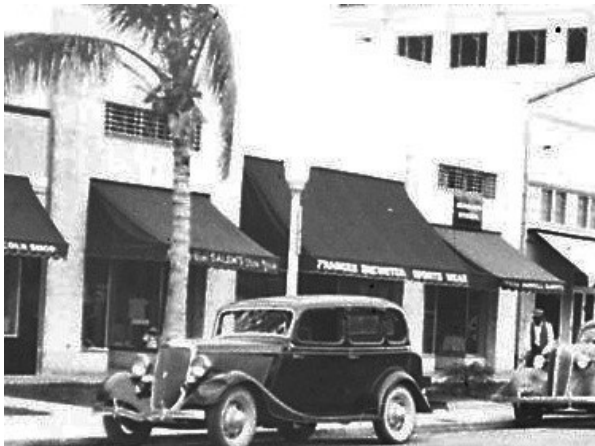
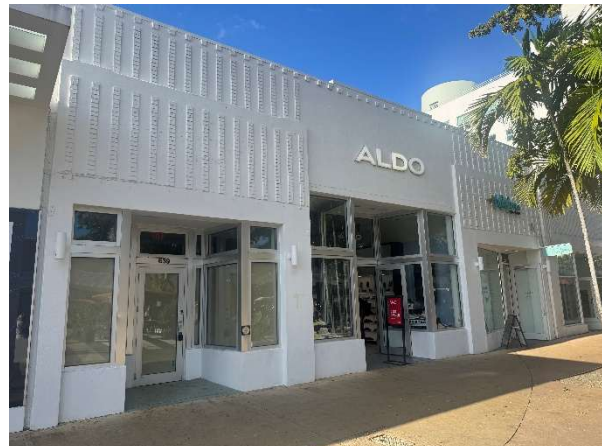
The building at 635-639 Lincoln also retains its recessed storefronts, but the upper façade above the outer stores has been covered. (Figure 7, Figure 8)

*Figure 7. 635-639 Lincoln Road, c. 1936
(Phillip Pessar, Flickr)*

Figure 8. 635-639 Lincoln Road, April 2026.

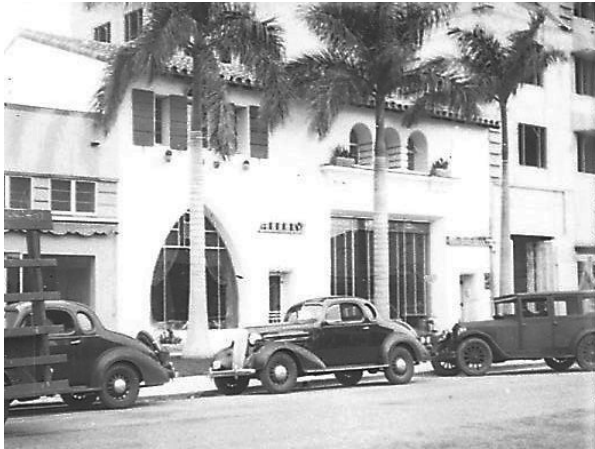
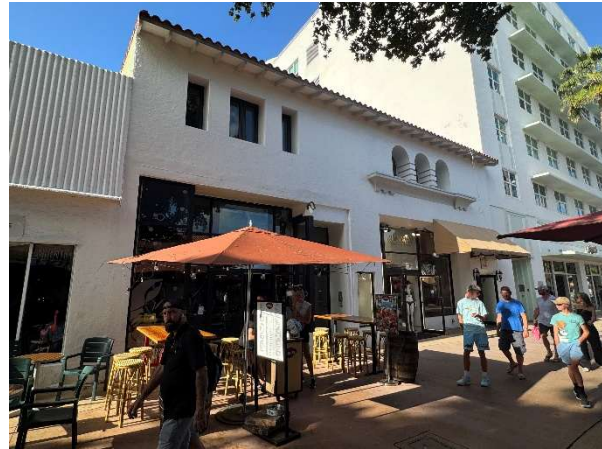
The Mediterranean Revival building at 607-611 Lincoln Road has lost its very distinctive pointed arch window. (Figure 9) A door was also removed to accommodate the large rectangular replacement window. (Figure 10)

*Figure 9. 607-611-Lincoln Road, c. 1936.
(Phillip Pessar, Flickr)*

Figure 10. 607-611-Lincoln Road, April 2026.

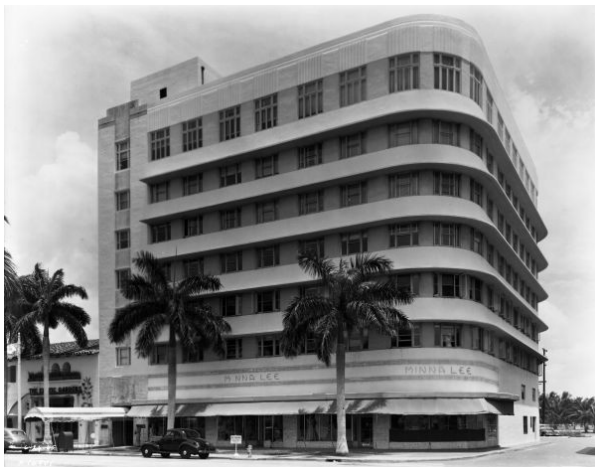
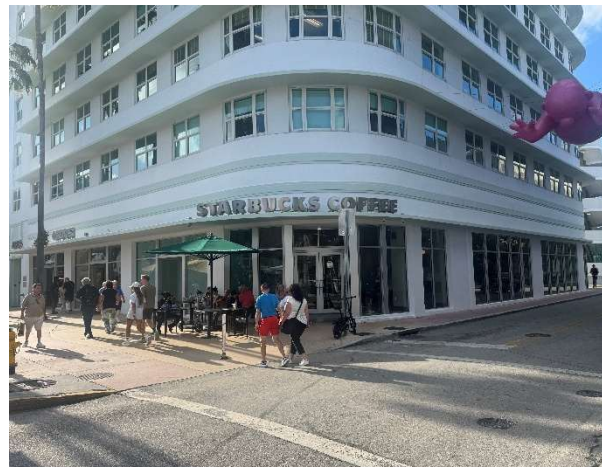
The storefront at 605 Lincoln Road has been modified extensively. The east façade formerly contained two windows at each of the first two levels. (Figure 11) This façade has been modified to include multiple storefront windows. (Figure 12) In addition, an entrance has been added to the corner, where originally the entrances were exclusively along Lincoln Road.

*Figure 11. 605 Lincoln Road, 1945.
(Florida Memory)*

Figure 12. 605 Lincoln Road, April 2026.

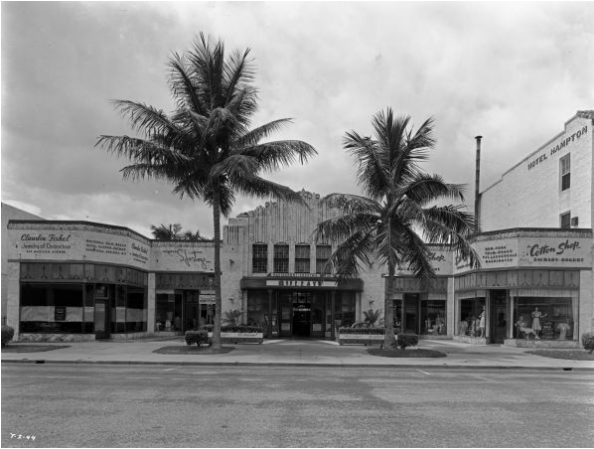
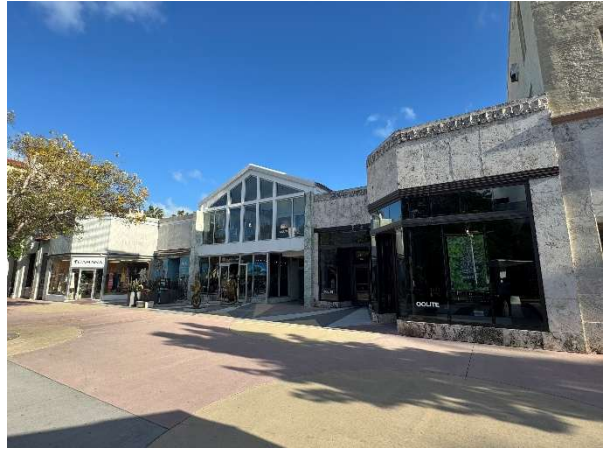
The building at 918-932 Lincoln Road has experienced substantial changes to the storefront. (Figure 13, Figure 14) The central bay has been replaced by a modern storefront element that bears no resemblance to the original. The windows at the east wing were reduced in size, and the upper part of the wing has been covered in a fluted material that appears to be painted metal.

Figure 13. 918-932 Lincoln Road, 1944.
(Florida Memory)

Figure 14. 918-932 Lincoln Road, April 2026.

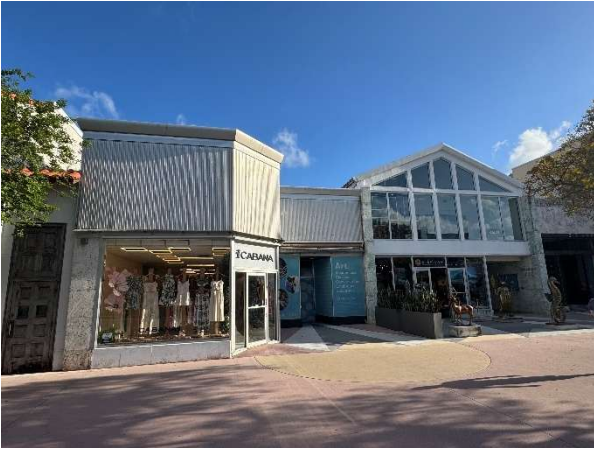
Figure 15. Detail of east wing and central bay
at 918-932 Lincoln Road, April 2026.

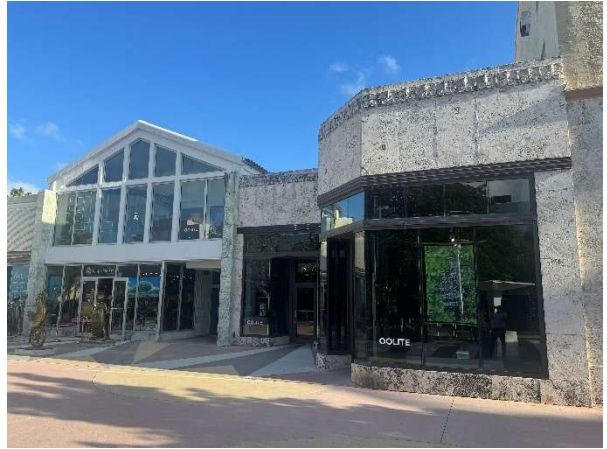
(Figure 15) Although the windows have been modified in the west wing, the window size was retained, and the upper façade retains its original cladding. (Figure 16)

Figure 16. Detail of central bay and west wing
at 918-932 Lincoln Road, April 2026.

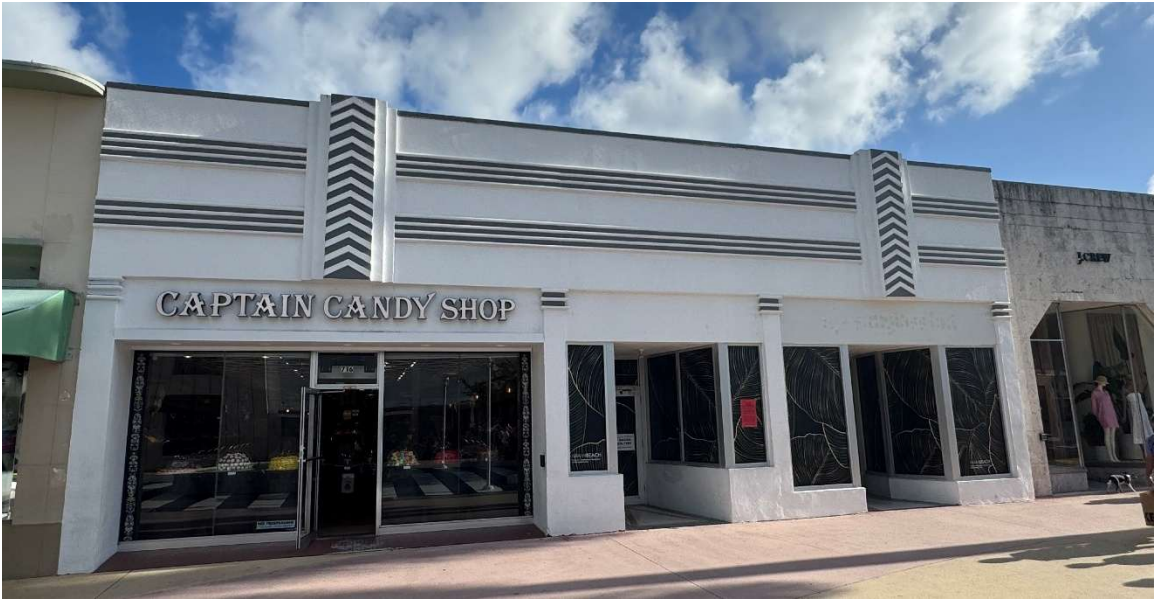
The one-story building at 716-720 Lincoln Road features a tripartite system at the storefront level. (Figure 17) The building is clad with stucco. The upper façade has two sets of horizontal fluted bands that extend the full width of the building, and the storefronts are separated by pilasters with fluted bands at the top. (Figure 18) The recessed areas of the fluted bands are painted gray to contrast with the rounded projecting portions, which are painted white. The bands in the upper façade are punctuated by two vertical pilasters with a raised chevron motif. Like the horizontal bands, the recessed areas of the chevrons are painted gray.

Figure 17. 716-720 Lincoln Road, April 2026.

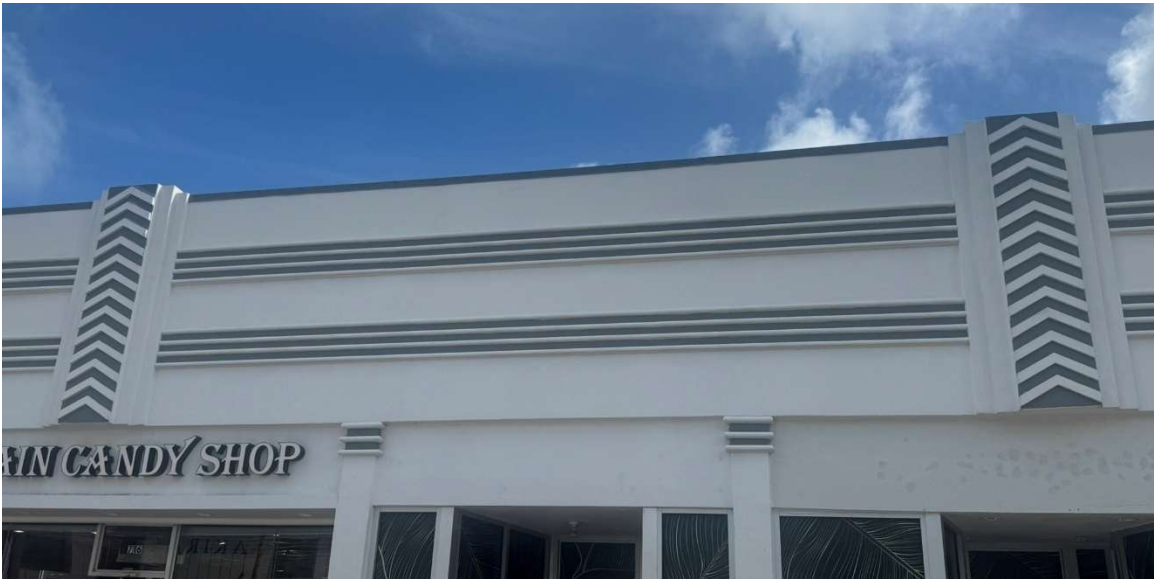
Figure 18. Detail of upper façade at 716-720 Lincoln Road, March 2026.

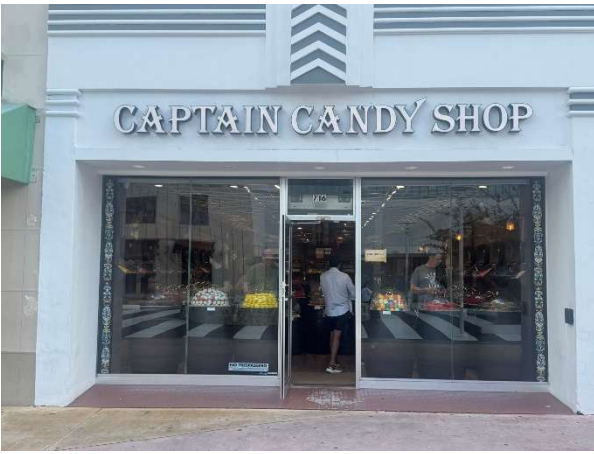
Figure 19. Detail of 716 Lincoln Road, March 2026.

The easternmost bay, at 716 Lincoln Road, has a flat aluminum storefront system. (Figure 19) The other two bays have original recessed entrances and angled storefront windows. (Figure 20, Figure 21) All of the entrance doors are replacements. The storefront at 716, which has been modified, has a plain band of terrazzo in front of the storefront. (Figure 22) The entrances at 718 and 720 Lincoln are paved with the original terrazzo in different decorative motifs. (Figure 23 Figure 24)

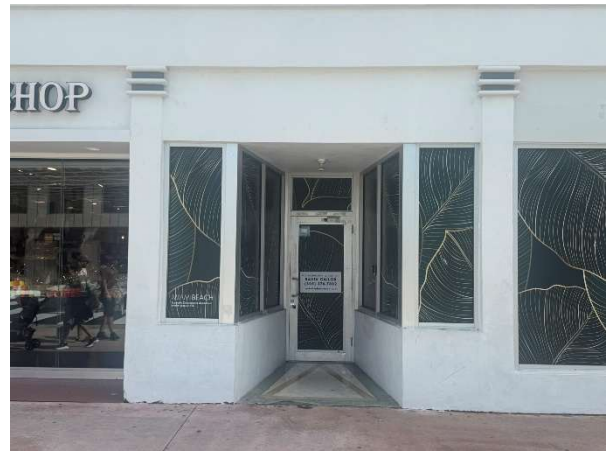
Figure 20. Detail of 718 Lincoln Road, March 2026.

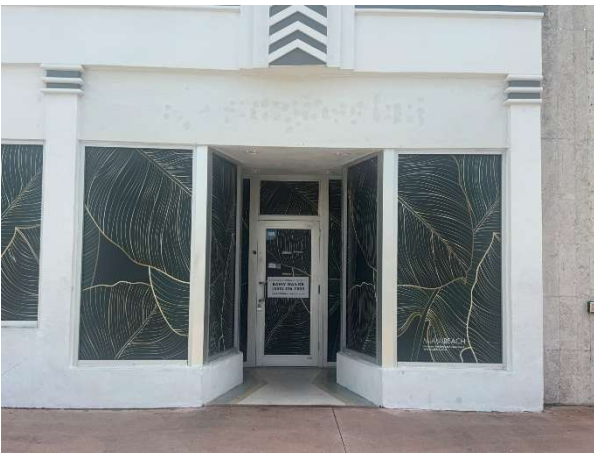
Figure 21. Detail of 720 Lincoln Road, March 2026.

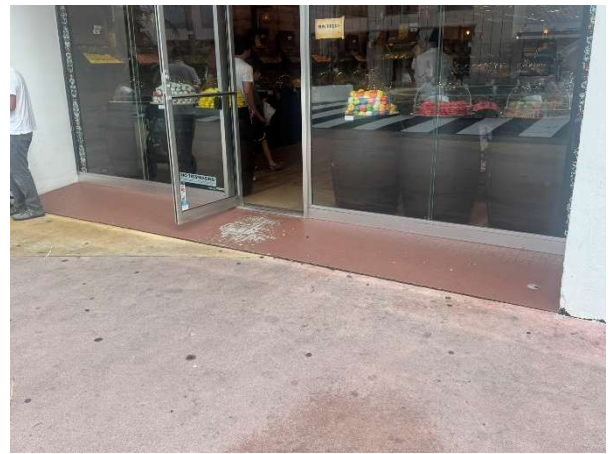
Figure 22. Detail of plain terrazzo at entrance to 716 Lincoln Road, March 2026.

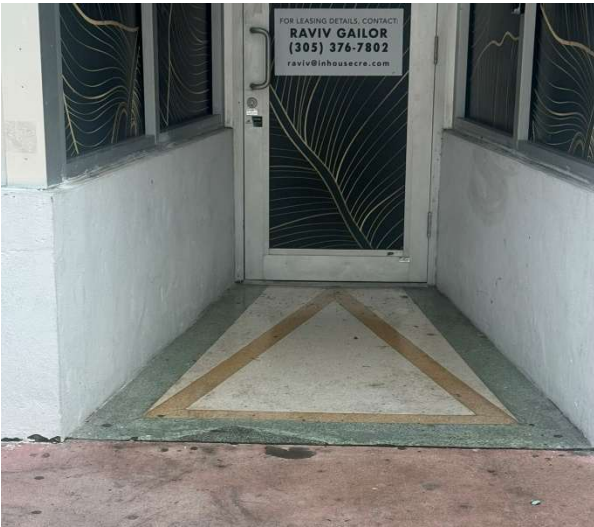
Figure 23. Detail of decorative terrazzo at entrance to 718 Lincoln Road, March 2026

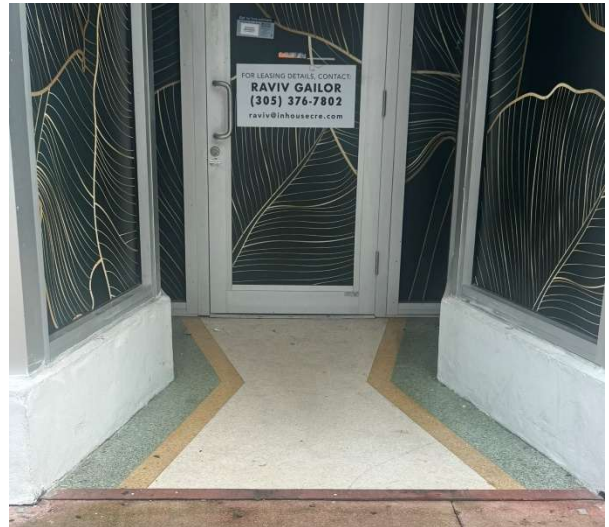
Figure 24. Detail of decorative terrazzo at entrance to 720 Lincoln Road, March 2026.

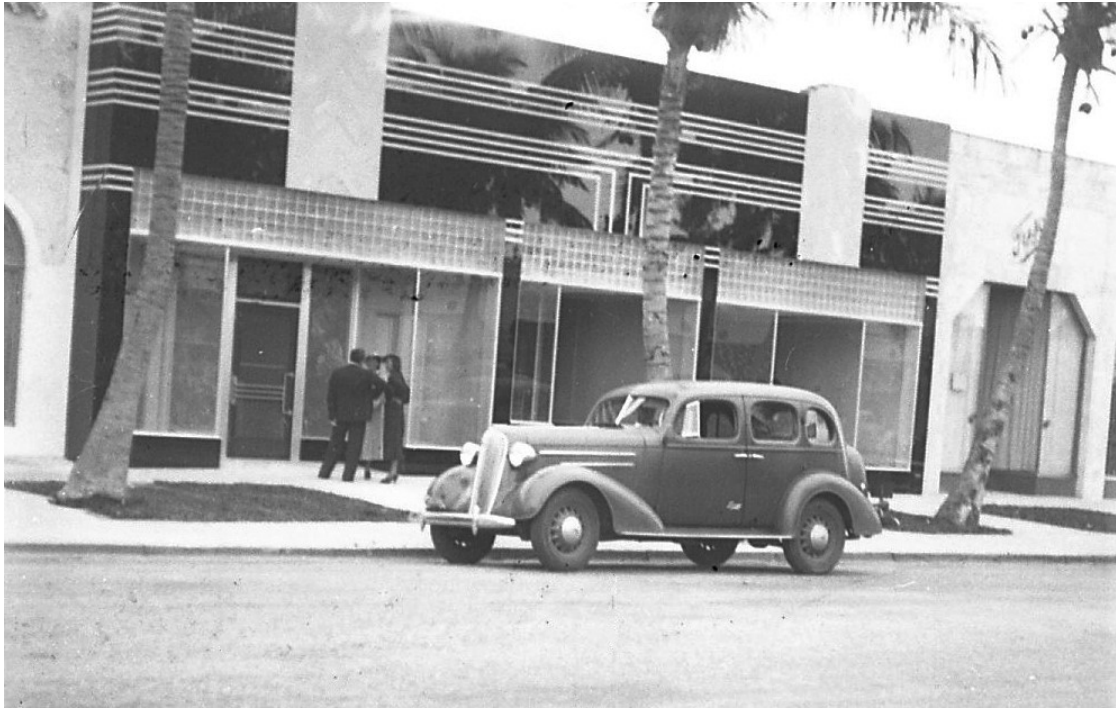
Recently discovered photographs indicate that the building was not constructed according to the drawings submitted for the building permit. (Figure 25) Instead, the building was covered with black Vitrolite or Carrara glass panels. (Figure 26) Two white pilasters with ziggurat tops were located on the upper portion of the façade. Horizontal bands stretched across the façade, and small prismatic glass blocks were located in the transom area. As in the original drawing, the storefront windows were situated on glass-paneled bulkheads, and the windows at the center storefront were shorter than those at the outer stores. (Figure 27) Each store had a different design in the terrazzo flooring leading to the entrance door. (Figure 28)

*Figure 26. 716-710 Lincoln Road, looking south, c. 1936.
(Phillip Pessar, Flickr)*

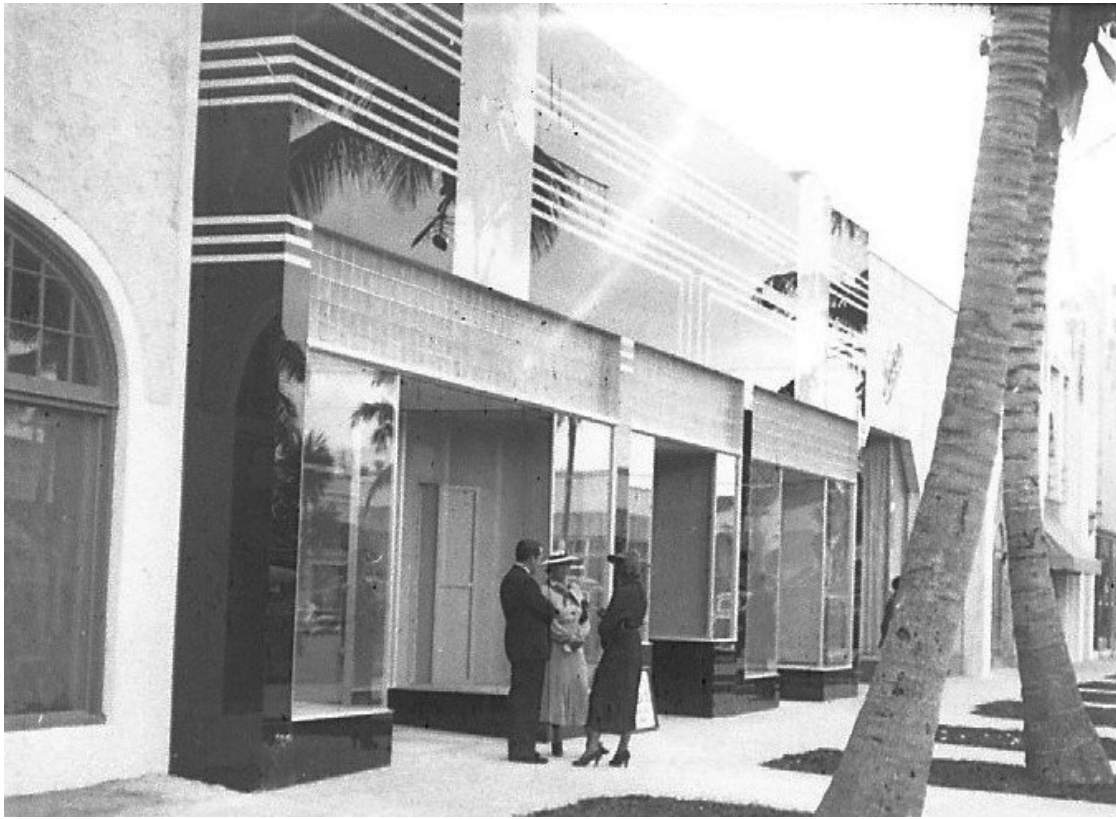
*Figure 27. 716-720 Lincoln Road, looking southwest, c. 1936.
(Phillip Pessar, Flickr)*

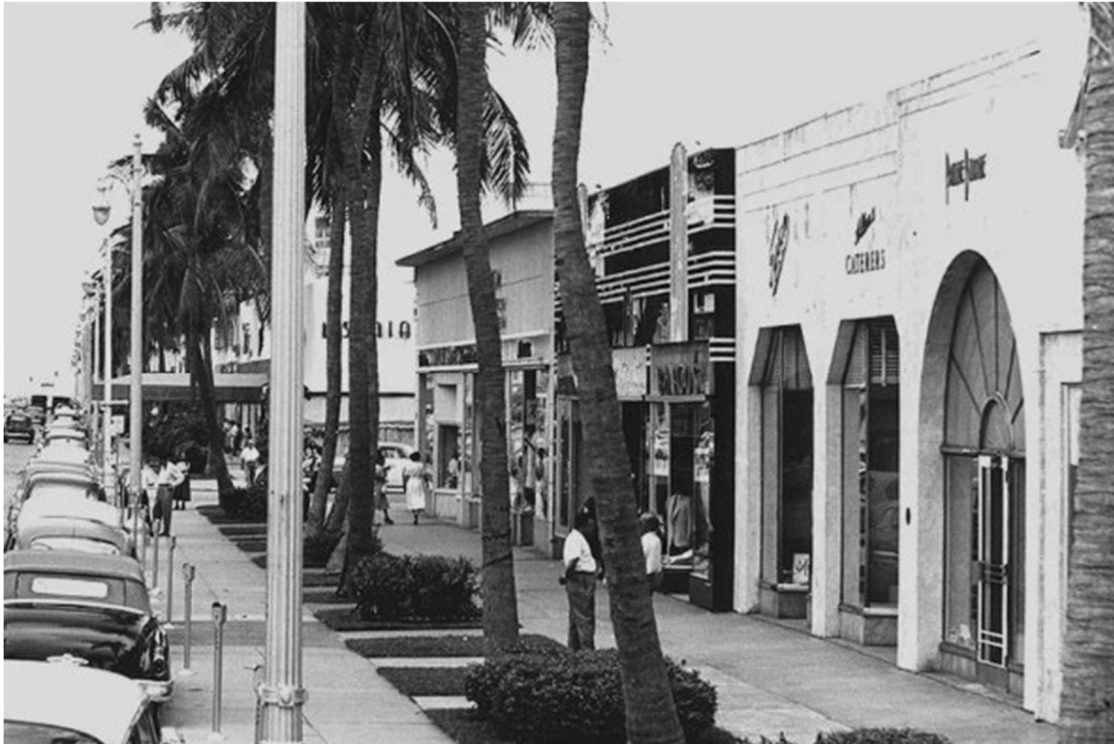
A permit for the remodeling of the storefront was issued on June 25, 1952. It appears that the prismatic glass blocks in the transoms were replaced by individual sign boards for each store. (Figure 29) The architect was Gilbert Fein.

*Figure 29. View of 716-720 Lincoln Road and adjacent buildings, c. 1954.
(Shulman + Associates)*

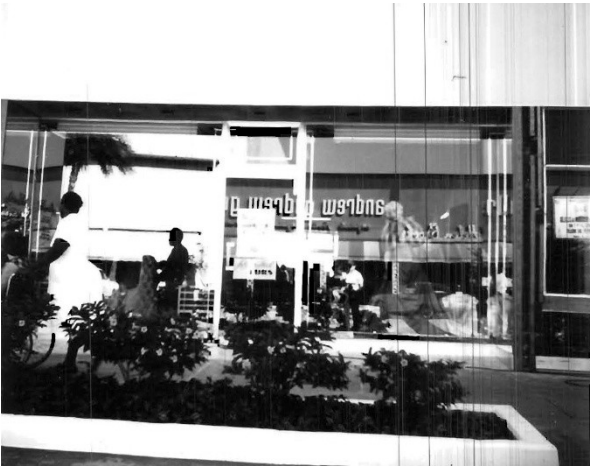
A permit to remodel 716 Lincoln Road was issued in September 1961. The permit was for a storefront of porcelain and aluminum and a new door, which was “not to swing on public property.”¹ The recessed storefront was replaced with a flat storefront system that was slightly recessed from the front of the building. The floor design at the entrance was replaced with plain terrazzo. In November 1961, a permit was issued for 718-720 Lincoln to cover the façade in porcelain panels. Photos taken by the property tax assessor in December 1961 reflect these changes. (Figure 30, Figure 31) Another storefront remodel was permitted in October 1966, but no specific addresses were included. The two vertical pilasters in the upper portion of the façade were removed at some point before October 1971. (Figure 32)²

*Figure 30. View of 716 Lincoln Road, 1961.
(Miami-Dade County Property Assessor)*

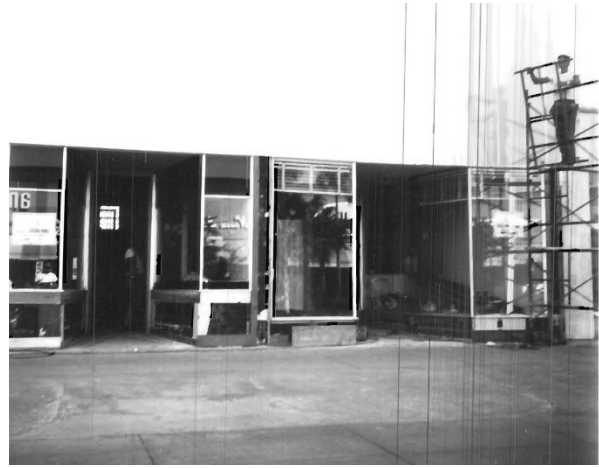
*Figure 31. View of 718 and 720 Lincoln Road, 1961.
(Miami-Dade County Property Assessor)*

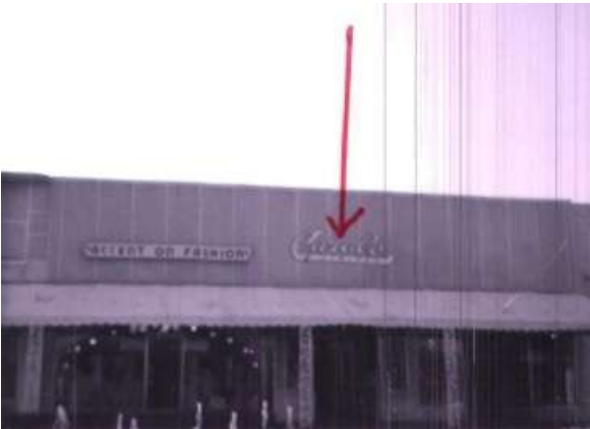
*Figure 32. View of upper façade showing absence of
vertical piers, 1971.
(Miami-Dade County Property Assessor)*

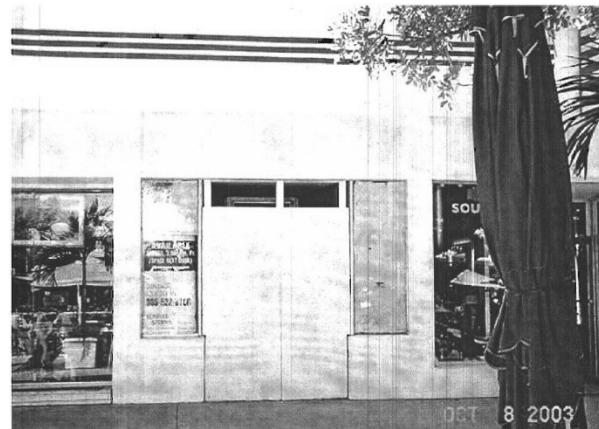
At some point before 2003, the front façade was remodeled according to the original drawing. (Figure 25) A photograph from October 2003 shows the storefront at 718 Lincoln Road covered with plywood. (Figure 33) The three horizontal lines at the upper façade that are visible in current photos were extant, but the horizontal lines at the top of the pilasters flanking the storefront were not yet in existence. (Figure 33)

*Figure 33. View of 718 Lincoln, 2003.
(Miami-Dade County Property Assessor)*

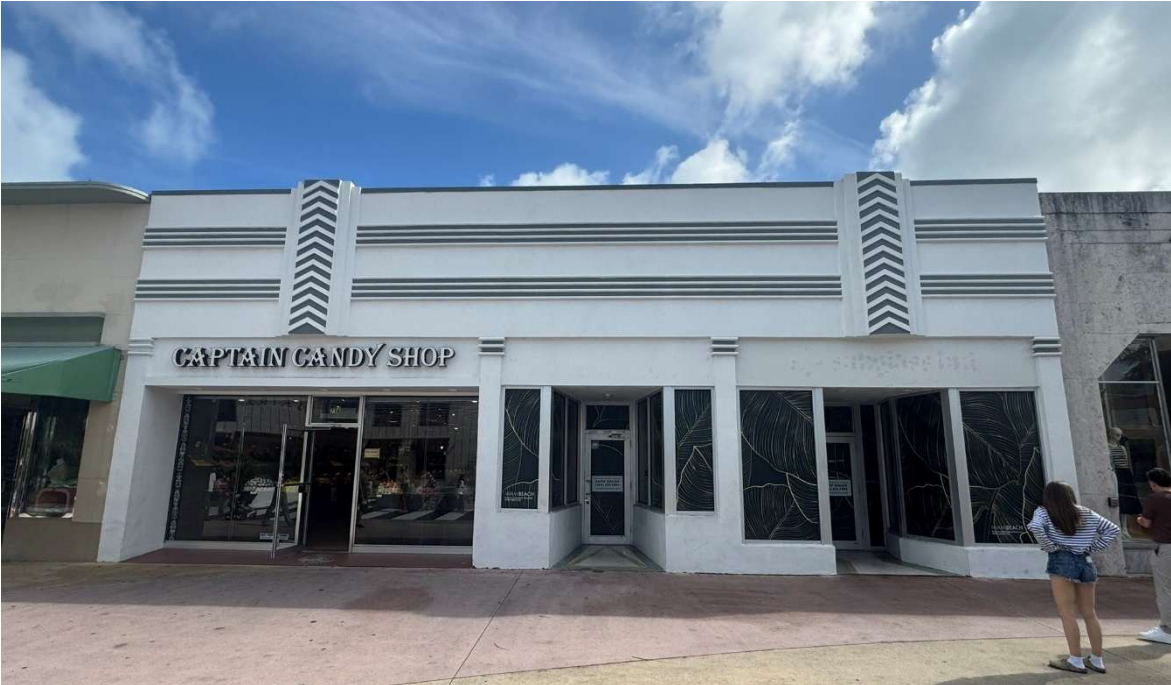
Figure 35. Current view of 716-720 Lincoln Road, March 2026.

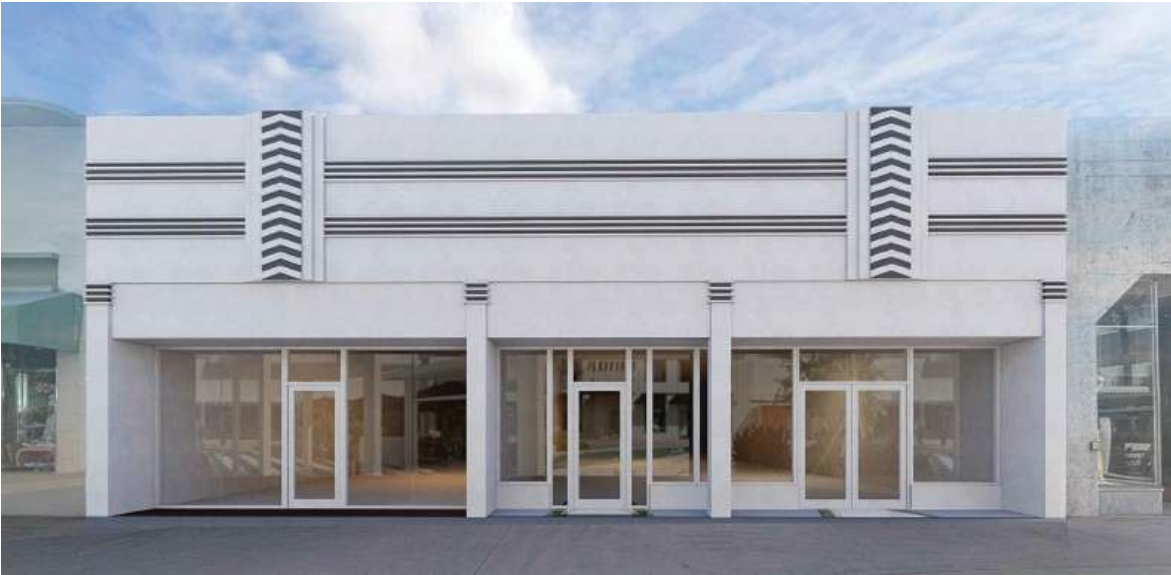
The proposed modifications include the removal of the recessed entrances, including bulkheads, windows and doors, at 718 and 720 Lincoln Road. The two storefronts would be replaced by a single glass entry door at the central bay (718) and one set of glass double doors at the west bay (720). The new storefronts would align with the entrance at the east bay (716) and create a unified storefront system across the three bays. The existing terrazzo at the entrances to 718 and 720 will be retained. The upper façade will also be retained.

Figure 36. Rendering of proposed modifications to storefronts at 718-720 Lincoln Road, March 2026. (Final Submittal 03-08-26, HPB26-0687)

- Will retain the historic tripartite architectural rhythm of the storefronts
- Will retain the terrazzo flooring at the entrances to 718 and 720
- Will not affect the upper façade
- Will restore consistency of the front façade by aligning the storefront systems
- Will provide a unified entrance with large display windows, which will make the space more inviting to potential customers
- Will not adversely impact the historic character of the building, which has already been compromised by previous alterations
