GANEM CONSULTING ENGINEERING
C.A. 31187
15805 Biscayne Blvd suite 105
North Miami Beach– Florida 33160
Phone (786) 916-6546
info@ganemce.com

EVALUATION REPORT

For Project located at: 7801 ATLANTIC WAY. MIAMI BEACH, FLORIDA. 33141

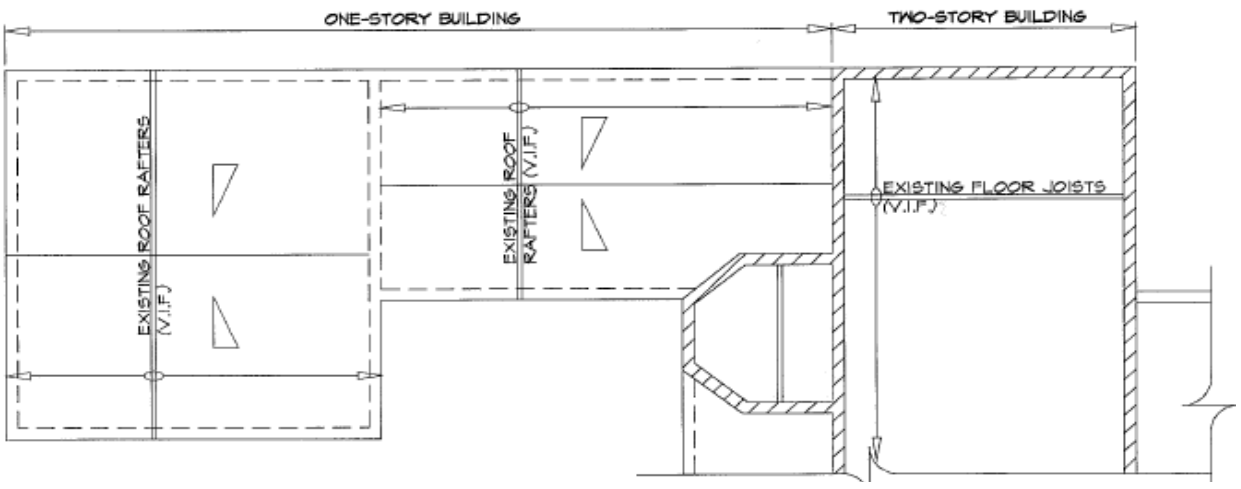
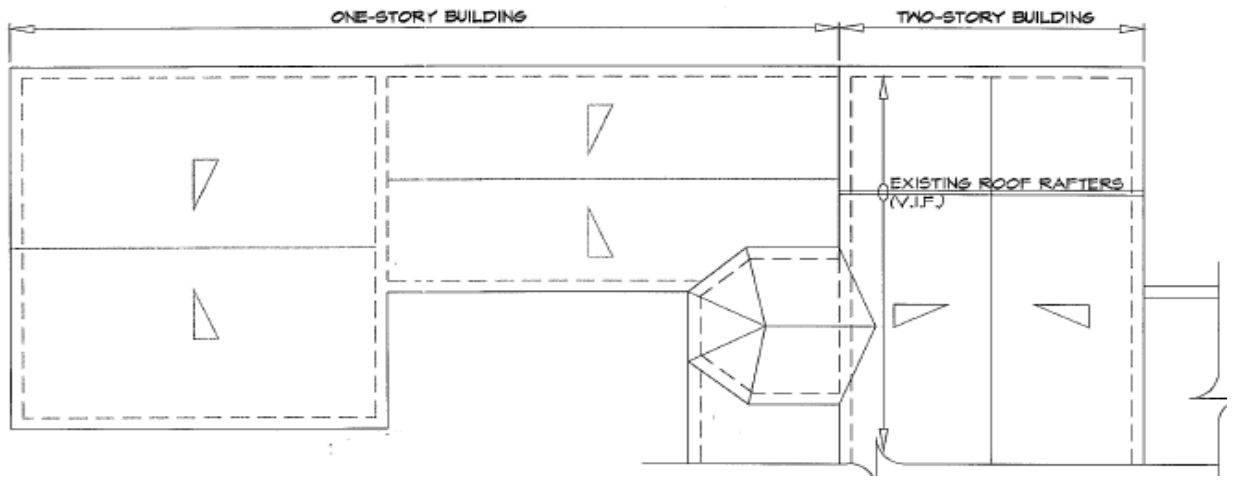
Figure 2.

The existing building consists of a two-story residential home. The existing Structural System is composed of masonry walls, with concrete beams and columns acting as load-bearing elements in the open areas and critical structural zones. See Figure 2 below. The load-bearing diaphragm of the second level consists of joists and roof rafters as part of the composition of the structural system of the home.

Existing Second Floor & Low Roof Framing Plan

Existing Roof Framing Plan

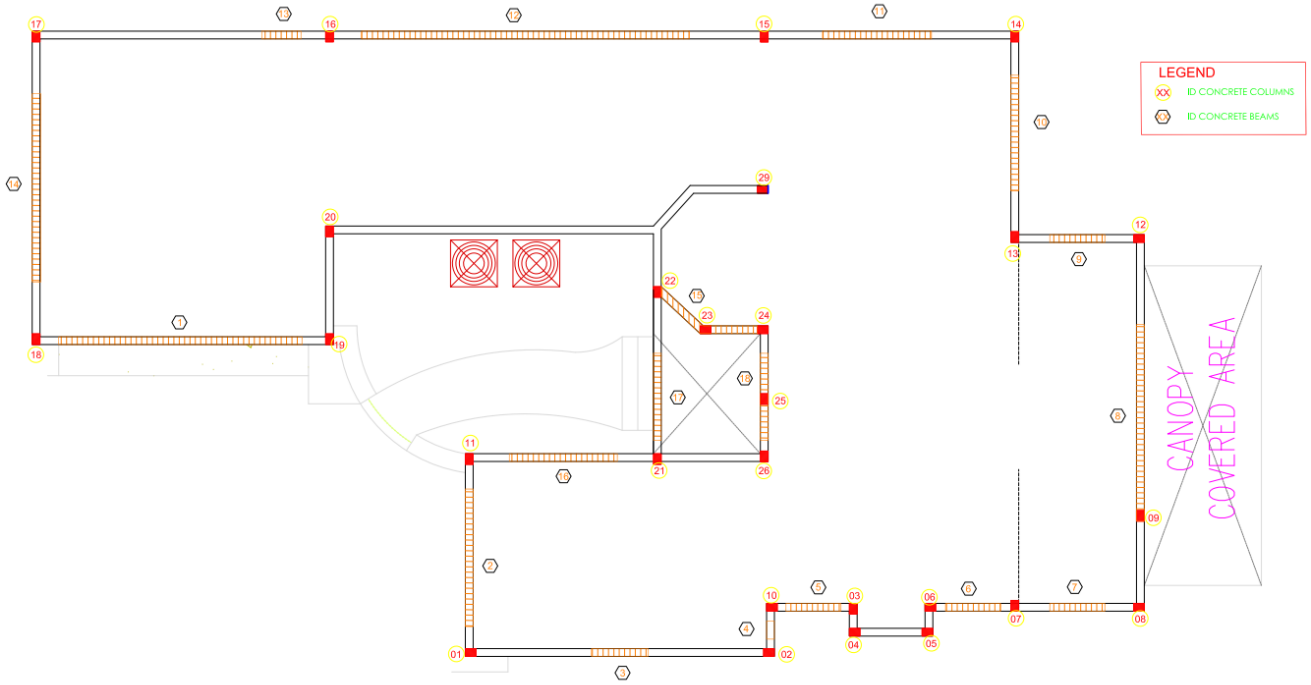
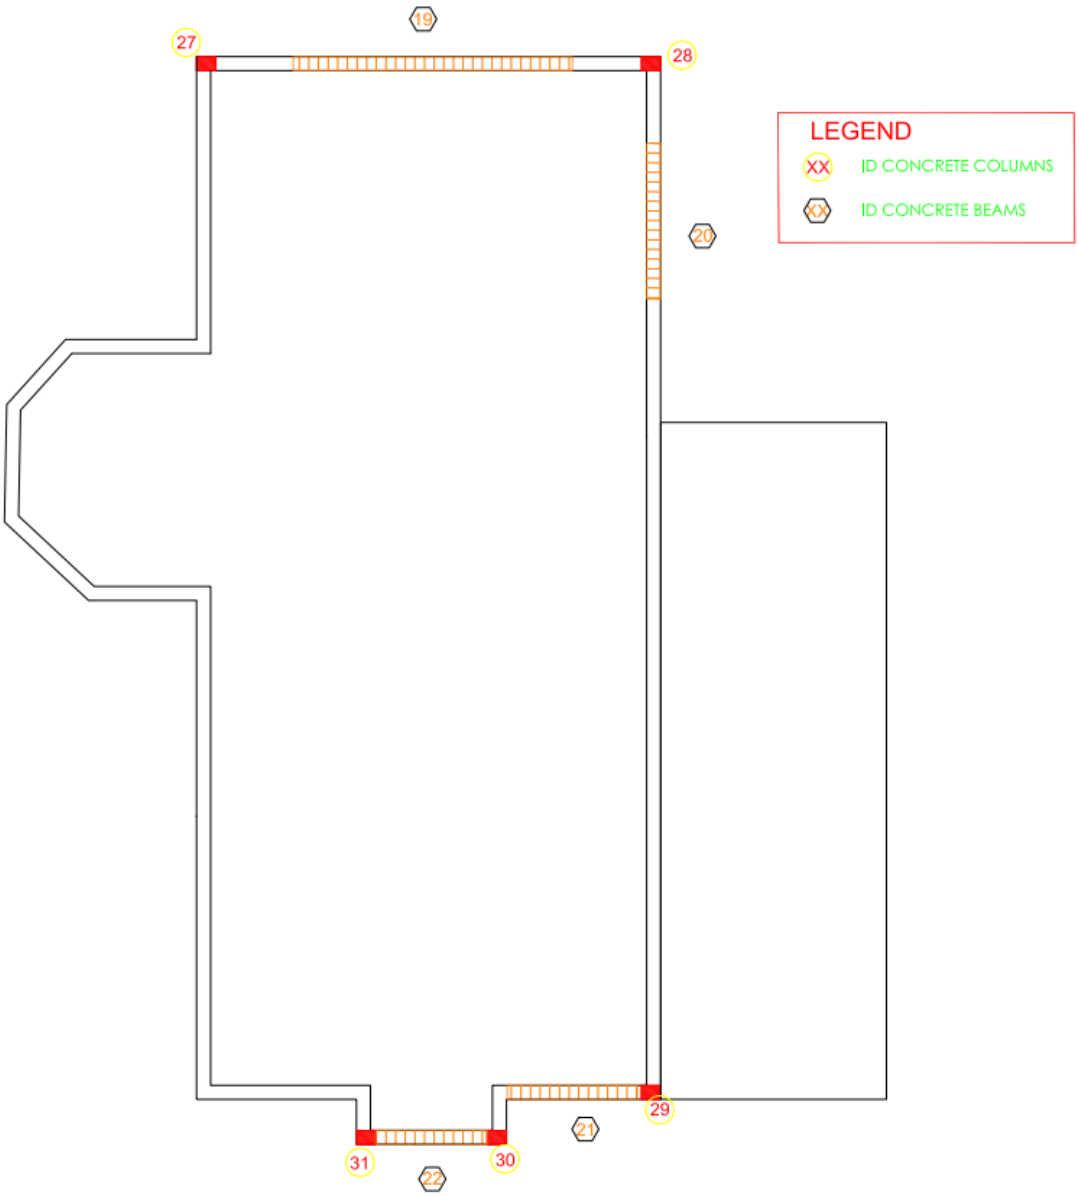
SCLEROMETER TEST RESULTS FOR CONCRETE BEAMS

19
27
28
LEGEND
XX ID CONCRETE COLUMNS
XX ID CONCRETE BEAMS
20
29
21
31
30
22

ANALYSIS OF THE RESULTS

Based on the structural compression capacity obtained from the test carried out the less than average results determined that the home is compromised to resist future loads, safely and without danger of collapse. Moreover, with the water-cement ratio used to produce a concrete with an f'c of 3000 psi, it is not possible to achieve a water-cement ratio equal to 0.40 required by ACI, to ensure the durability of the structure. The highlighted results above indicate all of the noncompliant samples. Of the 31 test averages, only 5 complied with the minimum standard required pursuant to ACI 318, Table 4.3.1. The one "FAIL" in the results indicates that there was no resistance, and the compression capacity could not be determined.

- The compressive stress of the concrete obtained for the different bearing elements (beams and columns) averaged 3-3.5 ksi. ACI-318 requires a minimum strength of 5 ksi, with a water-cement ratio of 0.40.
  It is not possible to increase the strength of hardened concrete to achieve a compressive strength equal to 5000 psi required by the 2020 Florida Building Code.

Based on the results obtained from the tests carried out, a total demolition of the structure is recommended.

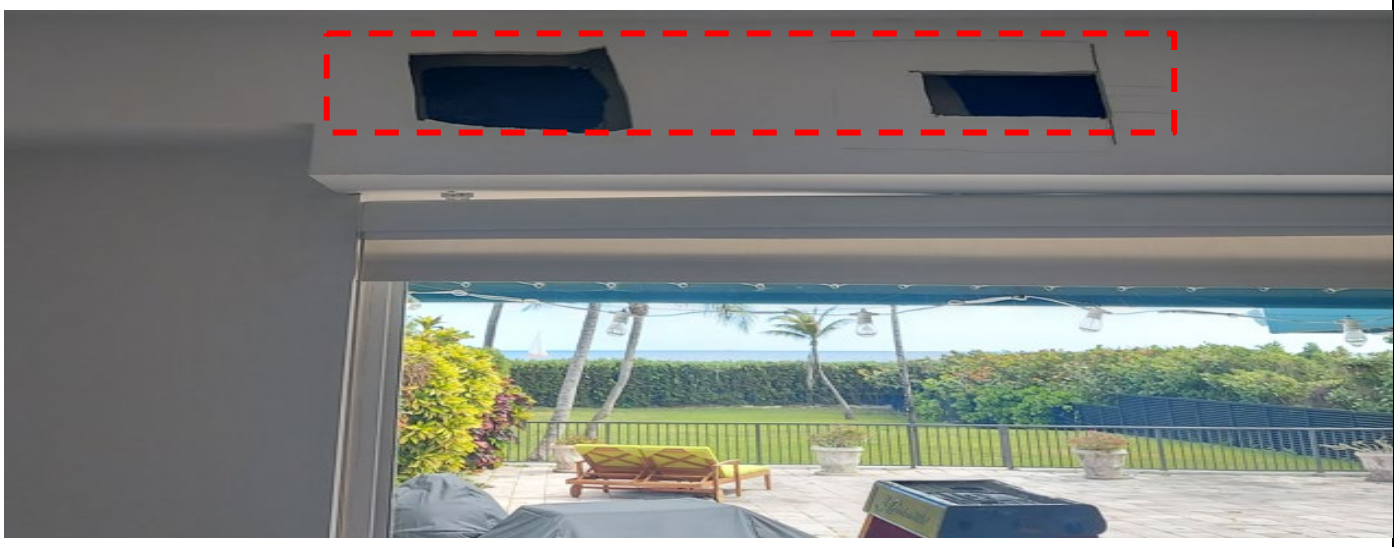
Figure 3. Cracking of the concrete in Main beam due to sulphation of the concrete and oxidation of the reinforcing steel

As a result of the visual inspection, cracks were observed in bearing elements of reinforced concrete. See Figure 3 below. This is produced as a consequence of the increase in volume of the reinforcing steel produced by an oxidation state. Sulfates attack concrete, forming expansive compounds that cause cracking. Chlorides, if they reach the rebars, cause its corrosion. The cracking caused by sulfates facilitates the penetration of chlorides and the corrosion of the reinforcement. Once the concrete cracks, the integrity and design capacity of the structural element are not guaranteed.

Cracking of the concrete in Main beam due to sulphation of the concrete and oxidation of the reinforcing steel

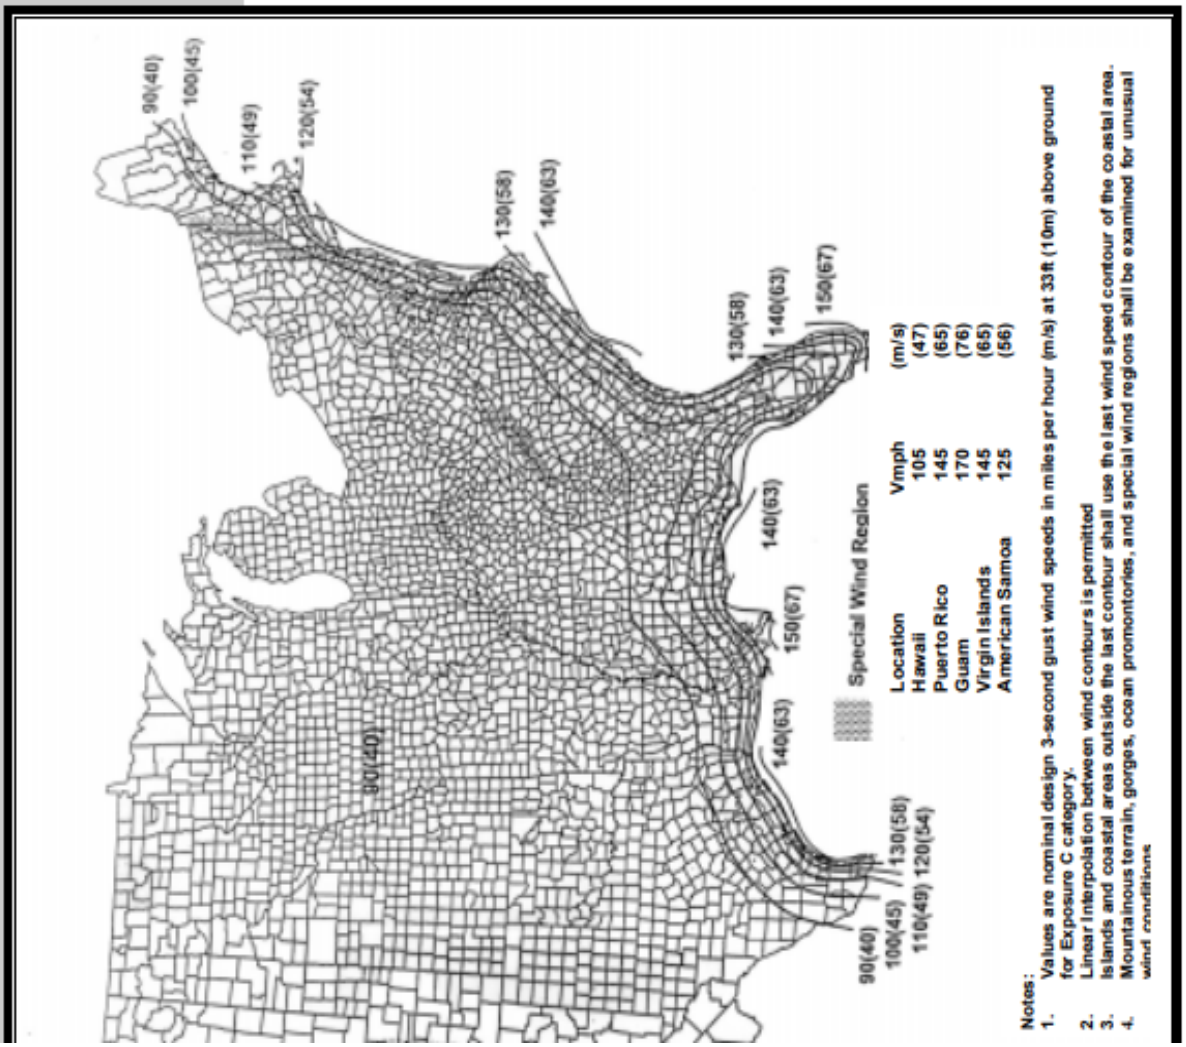
FIGURE 3.2 ***Basic Design Wind Speed Map from ASCE 7-98***

From 1998 to 2016, the basic wind speed to be considered in the design increased by 20%

V = 150 mph (Miami Area)

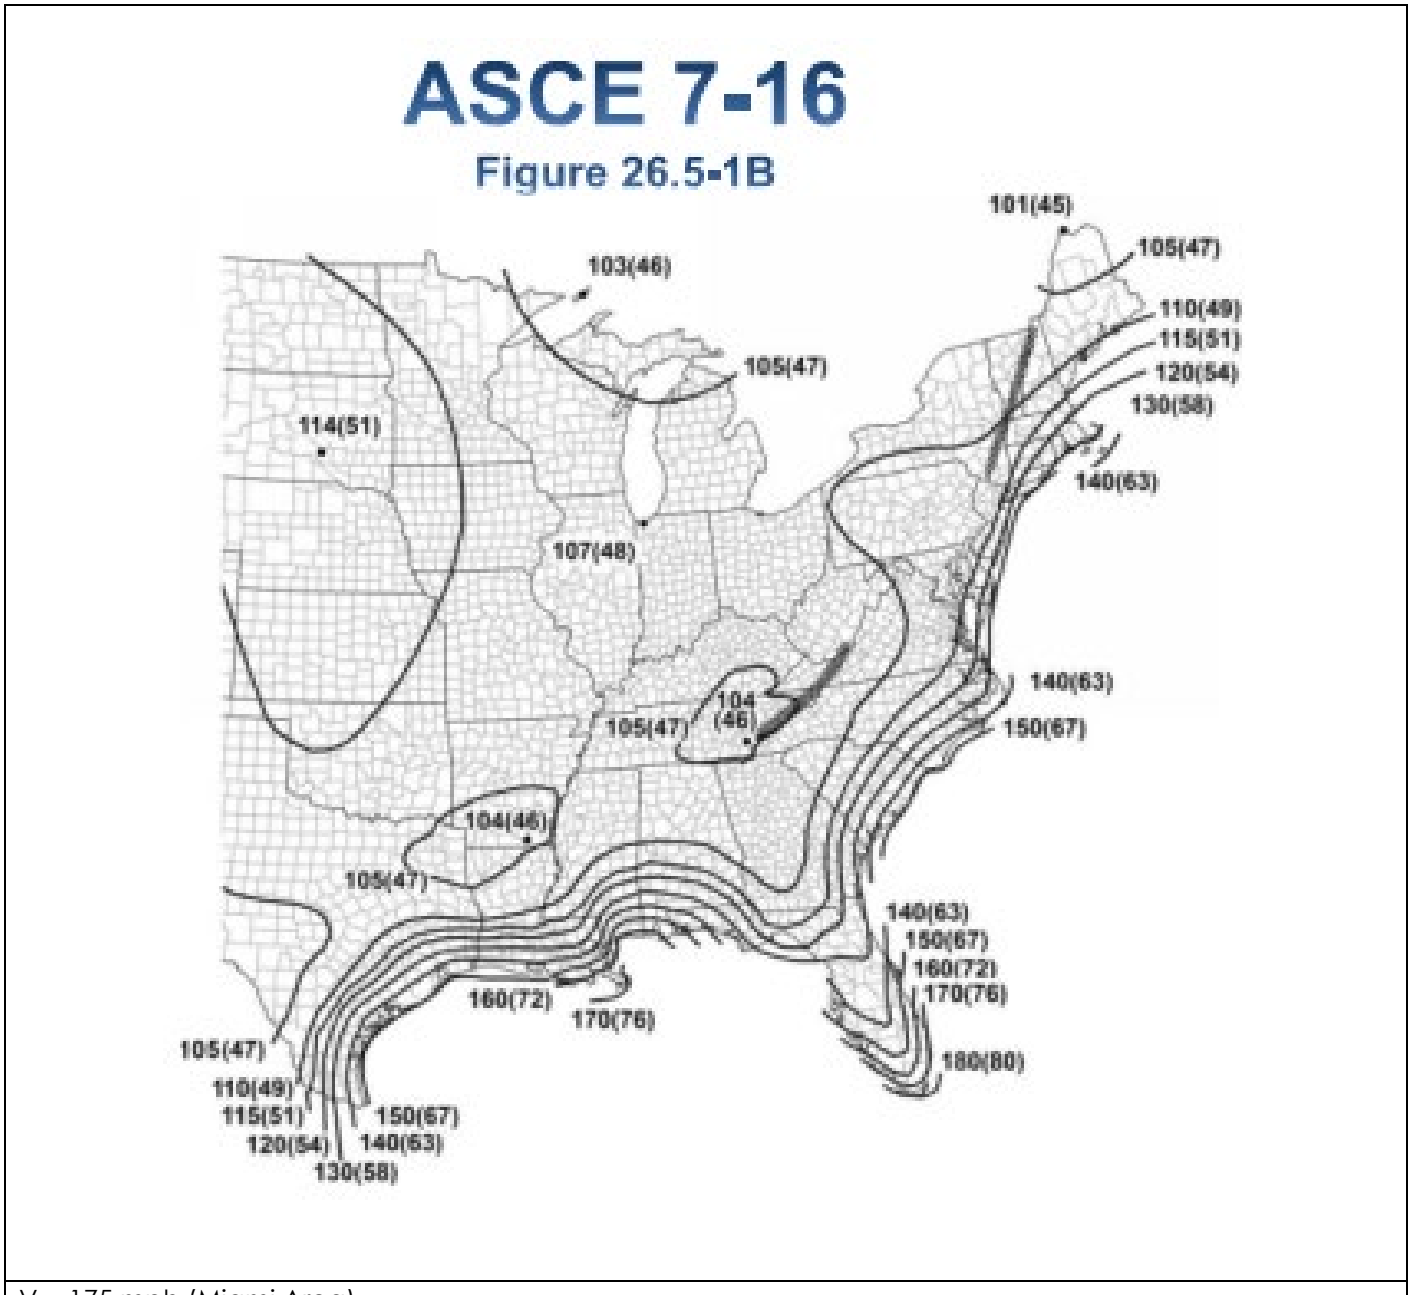
V = 175 mph (Miami Area)

Due to the above, the structural analysis of the existing house did not consider design parameters that are mandatory in the current code. The existing roof is approximately 21-years old. Therefore, the age of the roof predates the requirements of the current code. Even when additional ties could be included in the roof deck to make it resistant to design wind pressures, the masonry walls are not reinforced, so there is no transmission of forces to the foundations that guarantee resistance to uplift loads. The roof does not have gutters or downspouts, causing runoff in unintended locations.

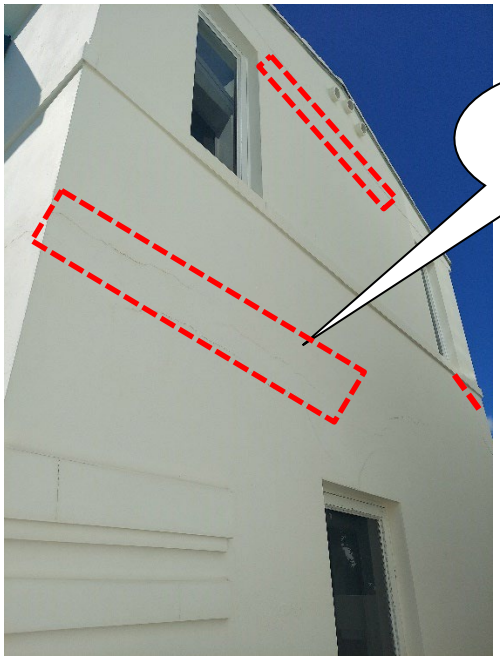
Cracked area.

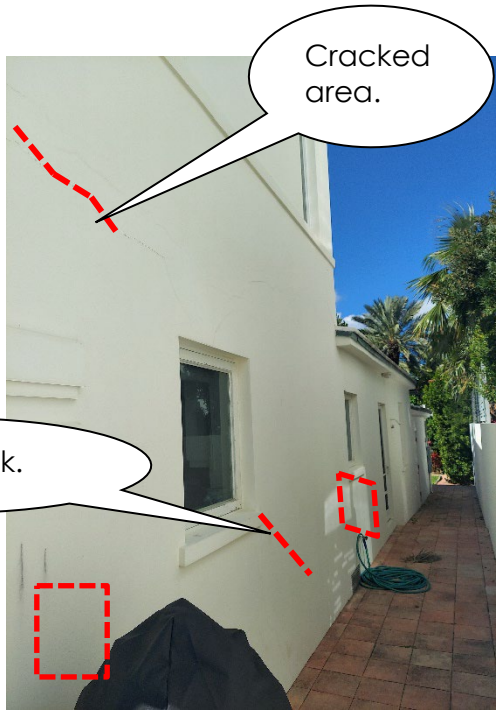
Cracked area.
Hairline crack.

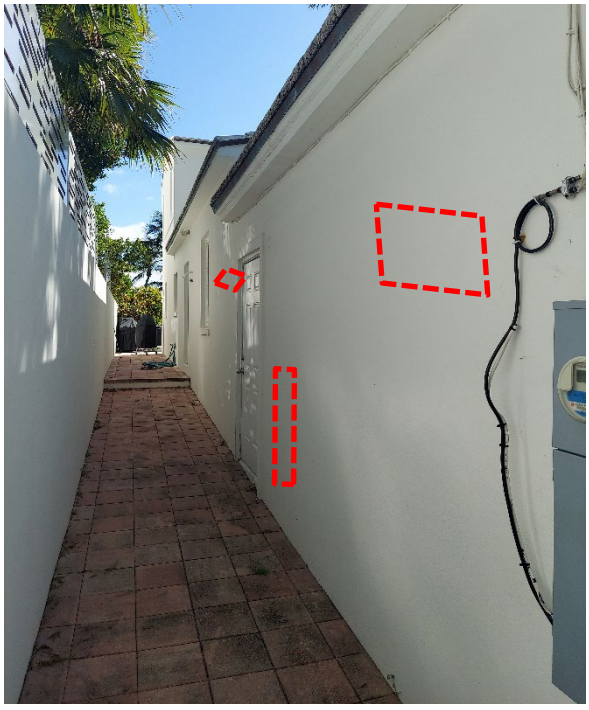
Stucco in poor condition
West side

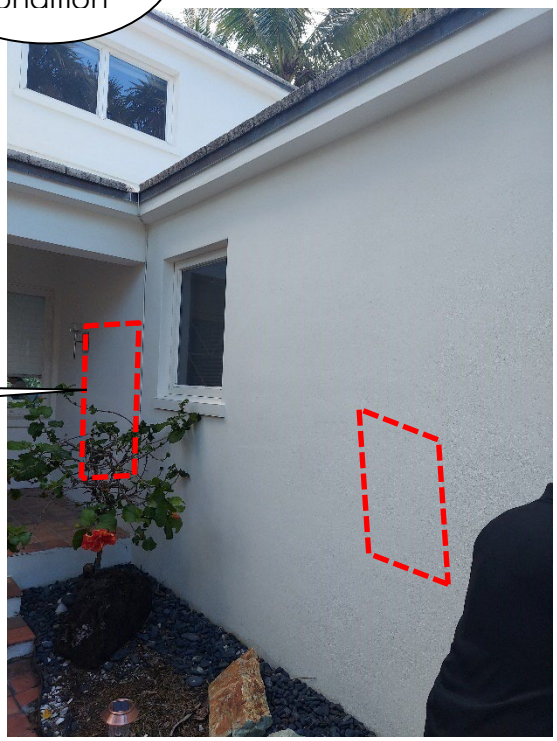
Stucco in poor condition

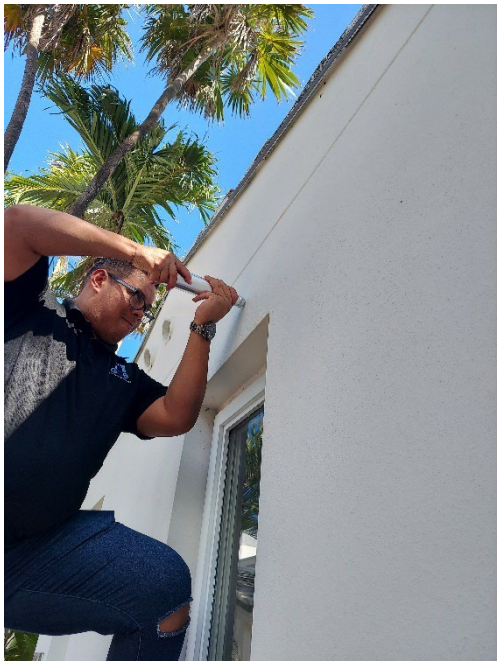
Sclerometer test

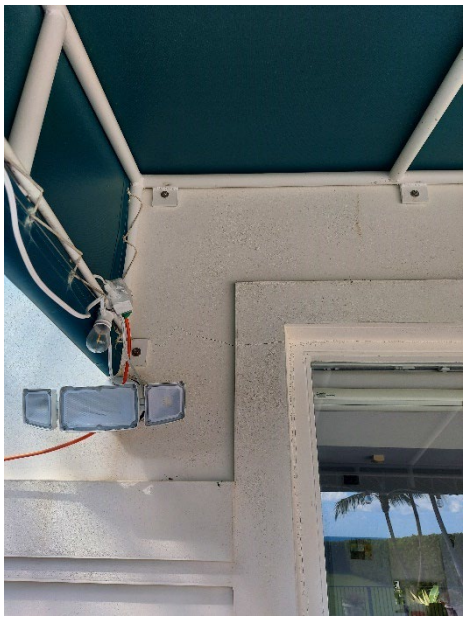
Façade stucco condition

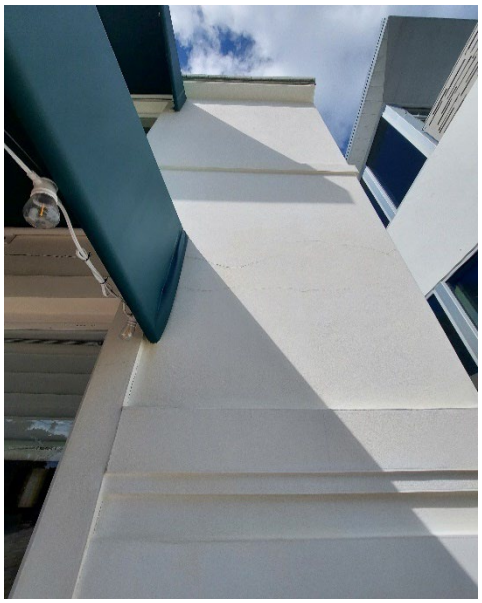
Cracked beam, east side.
