# **GENERAL ASSESSMENT REPORT**

## **EXISTING STRUCTURAL SYSTEMS**

**803 2<sup>ND</sup> STREET  
MIAMI BEACH, FLORIDA**

**APRIL 5, 2021**

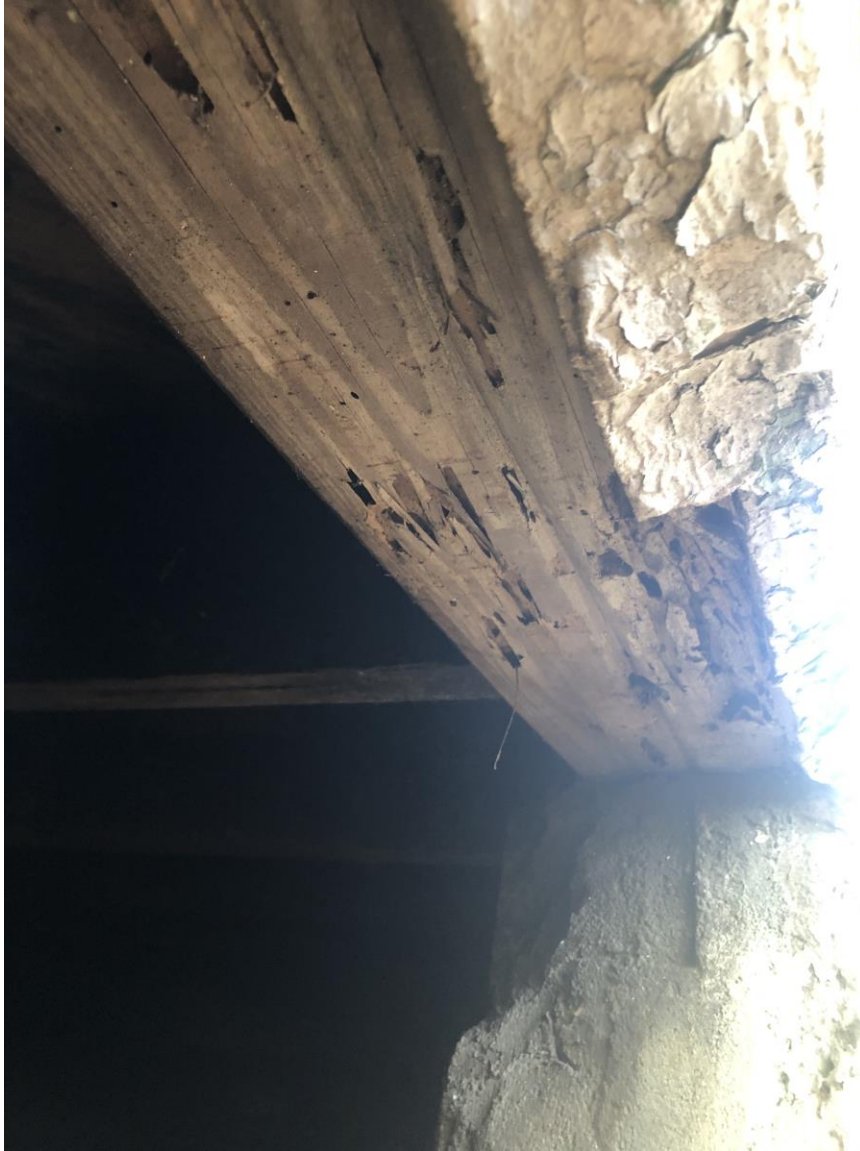
PHOTOGRAPH NO. 97

The exterior stem-walls, on which the floor joists bear, are constructed of concrete block. Refer to Photograph No. 97.

Direct observation of the floor structure was limited to one vent/access opening on the east side of the building. The original floors generally consist of wood board sheathing over wood joists. The joists generally bear on the exterior concrete block stem-wall (refer to Photograph No. 97) and on interior wood beams, which bear on wood shims on concrete blocks on concrete pads. Refer to Photographs Nos. 96 and 99.
