# Arborist Report

94 Palm Avenue

Miami Beach

11/14/2022

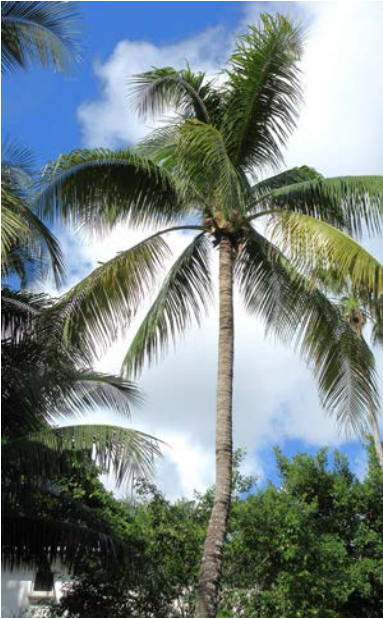
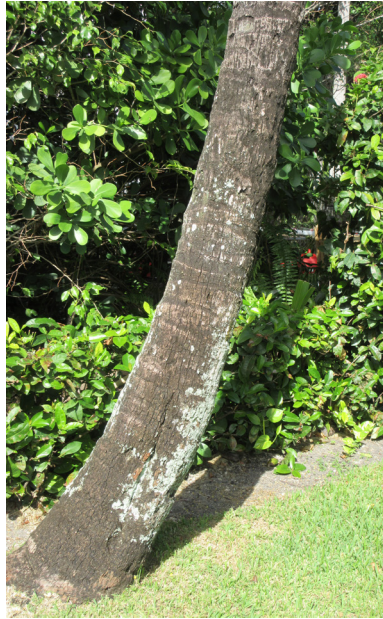
## Tree #17

**Condition -**  
FAIR

Tree #17 is a Coconut Palm located towards the northwest corner of the property. It is in fair condition with a thin canopy and yellowing fronds.

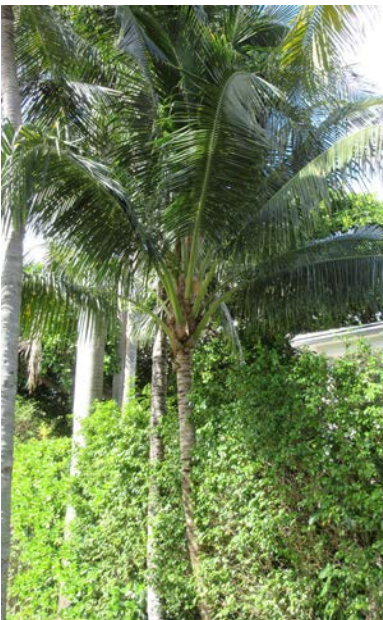
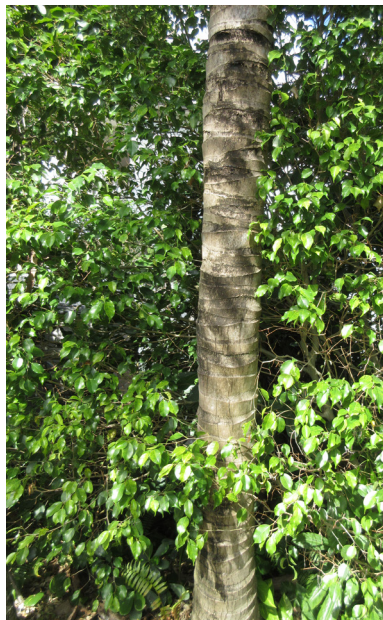
## Tree #18

**Condition -**  
FAIR

Tree #18 is a Coconut Palm located towards the northwest corner of the property. It is in fair condition with yellow spotting on the fronds.

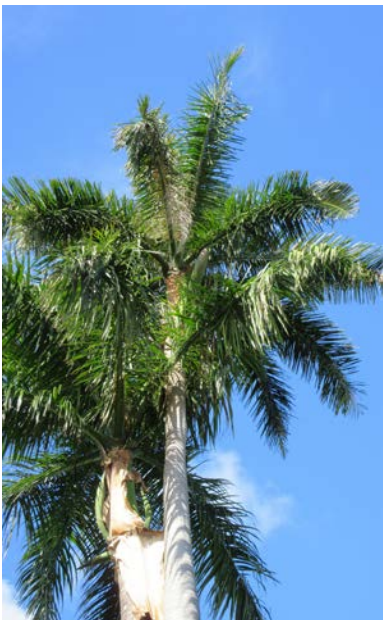
## Tree #24

**Condition -**  
FAIR

Tree #24 is a Royal Palm located on the west side of the property. It is in fair condition with a pencilling trunk and frizzled foliage.

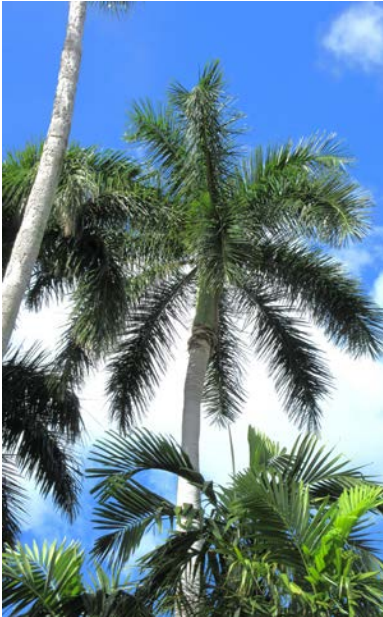
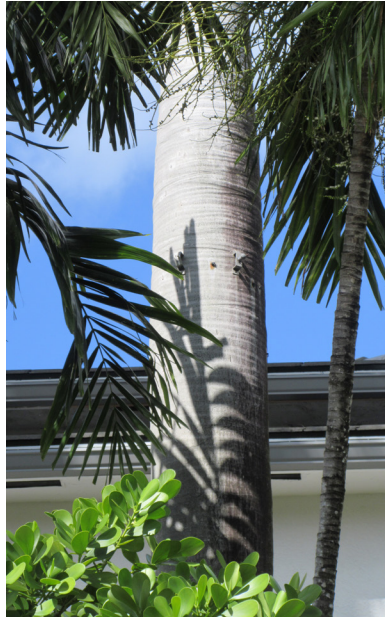
**Condition -**  
FAIR

Tree #27 is a Royal Palm located on the west side of the property. It is in fair condition with a pencilling trunk.

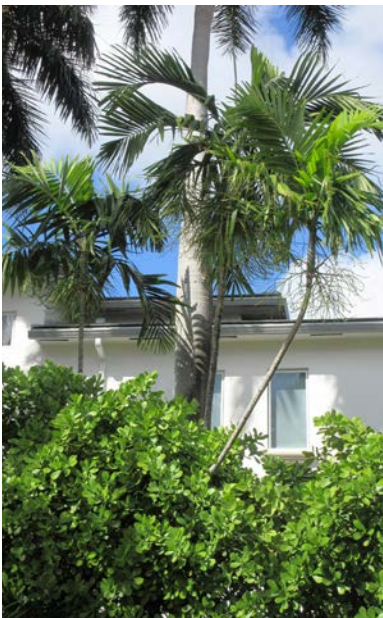
## Tree #28

**Condition -**  
FAIR

Tree #28 is a triple Alexander Palm located on the west side of the property. It is in fair condition.

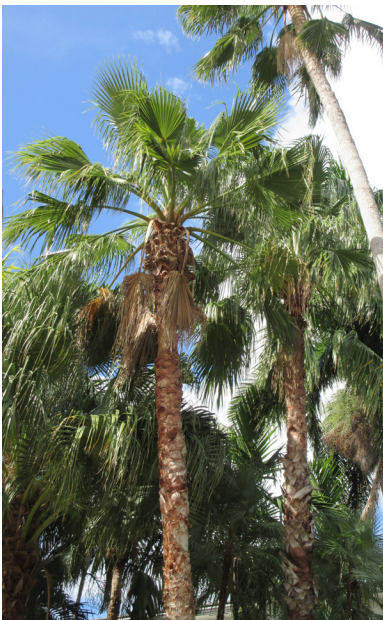
## Tree #30

**Condition -**  
GOOD

Tree #30 is a double Washingtonia Palm located on the west side of the property. It is in good condition.

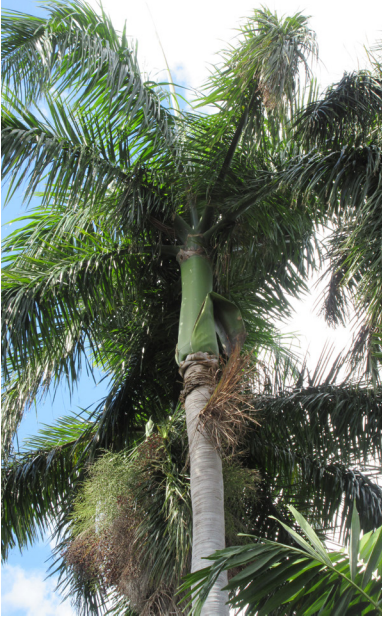
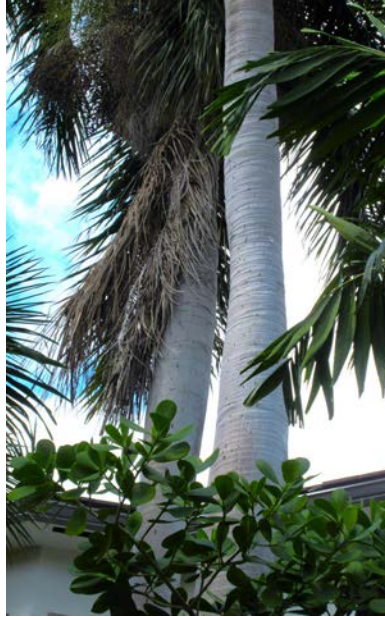
## Tree #31

**Condition -**  
FAIR

Tree #31 is a Royal Palm located on the west side of the property. It is in fair condition with a trunk that is narrowing.

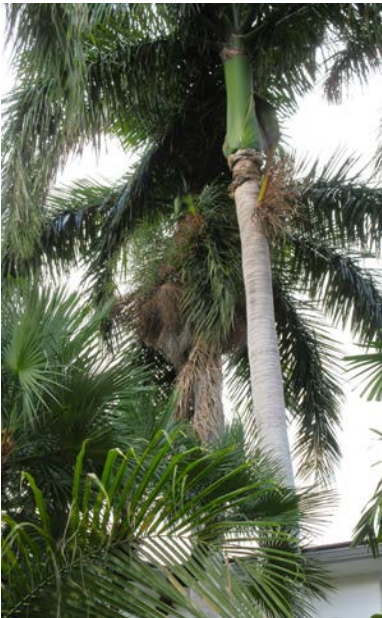
## Tree #32

**Condition -**  
FAIR

Tree #32 is a Royal Palm located on the border of the western neighbor's property. The propertyline chainlink fence is separated due to the tree. It is in fair condition.

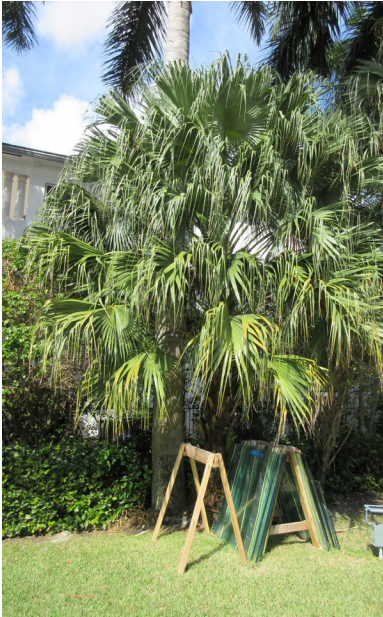
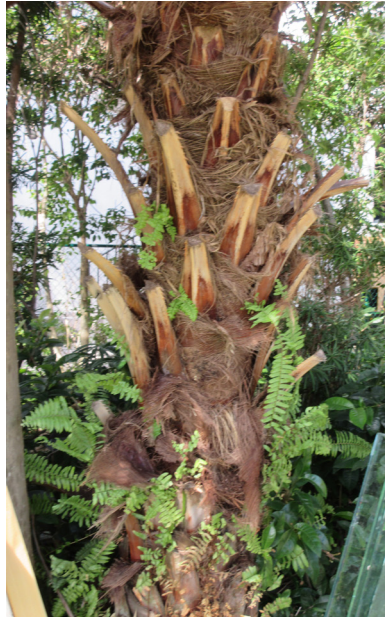
**Condition -**  
FAIR

Tree #35 is a Chinese Fan Palm located on the western side of the property. It is in fair condition with off-color fronds.

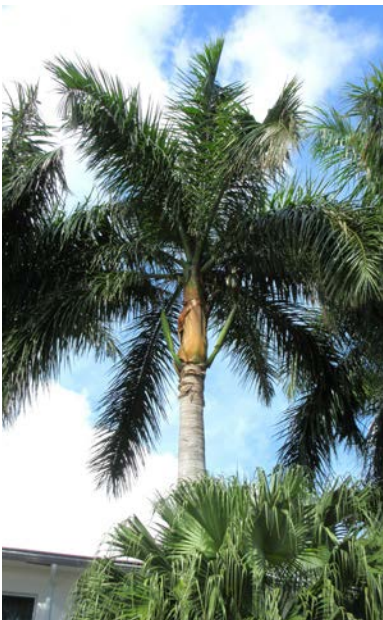
**Condition -**  
GOOD

Tree #36 is a Royal Palm located on the western side of the property. It is in good condition.

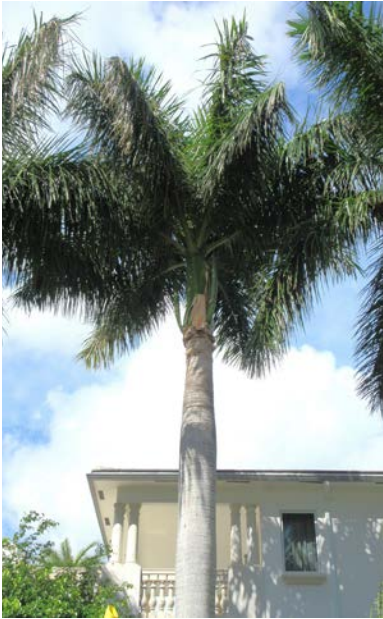
**Condition -**  
GOOD

Tree #37 is a Royal Palm located on the western side of the property. It is in good condition. The lower fronds have been overpruned.

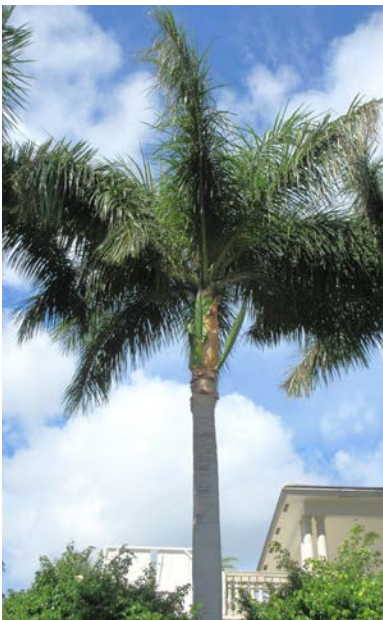
**Condition -**  
GOOD

Tree #38 is a Royal Palm located on the western side of the property. It is in good condition. The lower fronds have been overpruned.

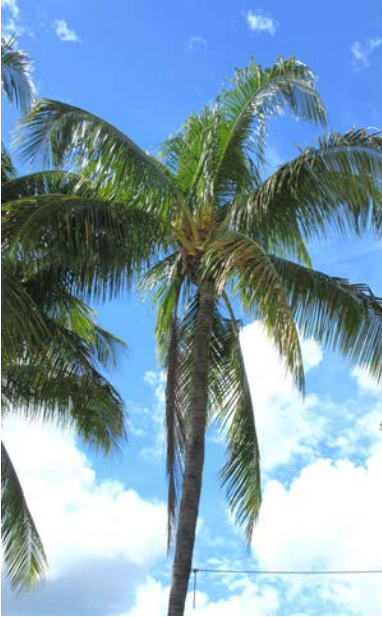
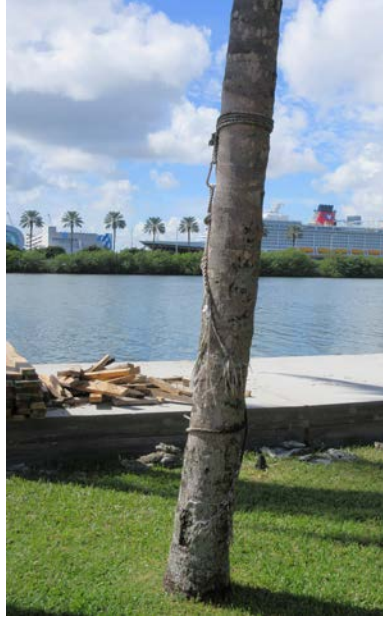
**Condition -**  
FAIR

Tree #41 is a Coconut Palm located towards the southwest corner of the property. It is in fair condition with yellowing fronds and nails in the trunk.

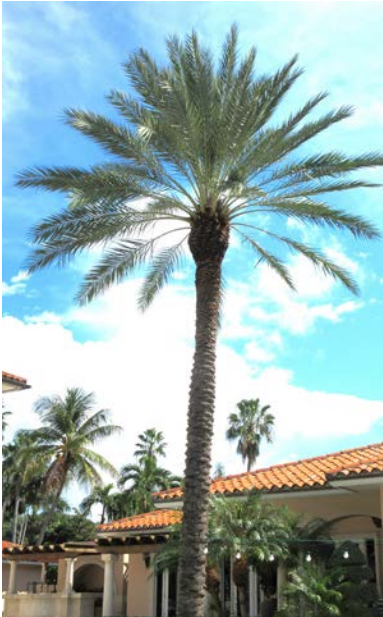
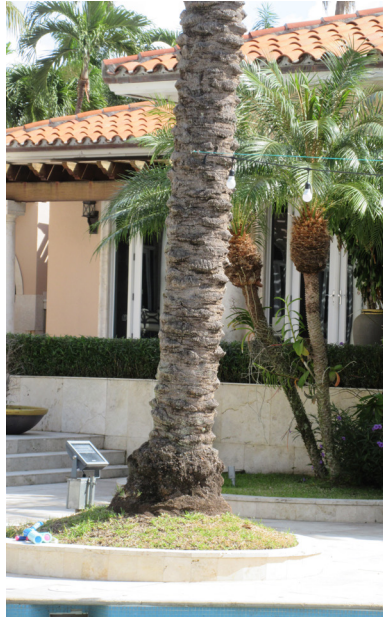
**Condition -**  
GOOD

Tree #47 is a Date Palm located next to the pool. It is growing in a raised planter with limited rooting space. The tree is good condition.

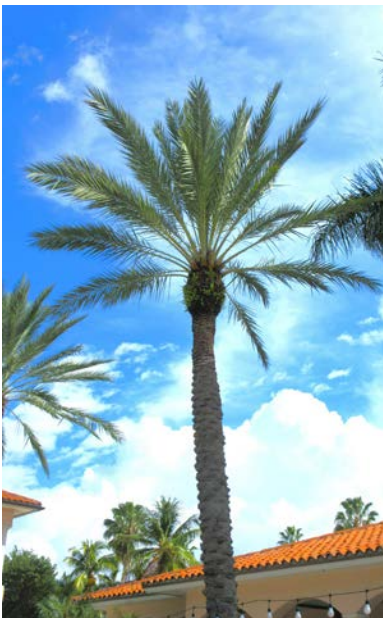
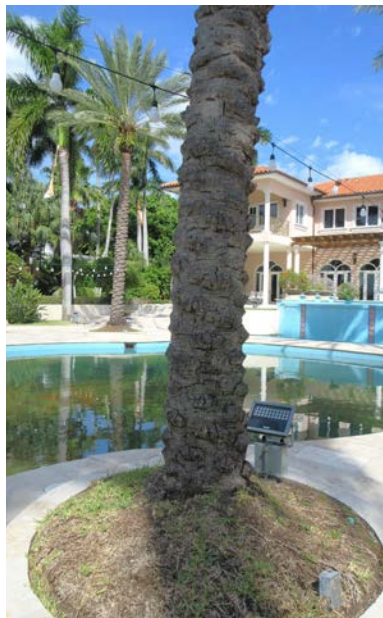
**Condition -**  
FAIR

Tree #48 is a Date Palm located next to the pool. It is growing in a raised planter with limited rooting space. The tree is fair condition with a pencilling trunk.

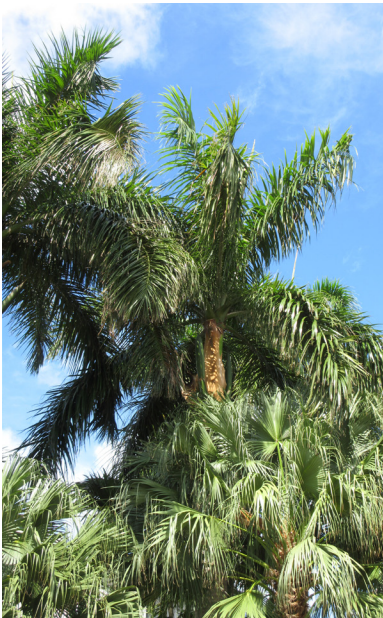
**Condition -**  
GOOD

Tree #56 is a Royal Palm located on the western side of the property. It is in good condition.

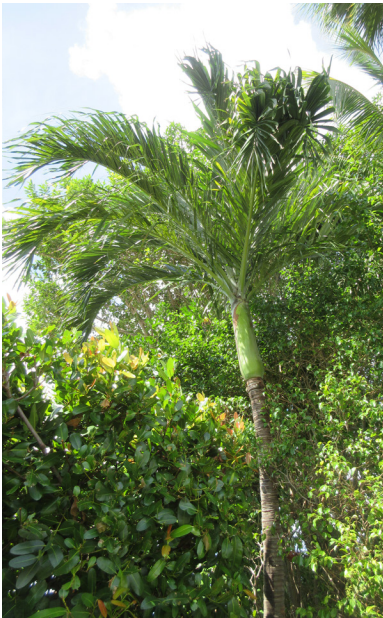
Tree #66 is a Christmas Palm located in the southwestern corner of the property. It is in good condition with some yellow spotting on the fronds.

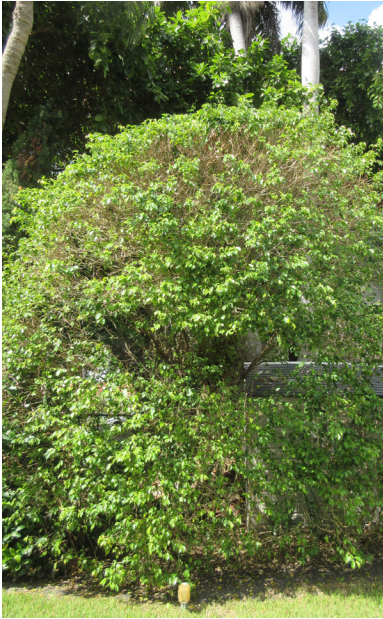
Tree #75 is a Weeping Fig located on the western side of the property. It is multi-trunked and in fair condition. The canopy has been shaped and there is thrips damage to the foliage.

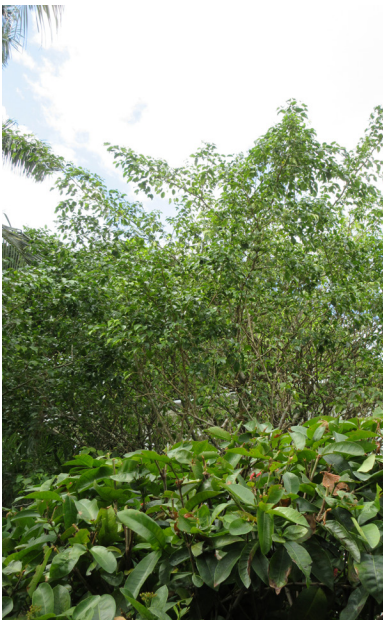
Tree #76 is a Weeping Fig located on the western side of the property. It is multi-trunked and in fair condition. The canopy is thin and there is thrips damage to the foliage.
