*EVALUATION REPORT*

*For Project located at: 7801 ATLANTIC WAY. MIAMI BEACH, FLORIDA. 33141*

The inspection of the building in reference (See Exhibit 1 for graphical representation), located at 7801 Atlantic Way, Miami Beach FL 33141, took place on Wednesday February 22nd, 2023, and was performed by Mr. Alioskar Ganem P.E. The main objective of the inspection was to identify general areas and critical details of the building components that may compromise the integrity of the Structure and represent a hazard to the users of this property. The following report examines the strength and viability of the structure from the slab to the roof.

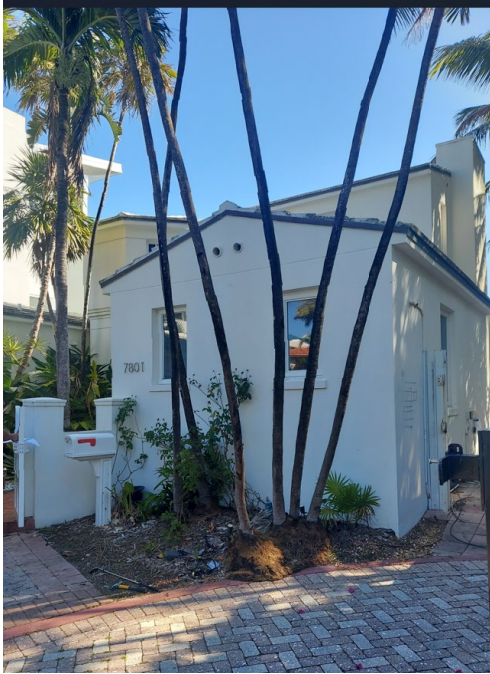
Existing Building conditions:

The House foundation: Elevated Crawl space. Based on photo evidence the existing building has flood vents.

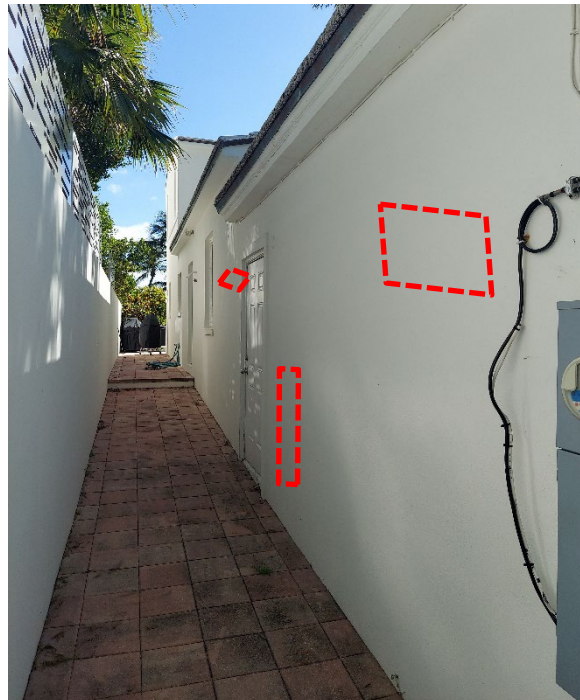
Cracked area.

Hairline crack.
