*EVALUATION REPORT*

*For Project located at: 7801 ATLANTIC WAY. MIAMI BEACH, FLORIDA. 33141*

The inspection of the building in reference (See Exhibit 1 for graphical representation), located at 7801 Atlantic Way, Miami Beach FL 33141, took place on Wednesday February 22nd, 2023 and was performed by Mr. Alioskar Ganem P.E. The main objective of the inspection was to identify general areas and critical details of the building components that may compromise the integrity of the Structure and represent a hazard to the users of this property and to ensure that all its components were built following the minimum standards of the Florida Building Code current at the time of construction, including a proper evaluation for the City of Miami Beach Building Department for the construction plans and construction inspections.

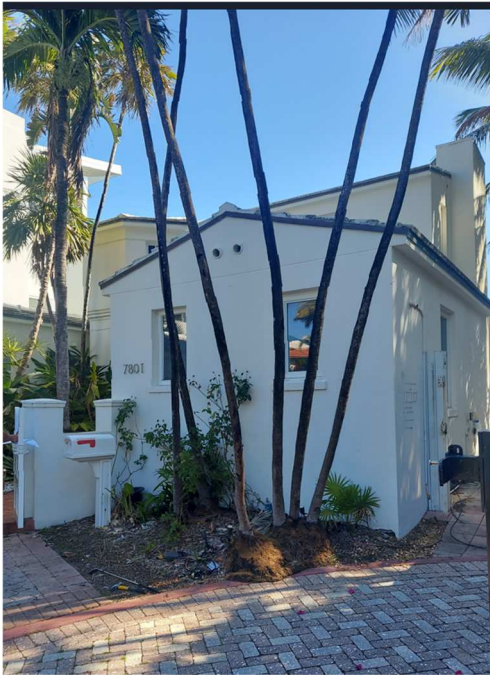
Existing Building conditions:

The House foundation: Elevated Crawl space. Based on photo evidence the existing building has flood vents.
