STRUCTURAL CONDITION ASSESSMENT  
235 Washington Ave  
Miami Beach, Florida

December 19, 2025

STRUCTURAL CONDITION ASSESSMENT for  
235 Washington Ave  
Miami Beach, Florida

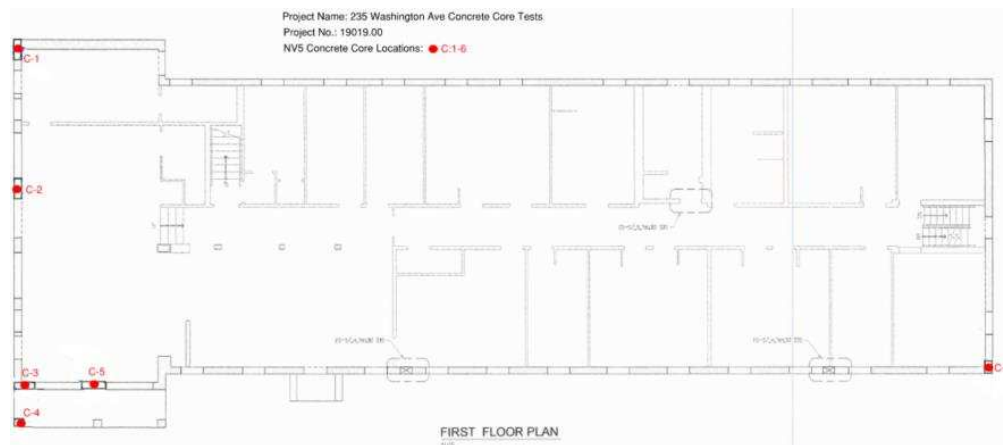
Figure 1: Concrete Core Locations (Red)

On November 20, 2025, an NV5 representative extracted twelve (12) concrete cores from exposed column locations selected by Youssef Hachem Consulting Engineering (YHCE). The cores were numbered as 1-6 and 1A through 6A as shown in Figure 1.

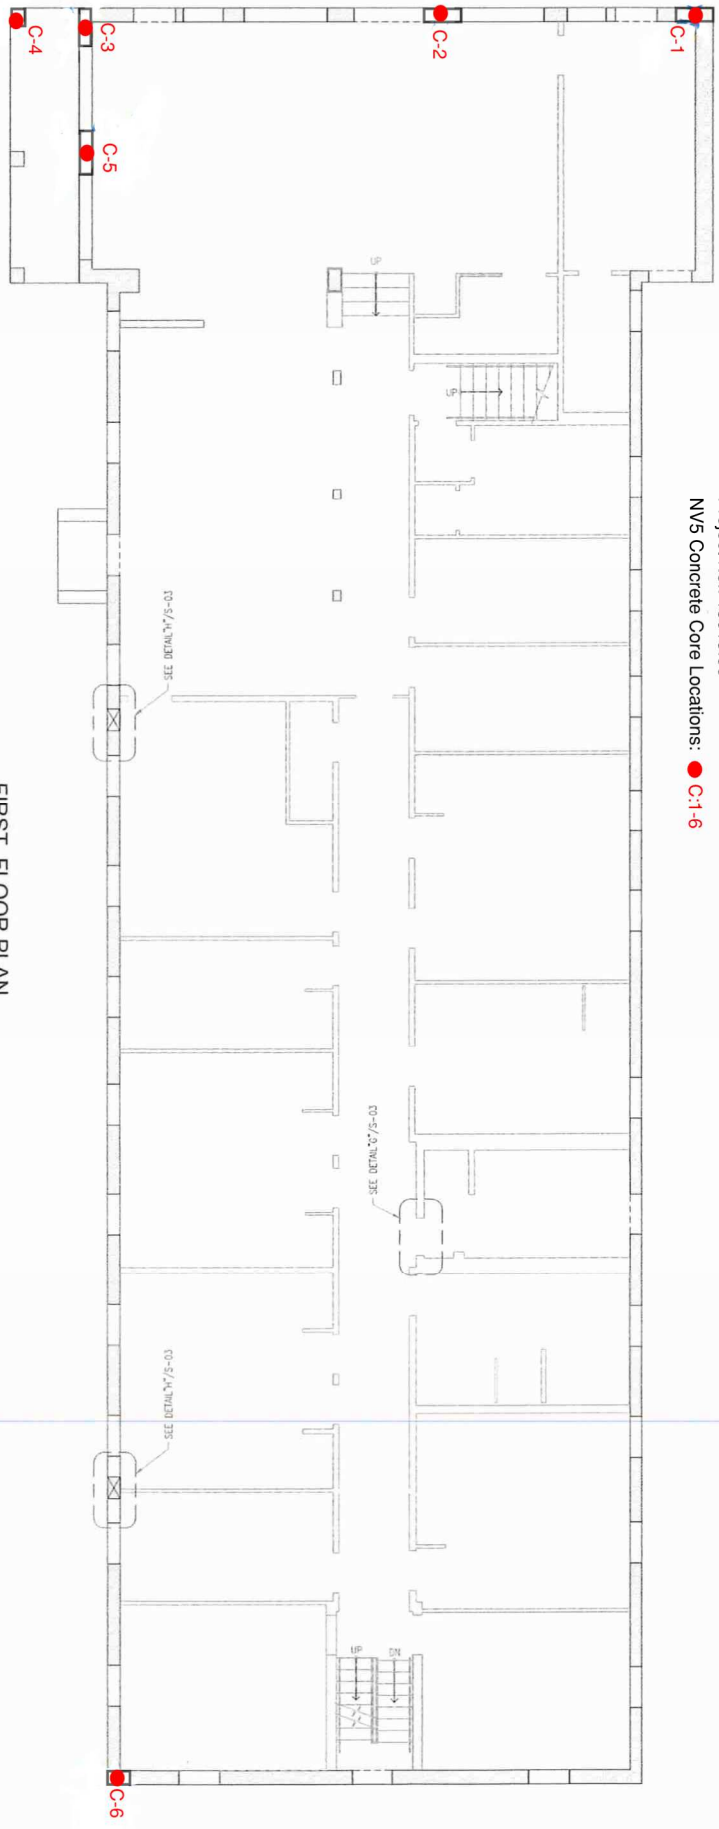
## DRAWING 1

Project Name: 235 Washington Ave Concrete Core Tests  
Project No.: 19019.00  
NV5 Concrete Core Locations: ● C-1-6

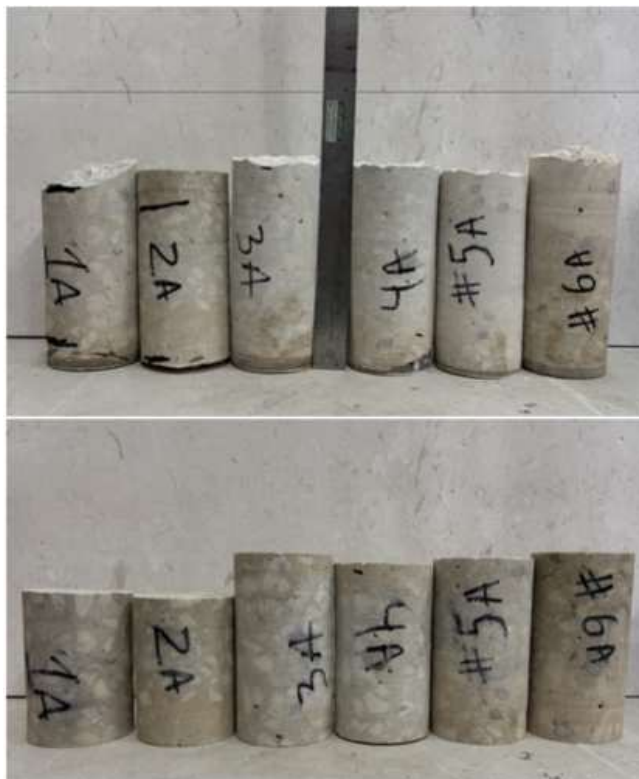
Photograph #2: Concrete Cores Before and After Preparation for Compressive Strength
