# SKETCH OF BOUNDARY SURVEY

(SEE PAGE 2 OF 3 FOR ELEVATIONS AND PAGE 3 OF 3 FOR TREE LOCATION)

PROPERTY ADDRESS:  
7801 Atlantic Way  
Miami Beach, Florida 33141-2120

**LEGAL DESCRIPTION:**  
Lot 6, Block 5, of Corrected Plat Altos Del Mar No. 1, according to the Plat thereof, as recorded in Plat Book 31, Page 40, of the Public Records of Miami-Dade County, Florida.  
Lot 6 bounded as follows: Bounded on the North by the dividing line between Lots 5 and 6; Bounded on the South by the Southerly line of Lot 6, said Southerly line also being the Northerly line of 78th Street; Bounded on the West by the Westerly line of Lot 6, said Westerly line also being the Easterly line of Atlantic Way; Bounded on the East by the Erosion Control Line of the Atlantic Ocean, as recorded in Plat Book 105, at Page 62, of the Public Records of Miami-Dade County, Florida.

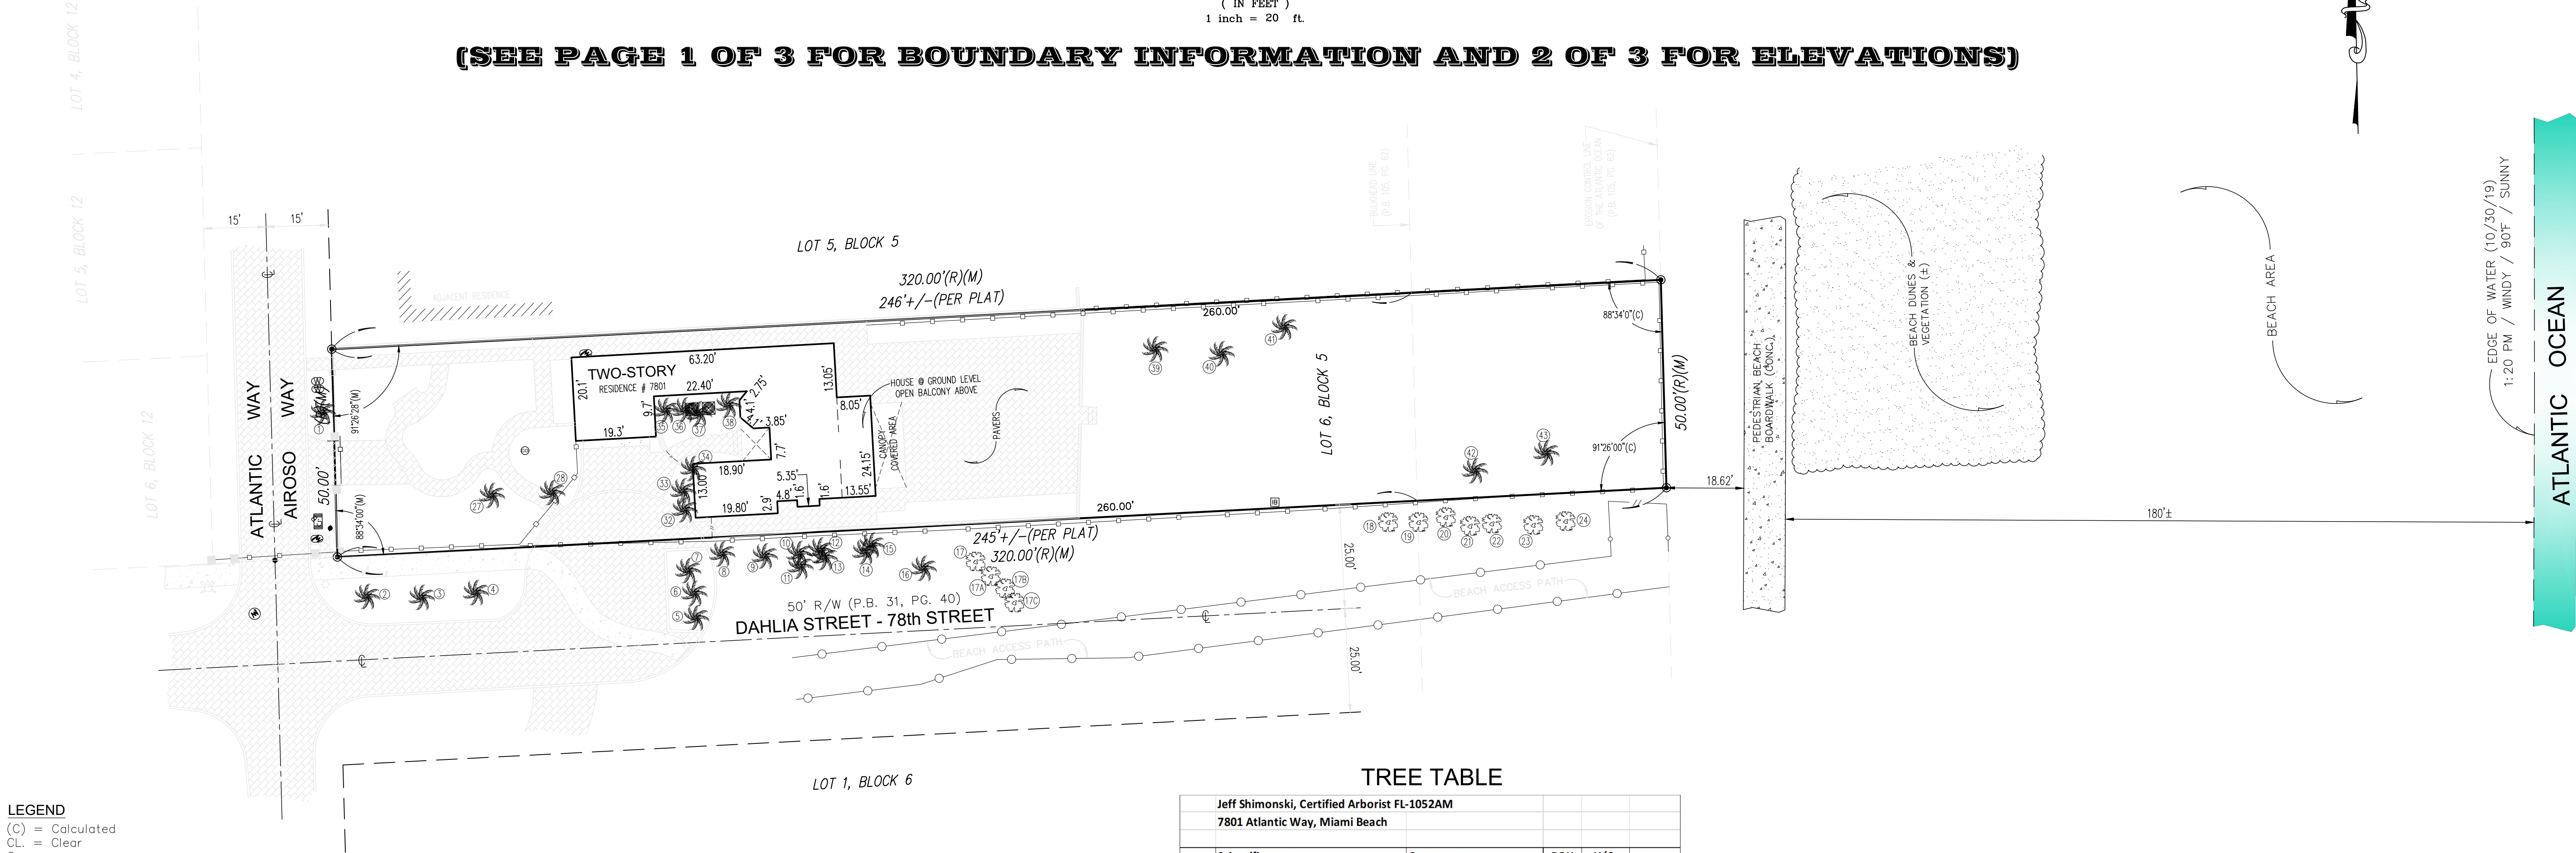
SKETCH OF BOUNDARY SURVEY

(SEE PAGE 1 OF 3 FOR BOUNDARY INFORMATION AND 2 OF 3 FOR ELEVATIONS)

Only the trees inside the subject property were revised at the time of the updated survey on May 23rd, 2022 under Job Number 19-5113D. Trees outside the subject property were not updated and was not part of the scope of work provided to the client.
