1800 Michigan Avenue

Historic Preservation Board

July 8, 2025

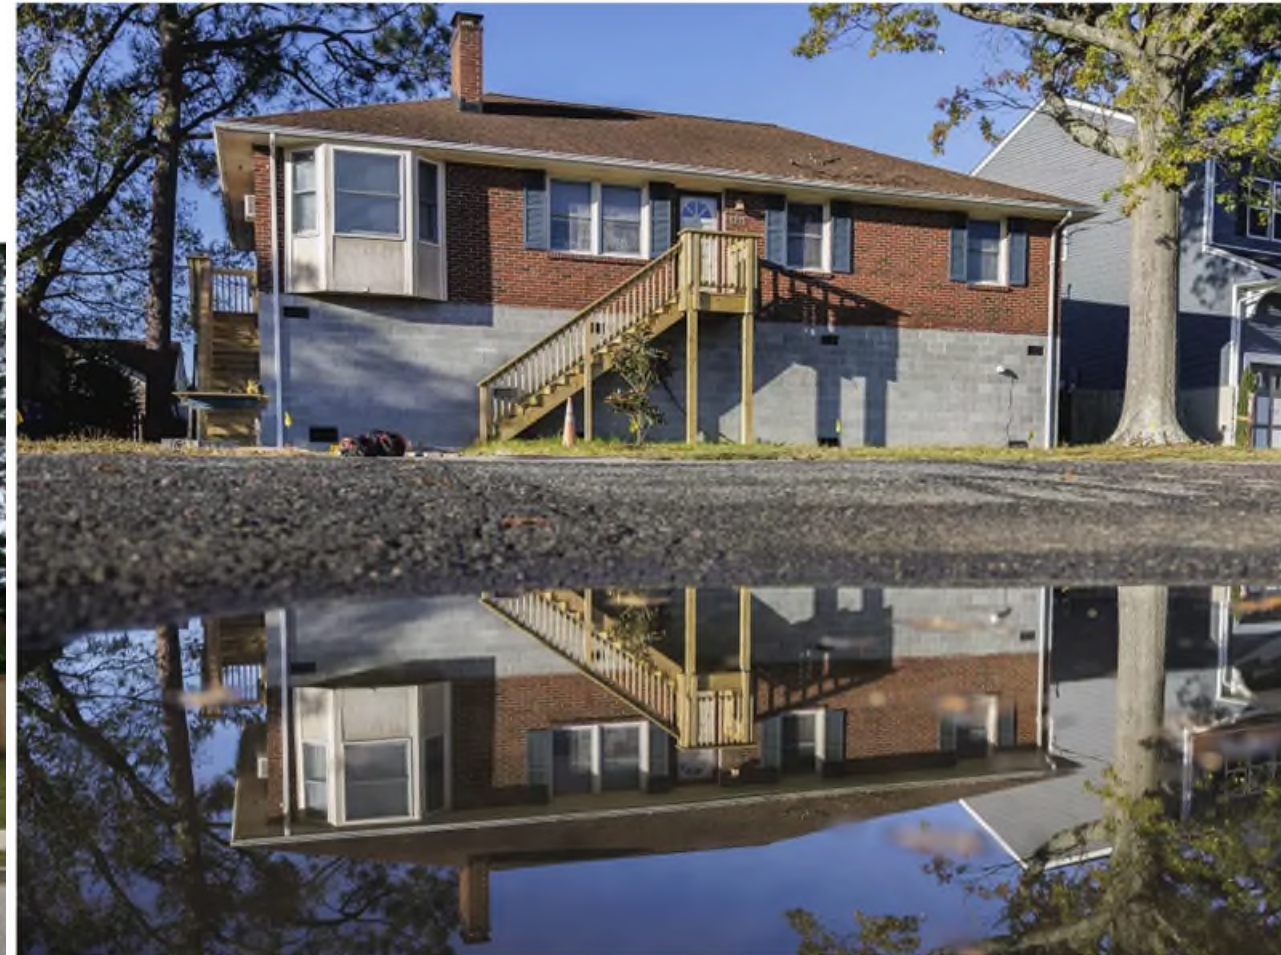
Raising a home involves lifting it off the ground and building a new higher foundation below it.

Photo By Sam Raising homes, which involves lifting it off the ground and building a new higher foundation below it, is one way homeowners are protecting their properties from flooding. | [Lathan Goumas/Virginia Sea Grant, CC BY-ND 4.0](#)

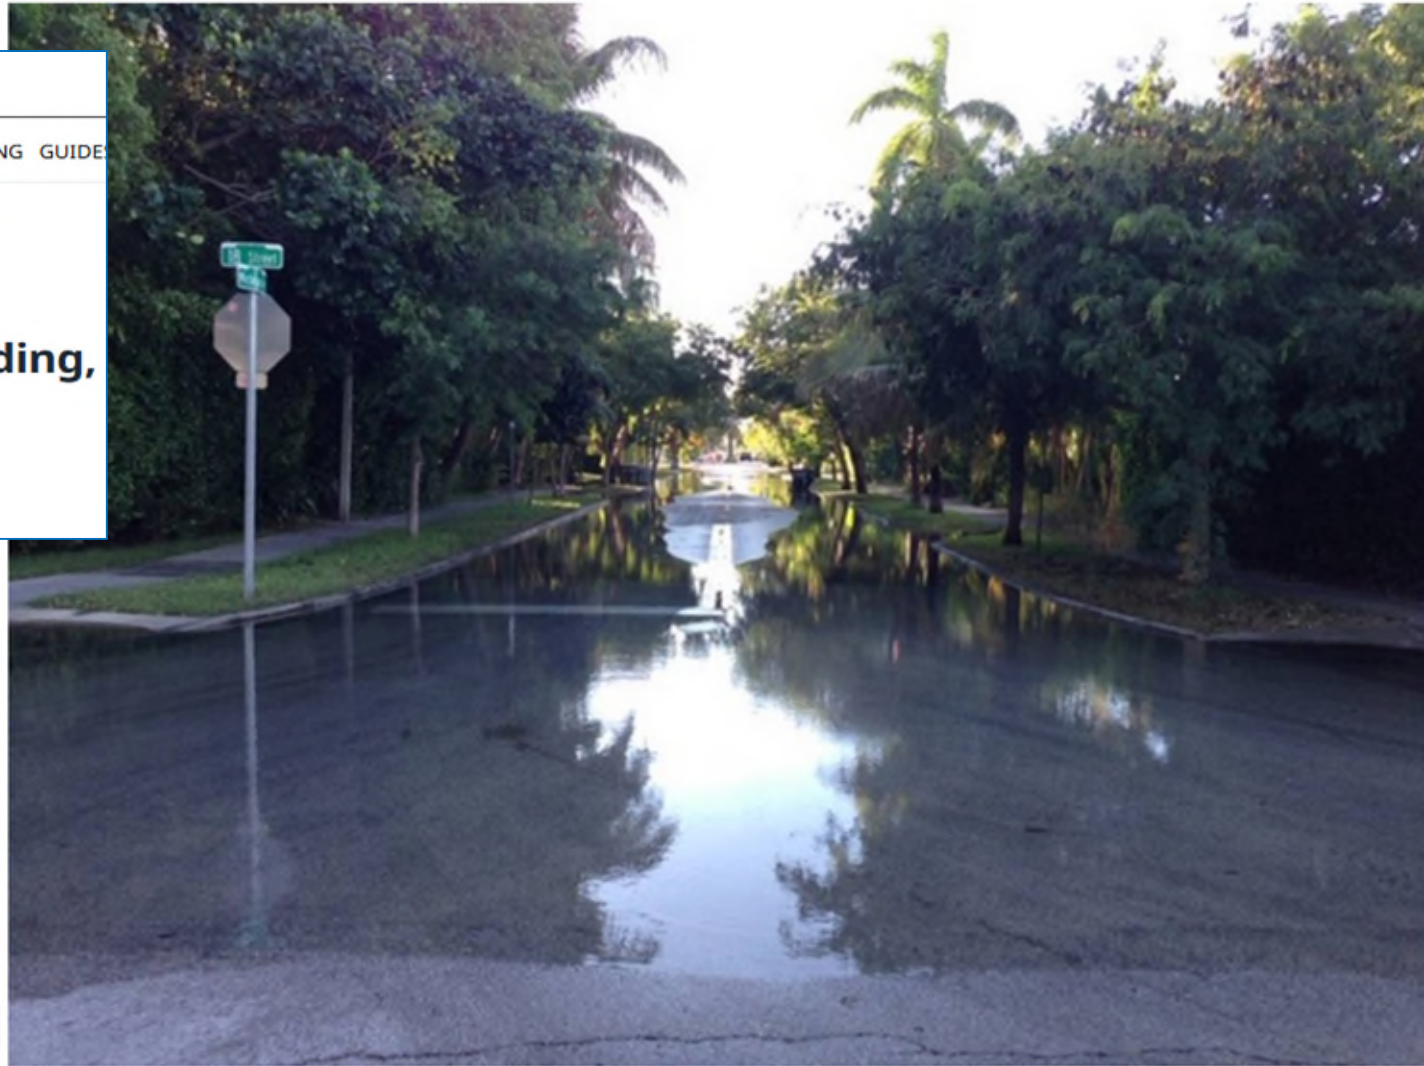
An image of the flooding in South Beach's Palm View neighborhood. Richard Silverman

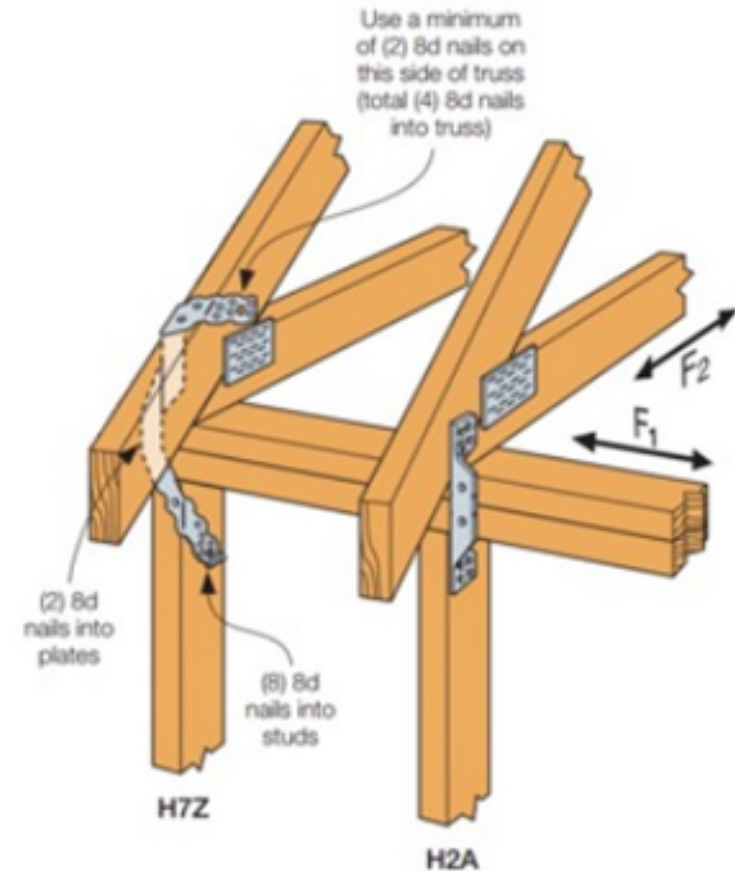
- Connections for wind uplift forces and wind lateral resistance are non-existent
- Requires roof connection tie downs to strengthen the roof

Figure 9. Roof-Framing-to-Stud Connection with Single Hurricane Tie

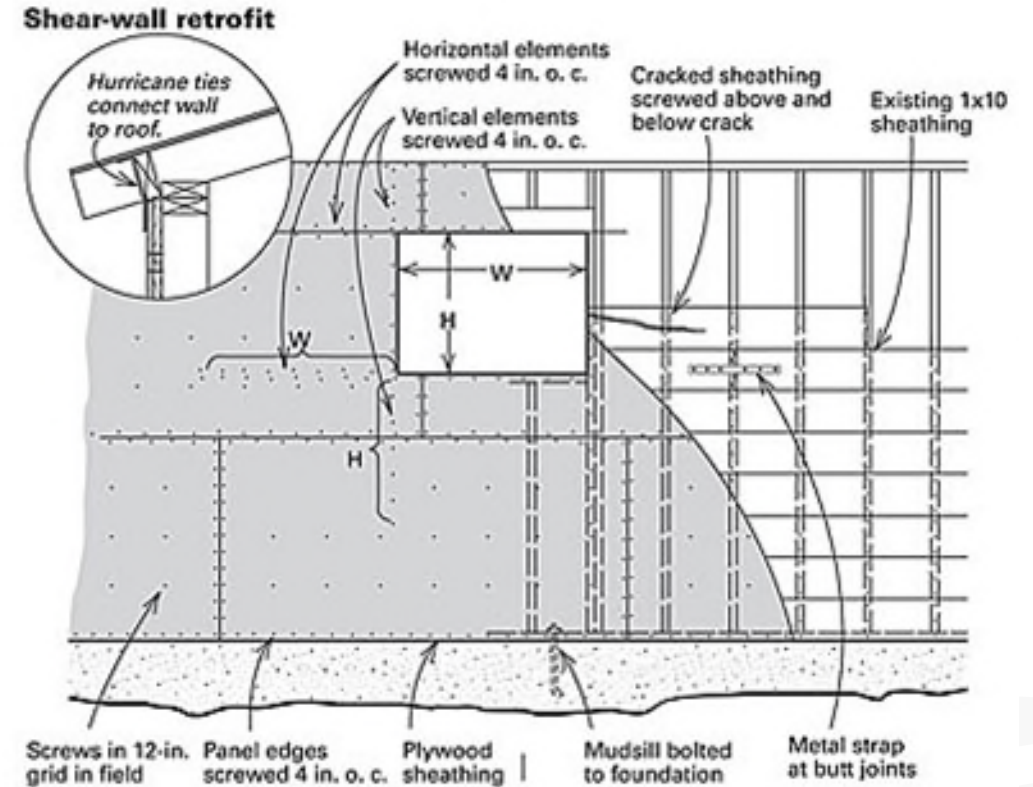
- Opening protection and wood reinforcing is non-existent
- Requires lateral load structural systems to be installed, such as shearwalls

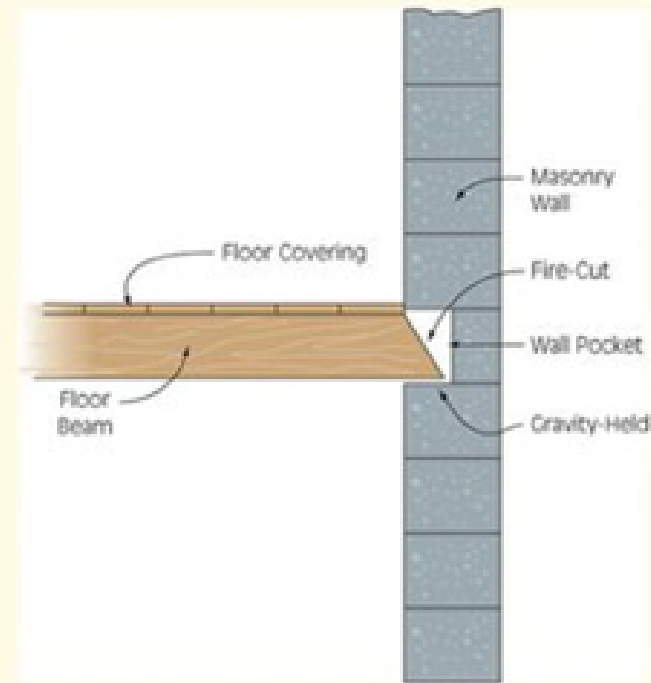
- All wood joists are “fire cut” into the wood wall, not connected to walls via strapping or any other mechanism

Figure 13-20 Wood and heavy timber beams were often “fire-cut” so that a fire-damaged, sagging floor would simply slide out of the wall pocket in order to preserve the wall.

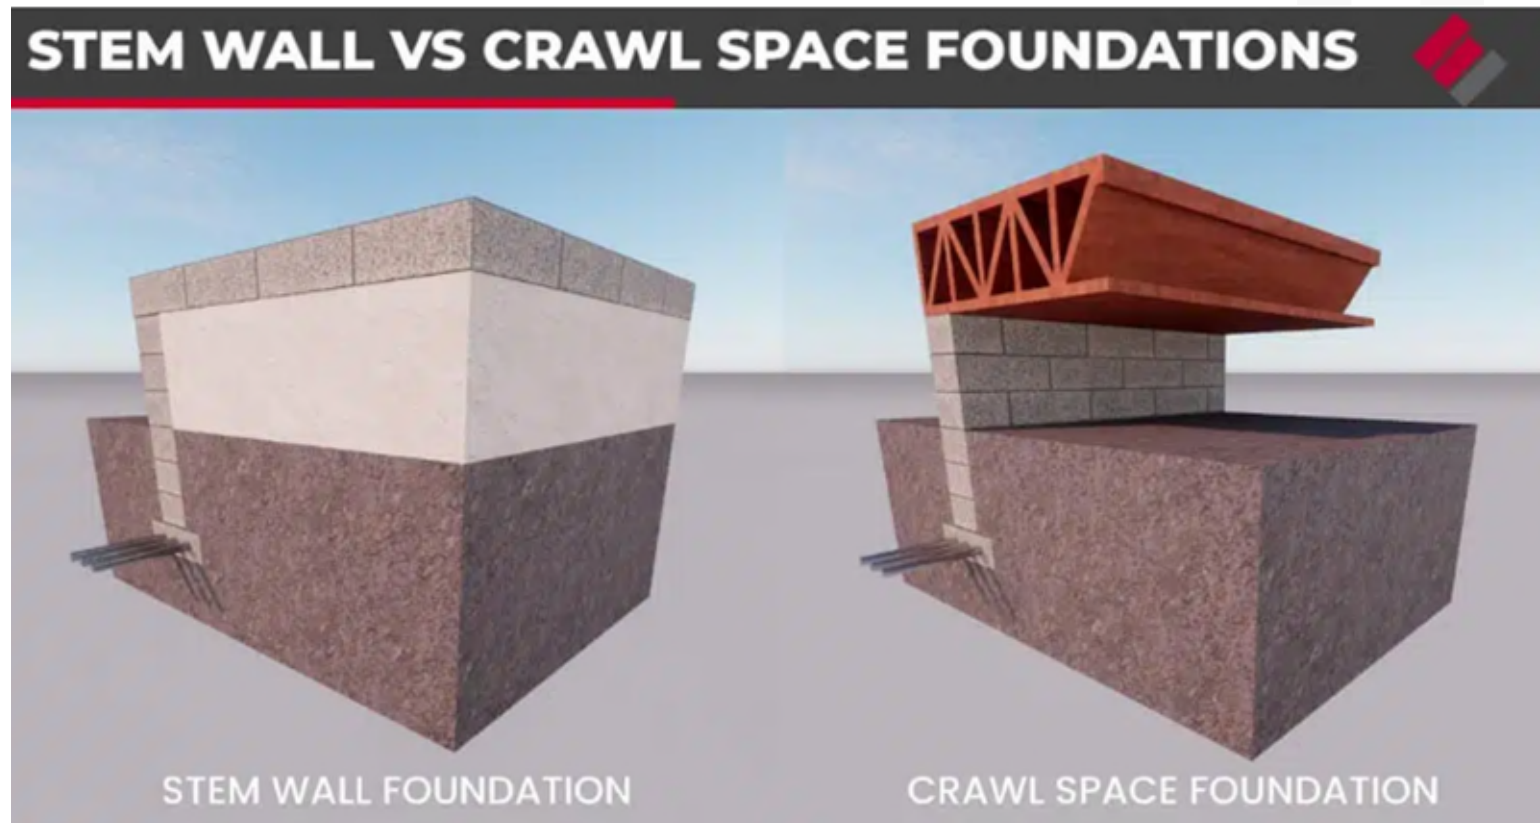
- Slab on grade
- Shallow foundation supporting concrete stem walls
- Foundation has to be strengthened to resist lateral loads

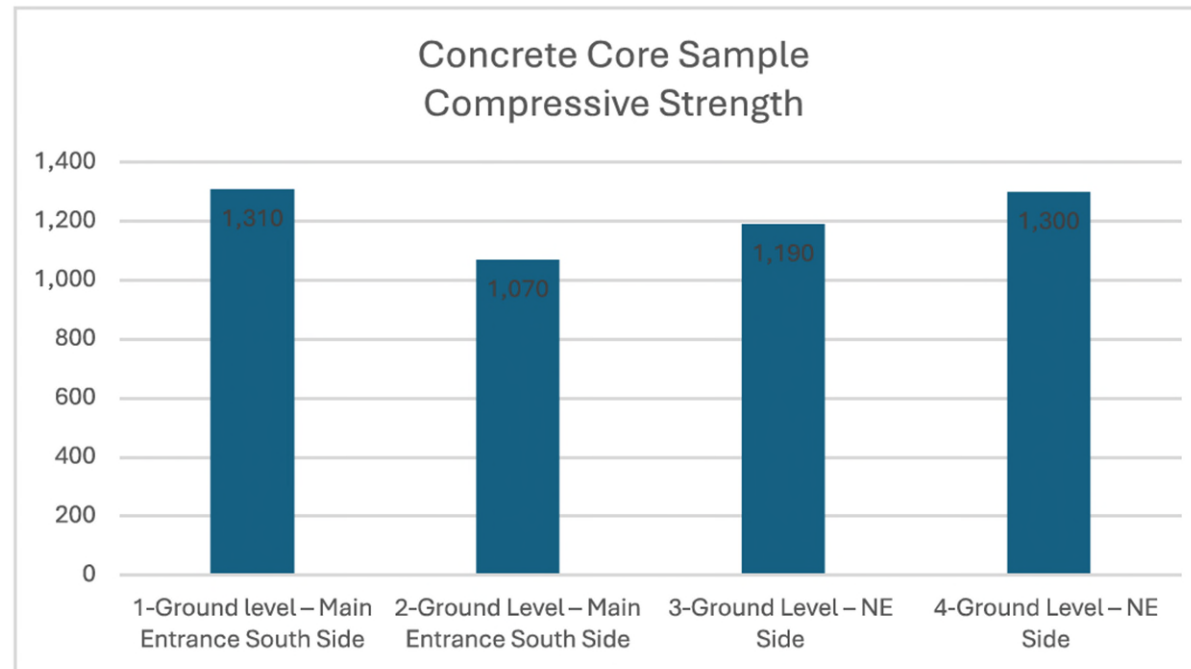
- Ability to withstand pressure before breaks or fails
- Low compressive strength concrete is more prone to cracking and spalling
- Lead to structural failure and compromise the stability

The Concrete compressive strength ranged from 1,070 to 1,310 PSI. Per Florida Building Code the concrete strength should be 5,000 PSI.

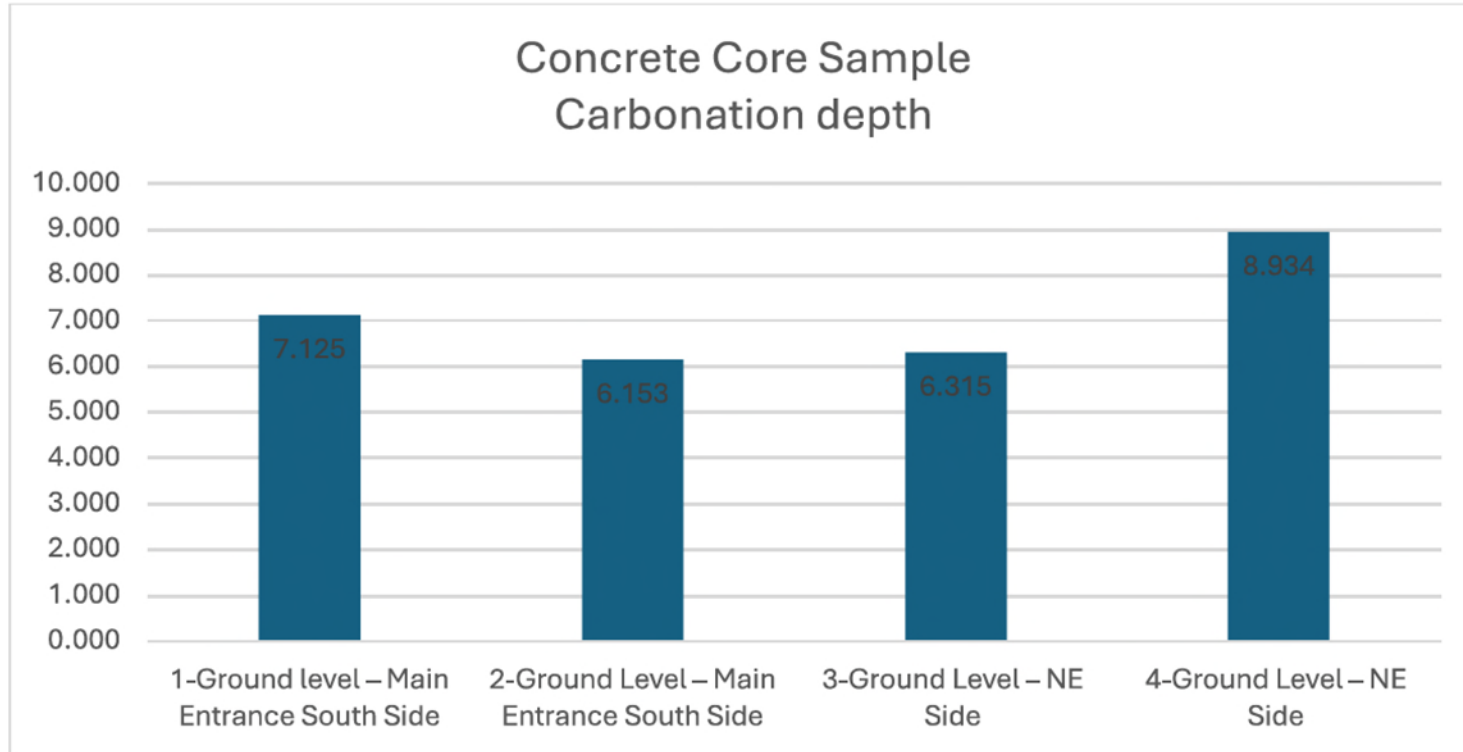
Concrete Testing

- Depth of carbonation is measured from the surface of the concrete
- Carbonation exposes the rebars to corrosion
- Carbonation is extensive ranging from 6.153" to 8.934"

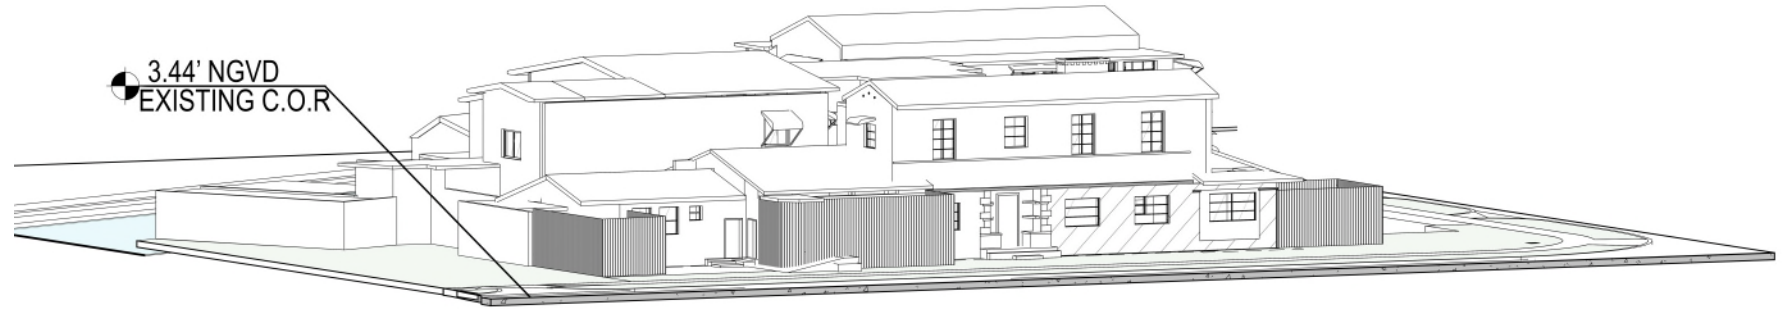
EXISTING AXONOMETRIC BEFORE DEMOLITION OF 1810 AND 1818

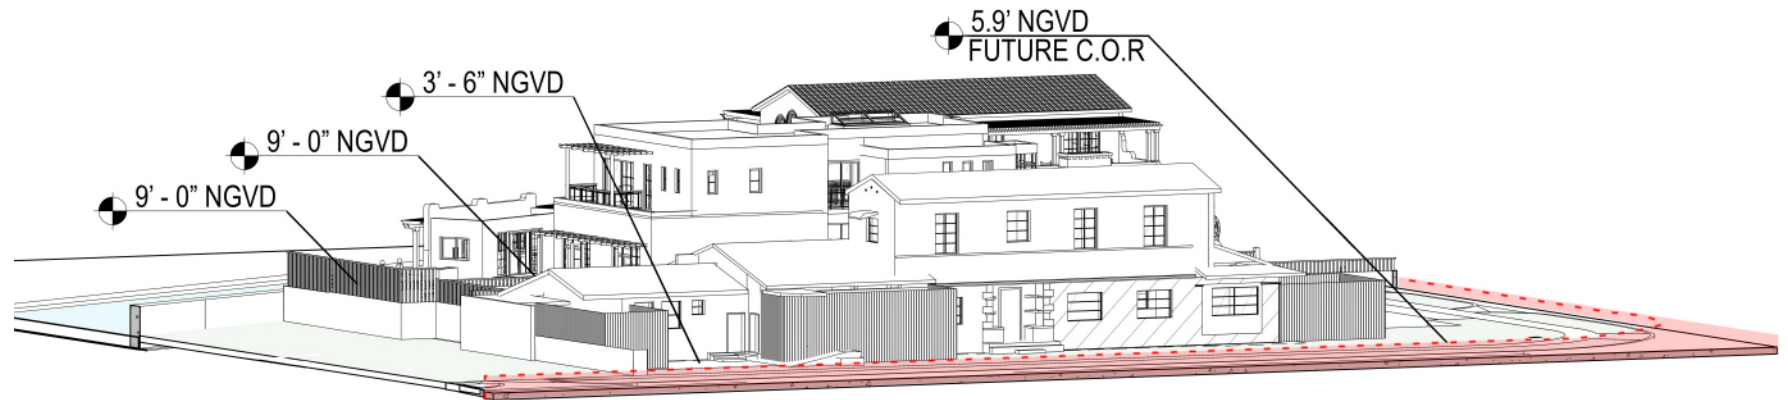
AXONOMETRIC SHOWING PROPOSED 1810 AND 1818

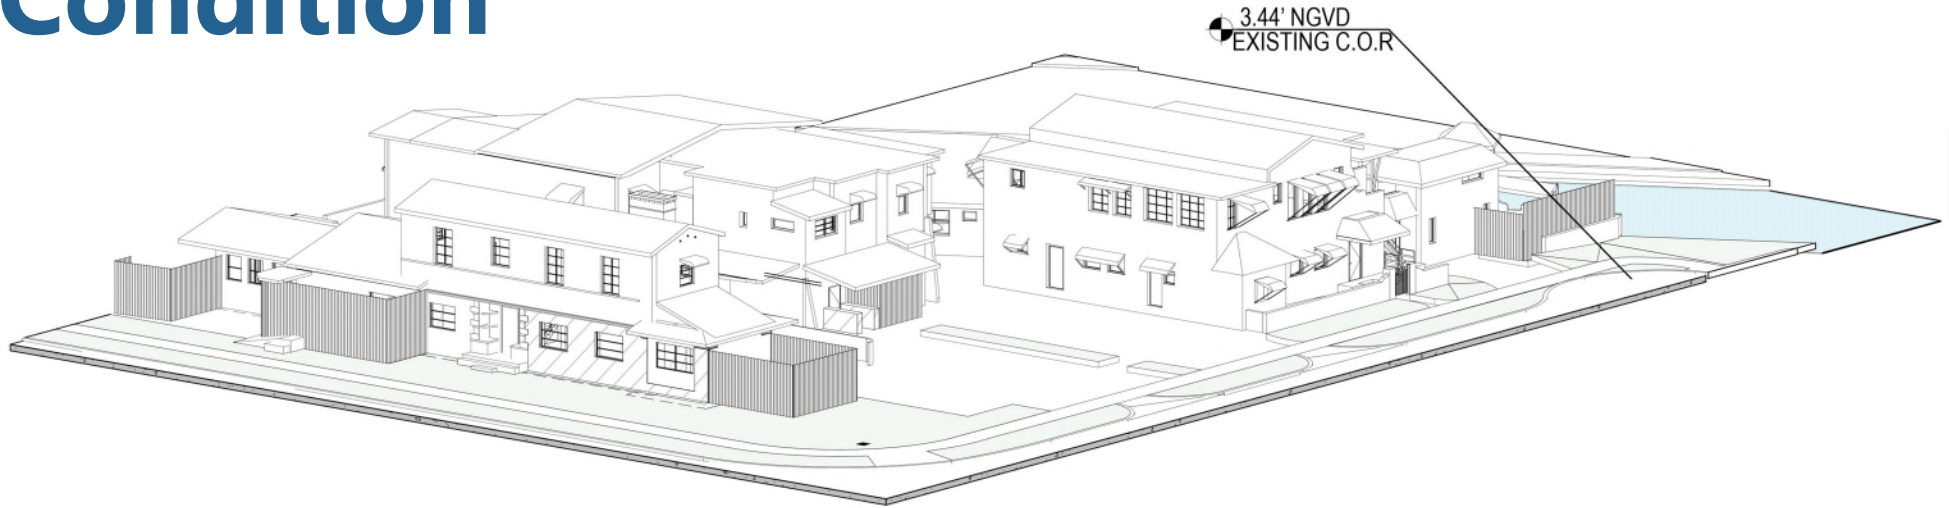
EXISTING AXONOMETRIC BEFORE DEMOLITION OF 1810 AND 1818

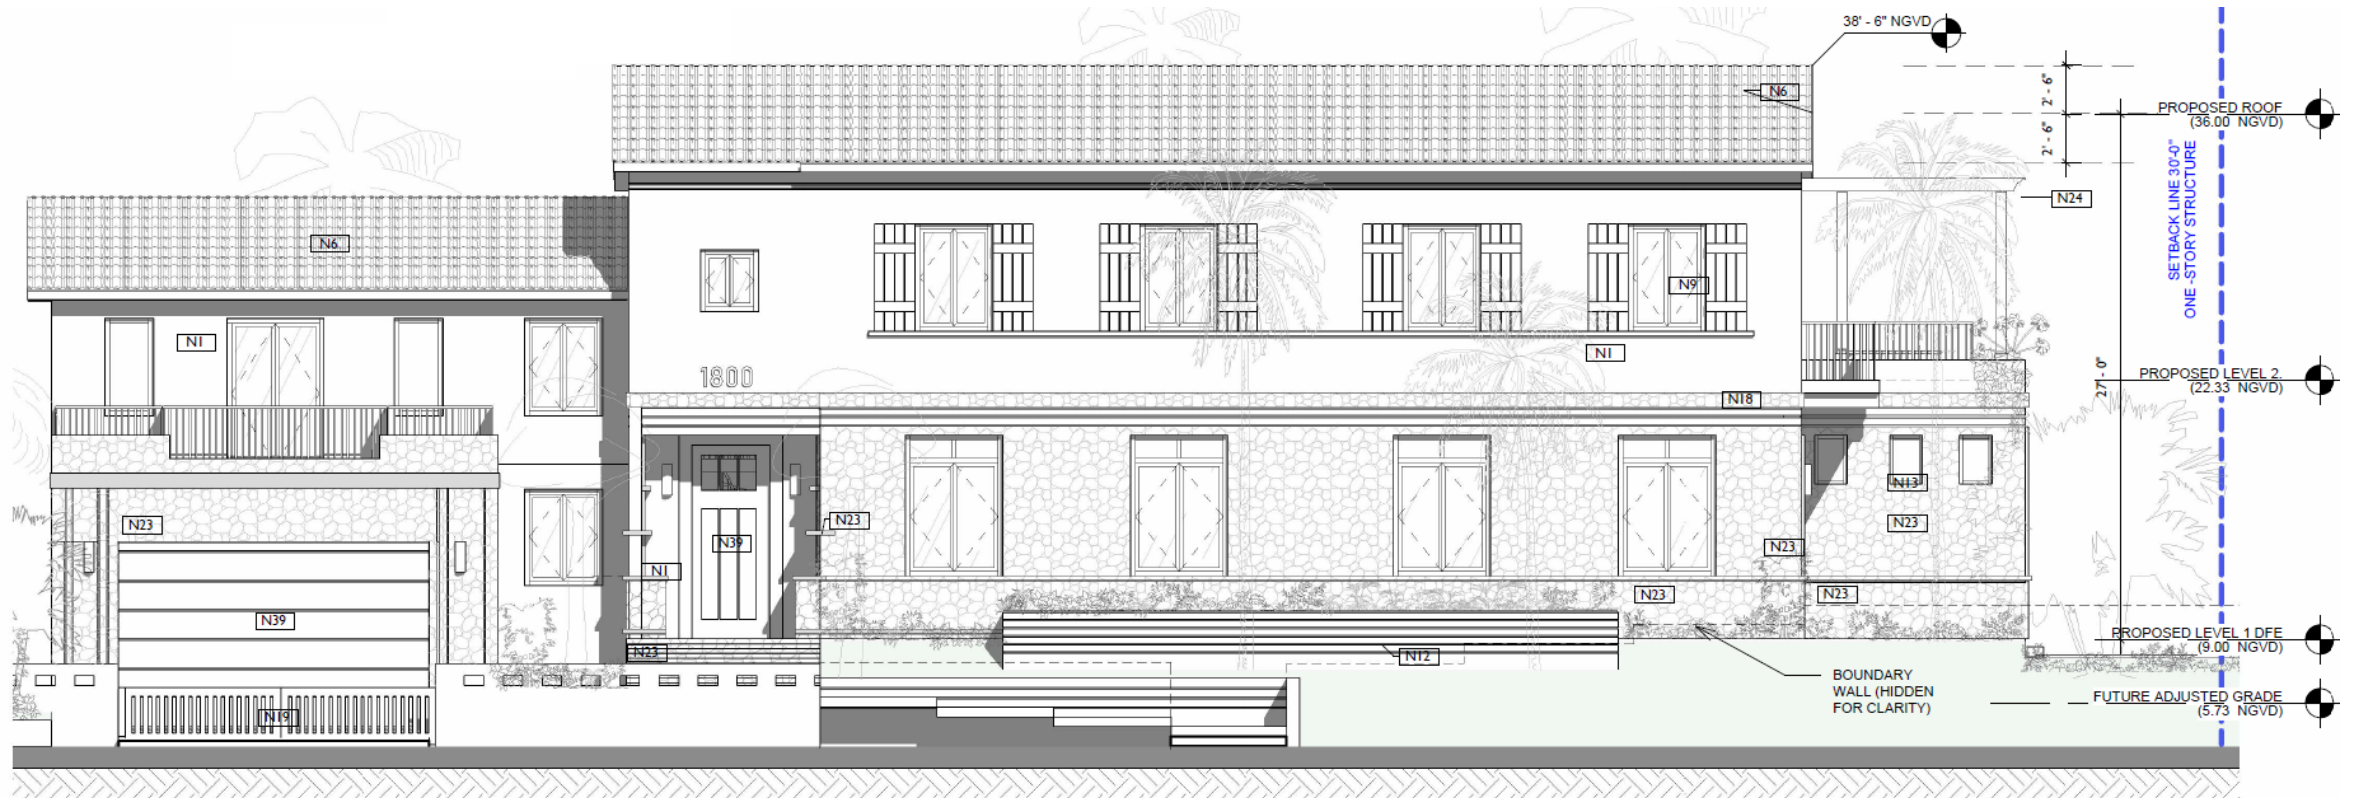
South Elevation

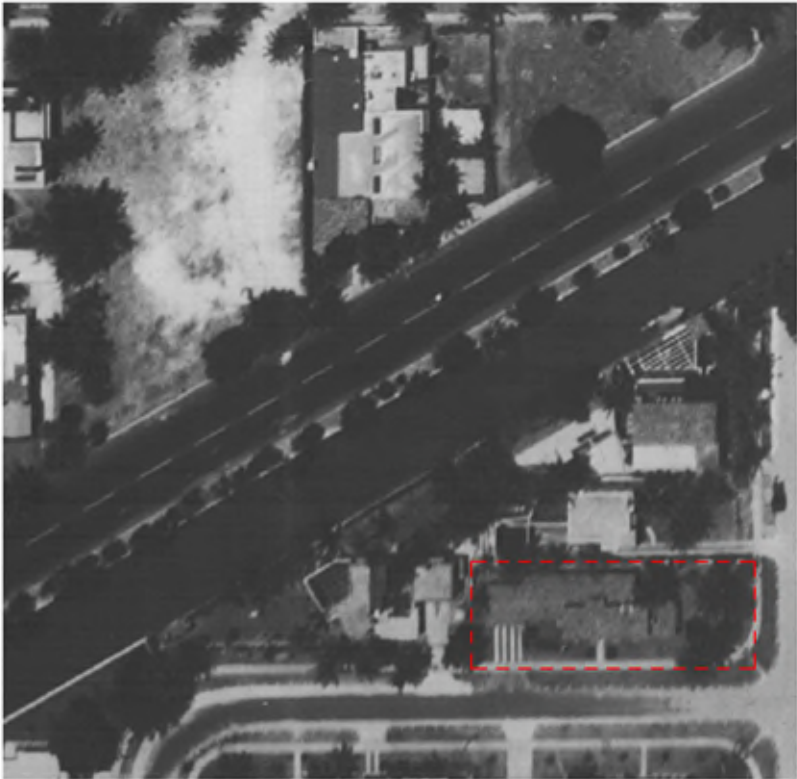
1941

Additions

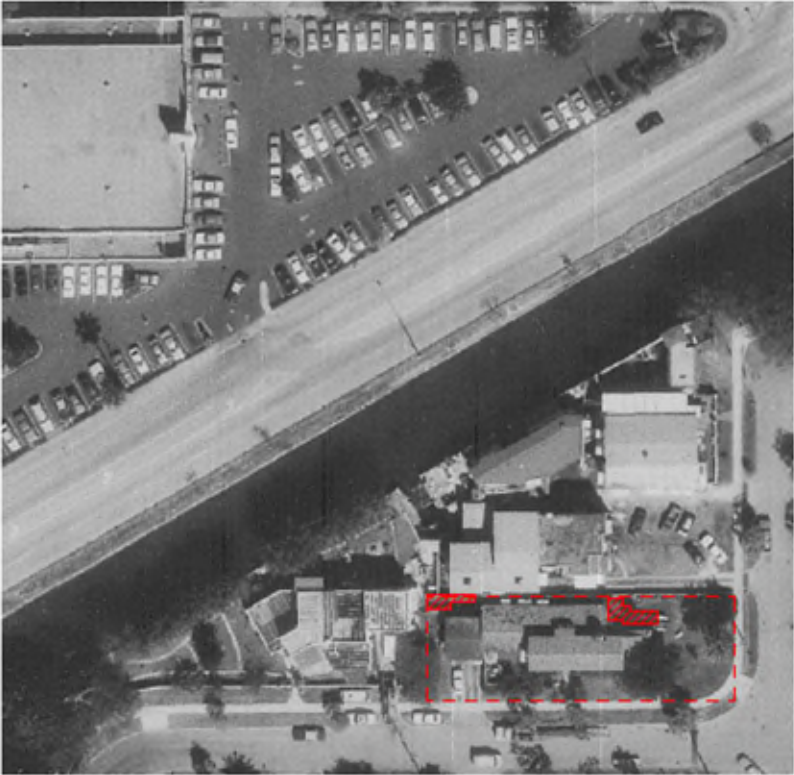
1985

Additions
