AMAN Hotel & Residences

3425 Collins Avenue, Miami Beach, Florida

Historic Preservation Board, September 16, 2025

HPB25-0662

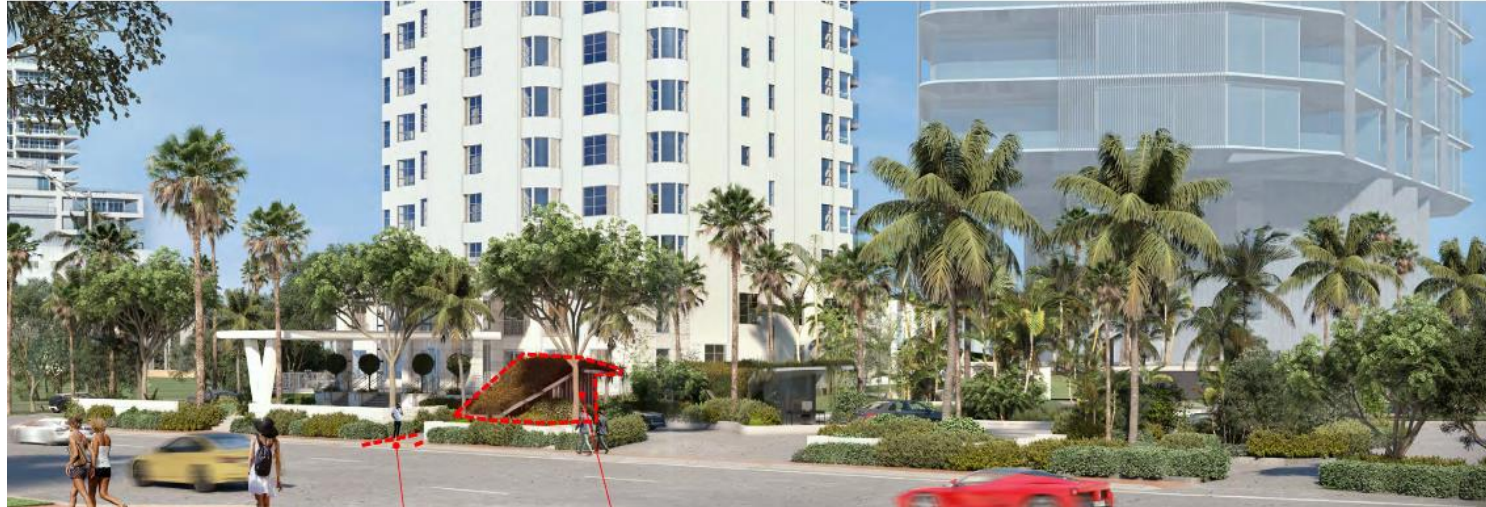
Collins Avenue Current Approval

Collins Avenue Comparative Views – Better Line of Site to Versailles

Remove Curbcut Remove Guardhouse

Guardhouse Single Structure

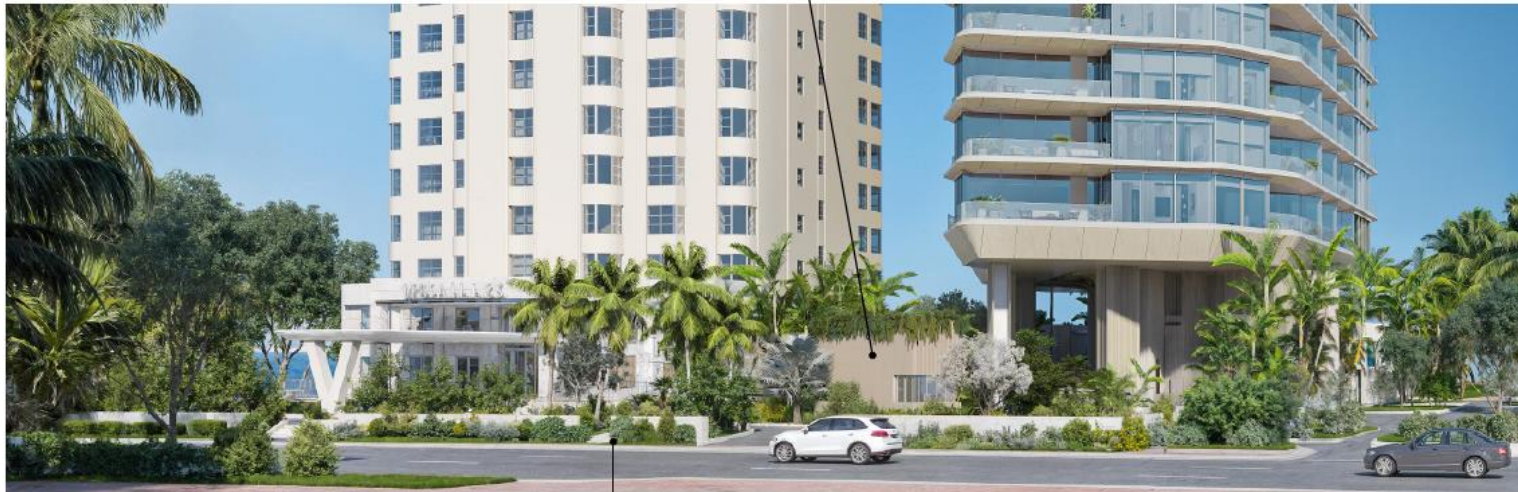
Collins Avenue Proposed

Improved Condition

- Improved Pedestrian Experience
- Increased Openness at Restored Versailles
- Added Landscape at Collins Avenue

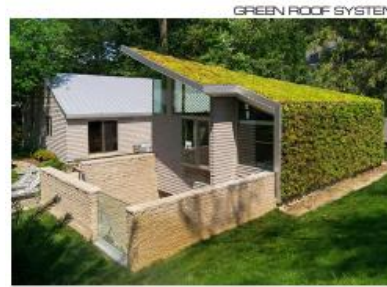
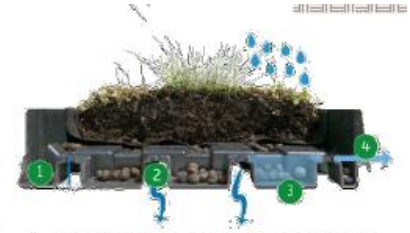
GREEN ROOF SYSTEM

1. The substrate is protected from pooling water, which can harm plants.
2. Excess water is drained off.
3. Rainwater is retained.
4. The water circulates from tray to tray.

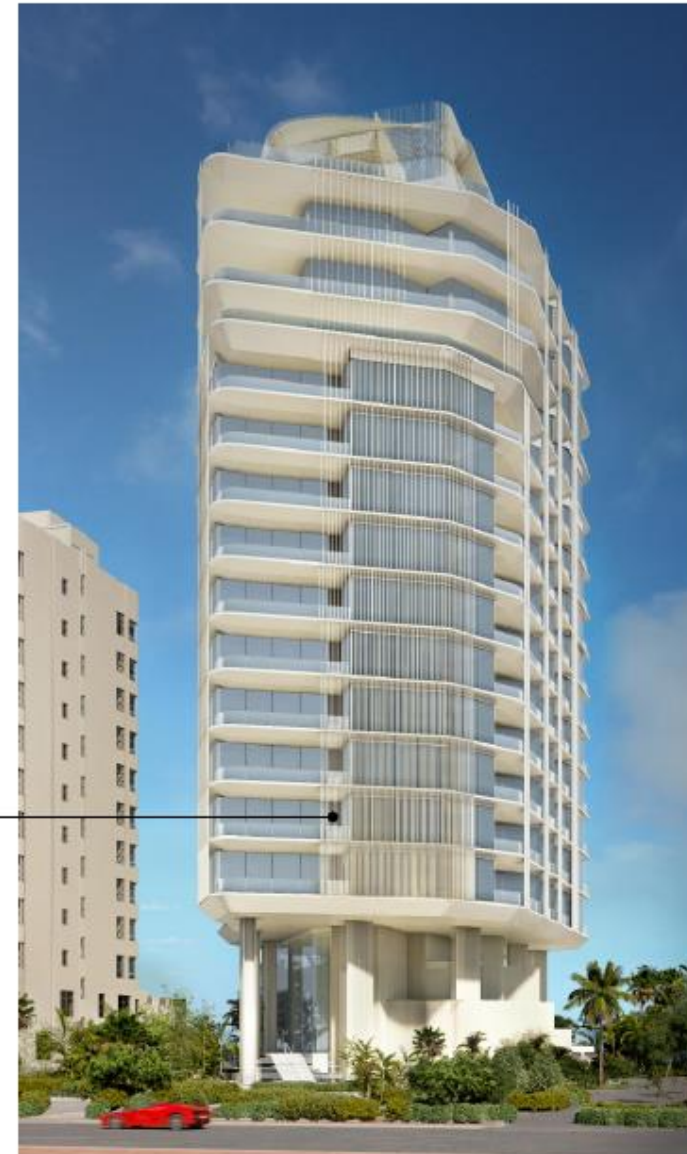
Vertical Lattice
Removal

Rationale For Proposed Removal

The design evolution of the Aman Residence, initially envisioned by Kengo Kuma & Associates (KKAA), prominently featured lattice profiles as a defining architectural element. However, as a result of thorough engineering and architectural analysis, "critical concerns necessitating their removal have arisen" as described in the report prepared by the Lindner Group, including:

- 1. Approved Design Fails to Meet Structural Integrity Standards**
- 2. Operational and Maintenance Impediments**
- 3. Safety Concerns Regarding Façade Cleaning**
- 4. Substantially Increased Obstruction of Views**

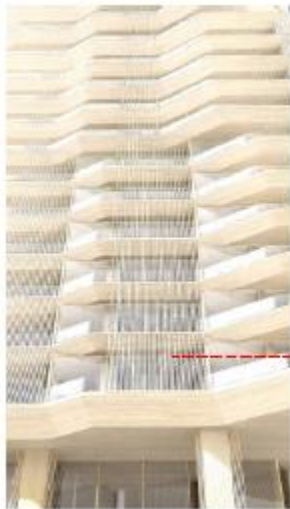
1. Approved Design Fails to Meet Structural Integrity Standards

"The initial conceptualization featured thinner, more numerous lattice profiles intended to complement the building's aesthetic. However, engineering analyses revealed that these profiles, constructed from aluminum, presented significant structural challenges. **The slender design threatened to bend or even break under environmental stresses such as wind loads.** This deformation risk was heightened by the proximity of the lattice to the facade glass, posing potential contact and damage — scenarios unacceptable by structural integrity standards. **Additionally, compensatory design adjustments necessitated the profiles' thickening, deviating from the architectural intent and introducing further complications.**"

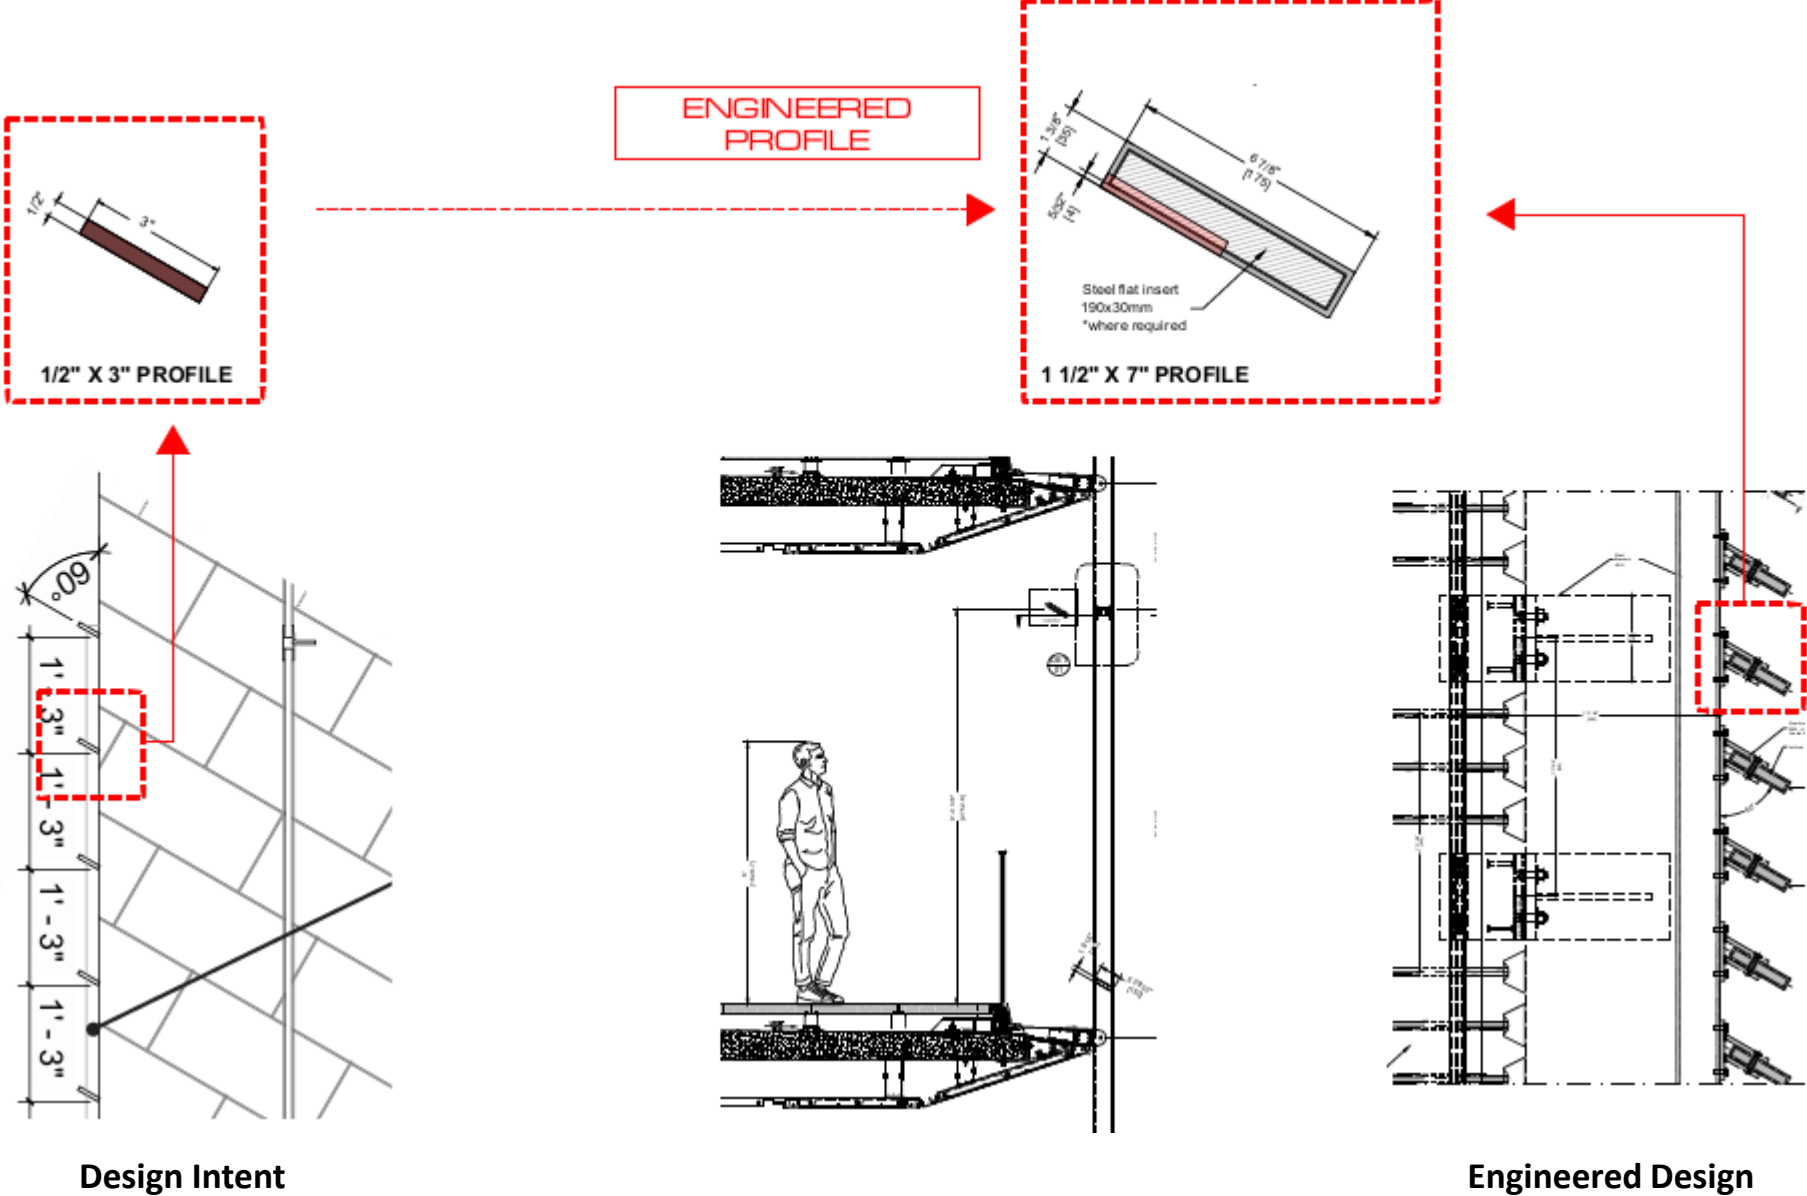
1. Approved Design Fails to Meet Structural Integrity Standards

Design Intent

Engineered Design

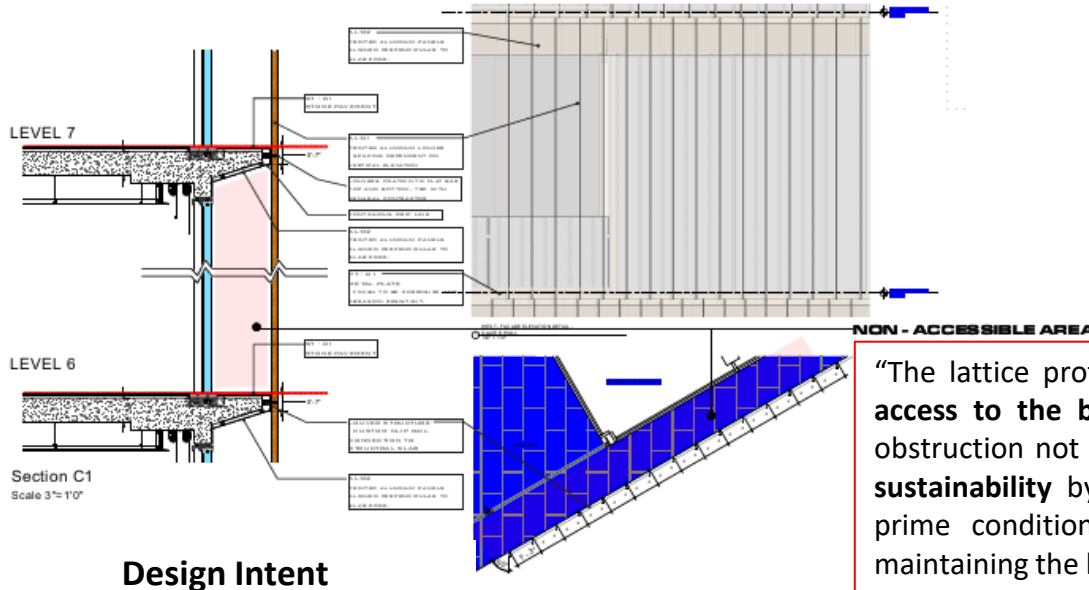
2. Operational & Maintenance Impediments

Engineered Design

Design Intent

“The lattice profiles, in their original and modified forms, **severely obstructed access to the building's glazing for routine cleaning and maintenance.** This obstruction not only raises operational costs but also **diminishes the building's sustainability** by increasing the difficulty of maintaining the glass surfaces in prime condition. The lattice thus emerges as a prohibitive factor against maintaining the building's aesthetic and functional longevity....”

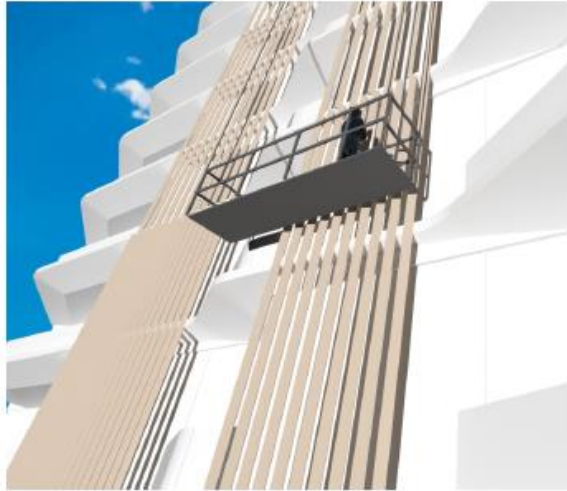
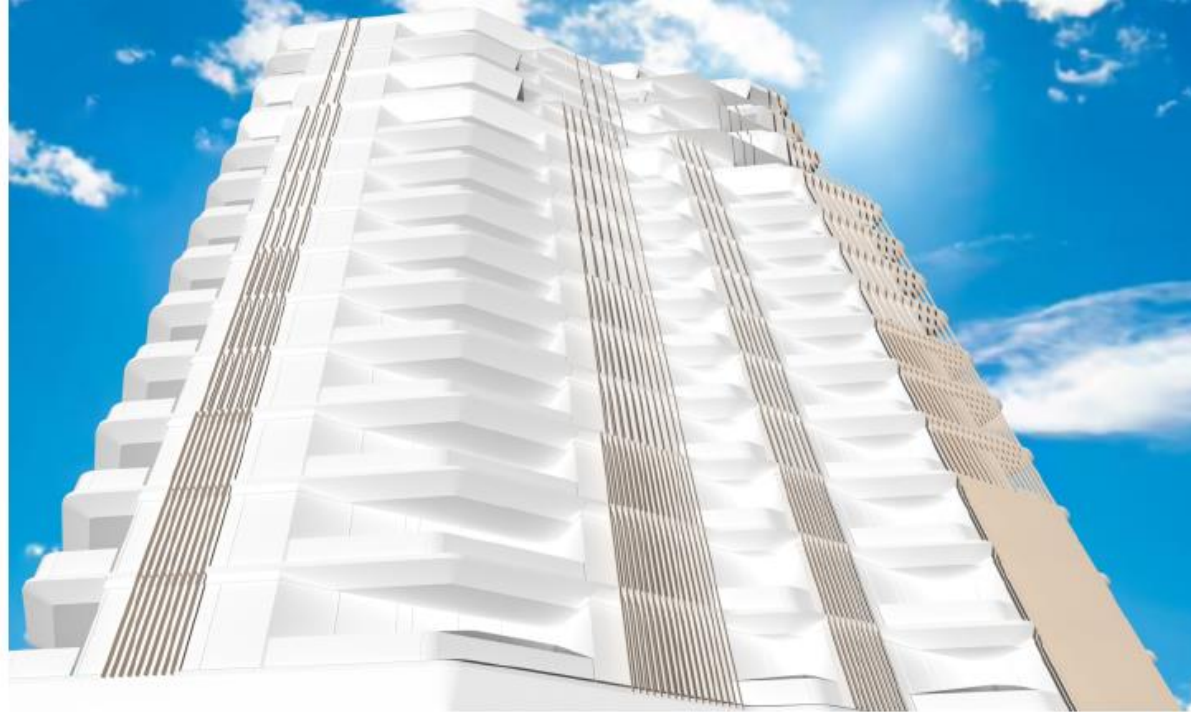
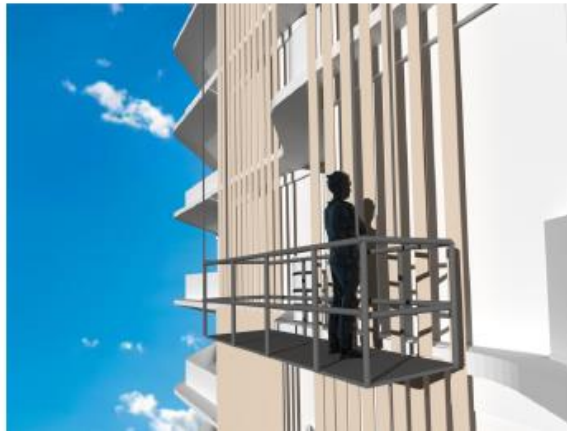
3. Safety Concerns Regarding Façade Cleaning

“Incorporating the lattice profiles induces **potential hazards** for maintenance personnel tasked with facade cleaning. The presence of these architectural elements introduces **collision risks** that could compromise safety during cleaning operations. Furthermore, any **accidental impact** with these profiles during maintenance activities could lead to **facade damage or personnel injury**, warranting significant concern and revision.” - Lindner Engineering Report

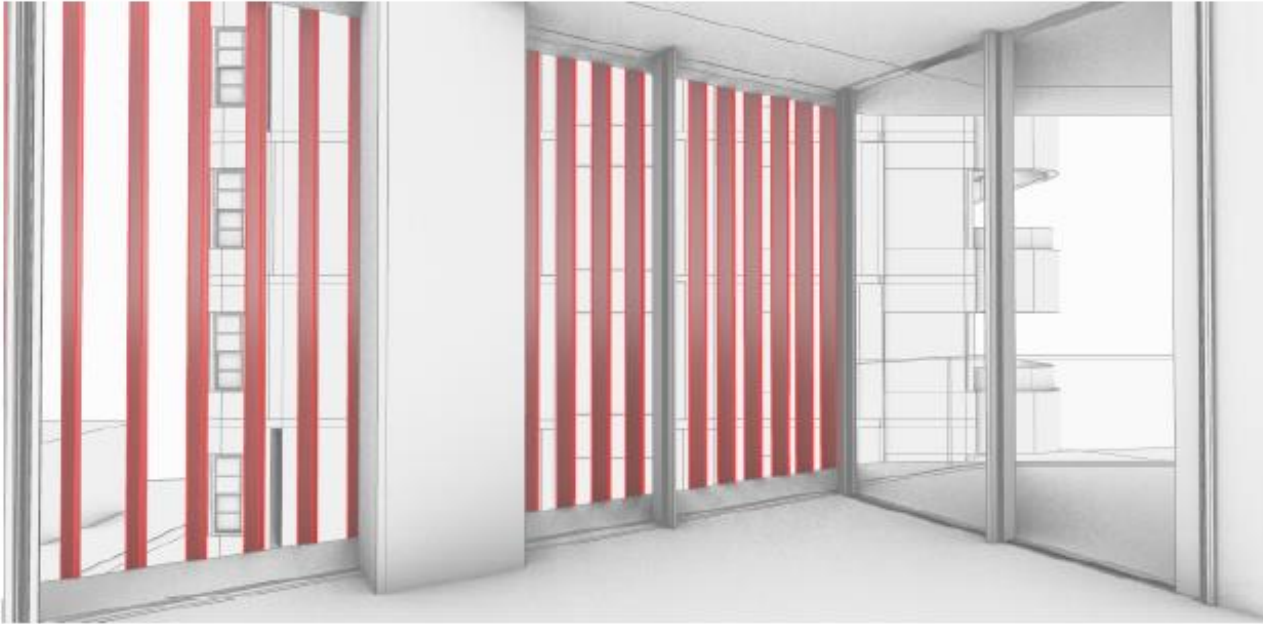
Interior View Study

4. Substantial Obstruction of Residents' Views

“In addition, the increased dimension of the lattice (to meet wind load requirements), substantially increases **obstruction of residents' views**, and **fails to meet the original design intent.**” - Lindner Engineering Report

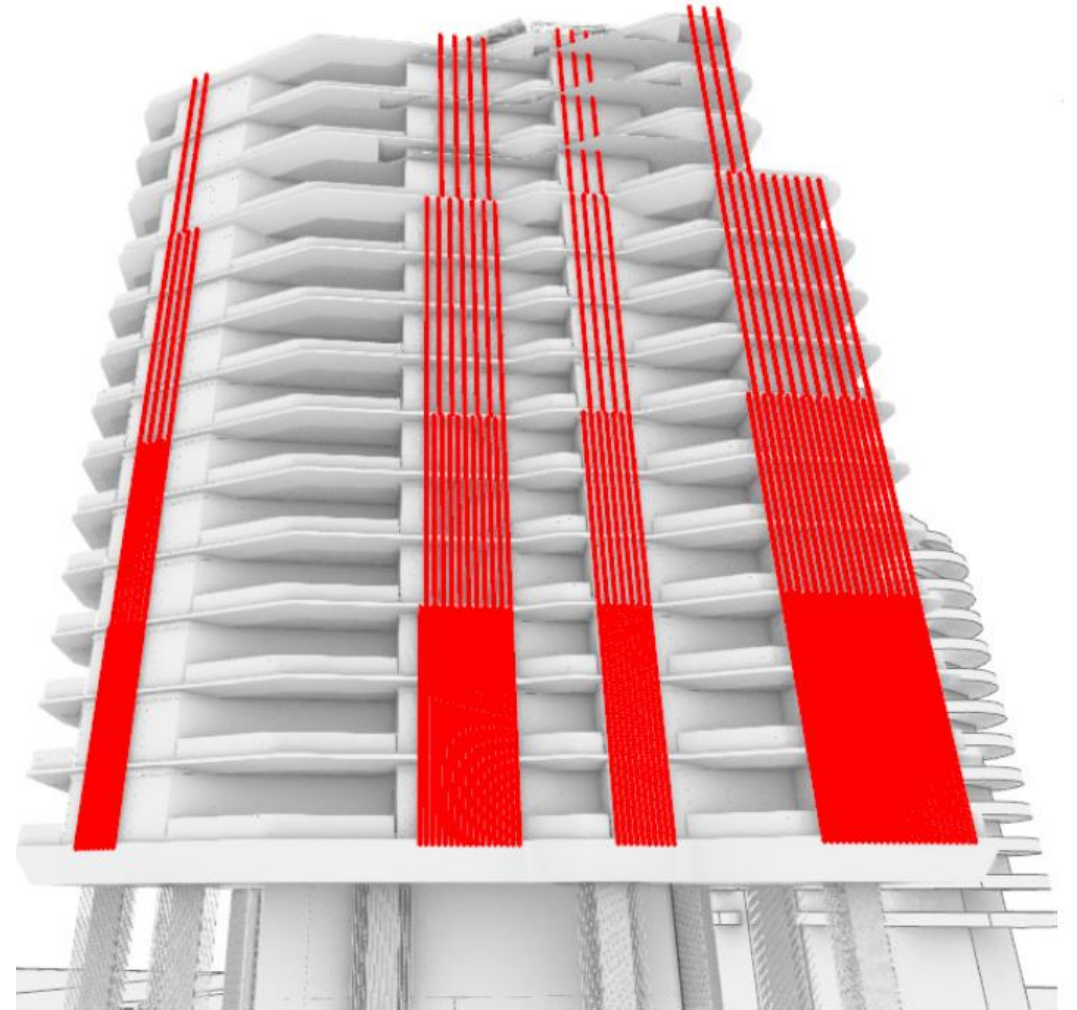
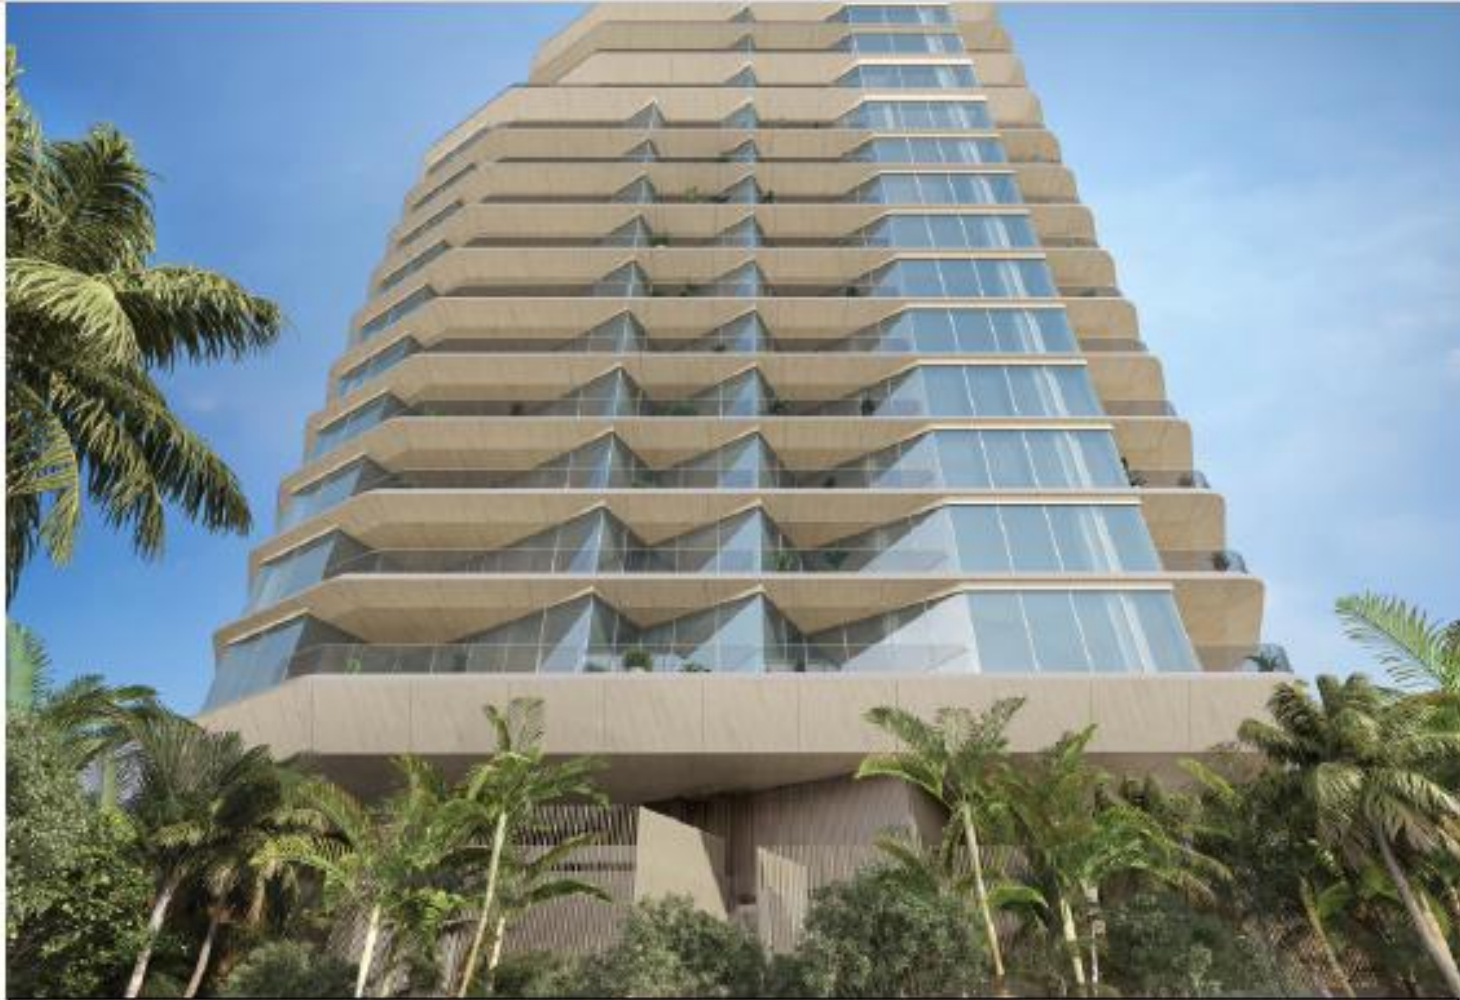
Façade Lattice Engineering Viability Report & Recommendation

Conclusions & Recommendations

“Given the outlined challenges — structural unreliability, maintenance impracticality, safety risks, and resident dissatisfaction — the decision to remove the lattice profiles is both prudent and necessary.” — Lindner Engineering Report

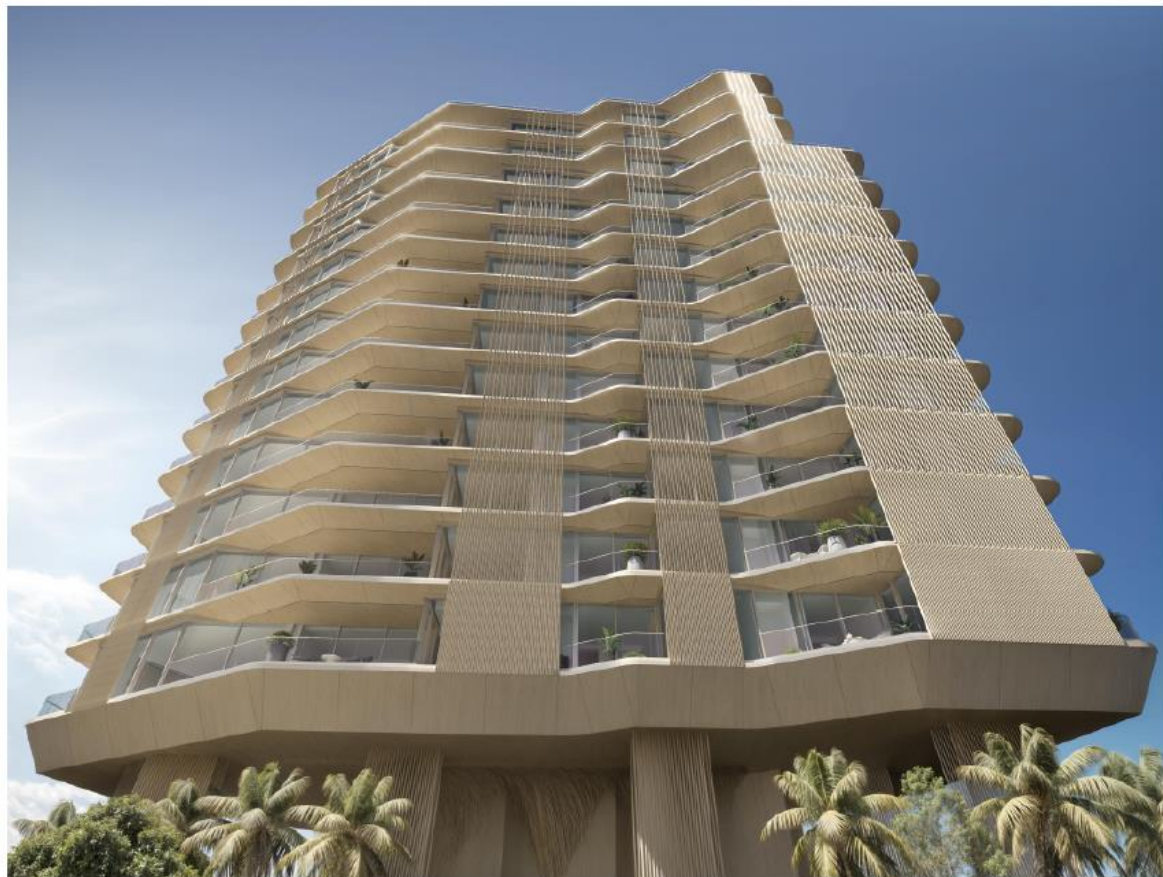
Current Approval vs. Proposed – North View

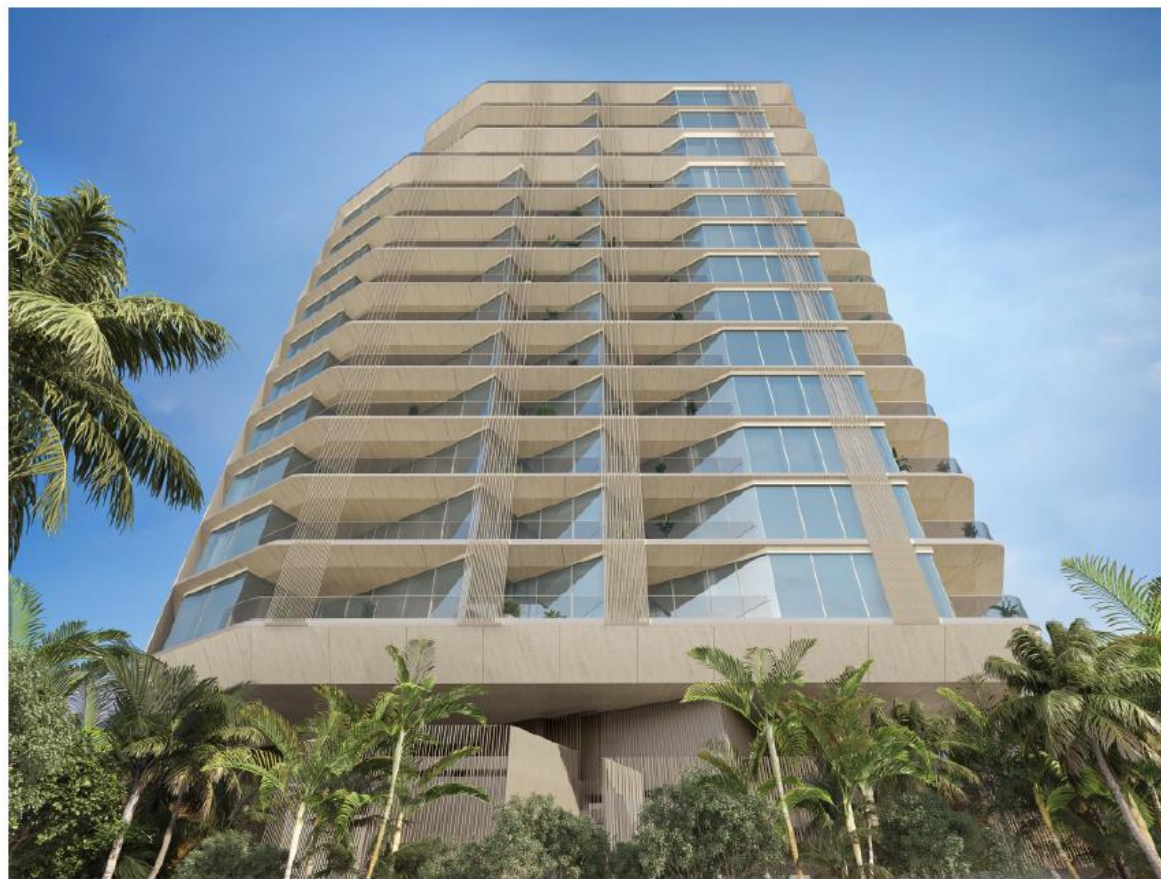
Current Approval vs. Proposed – South View

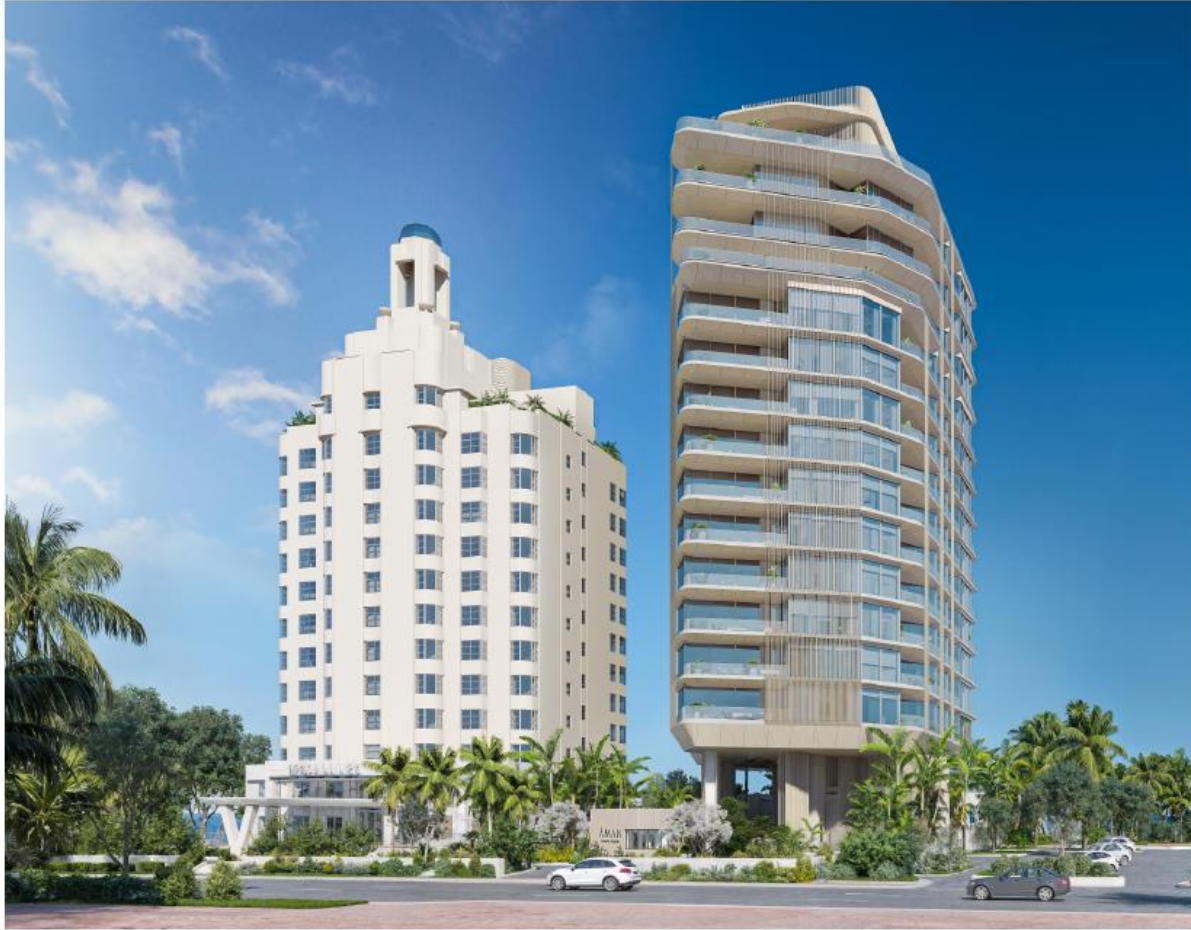
Current Approval vs. Proposed – West View

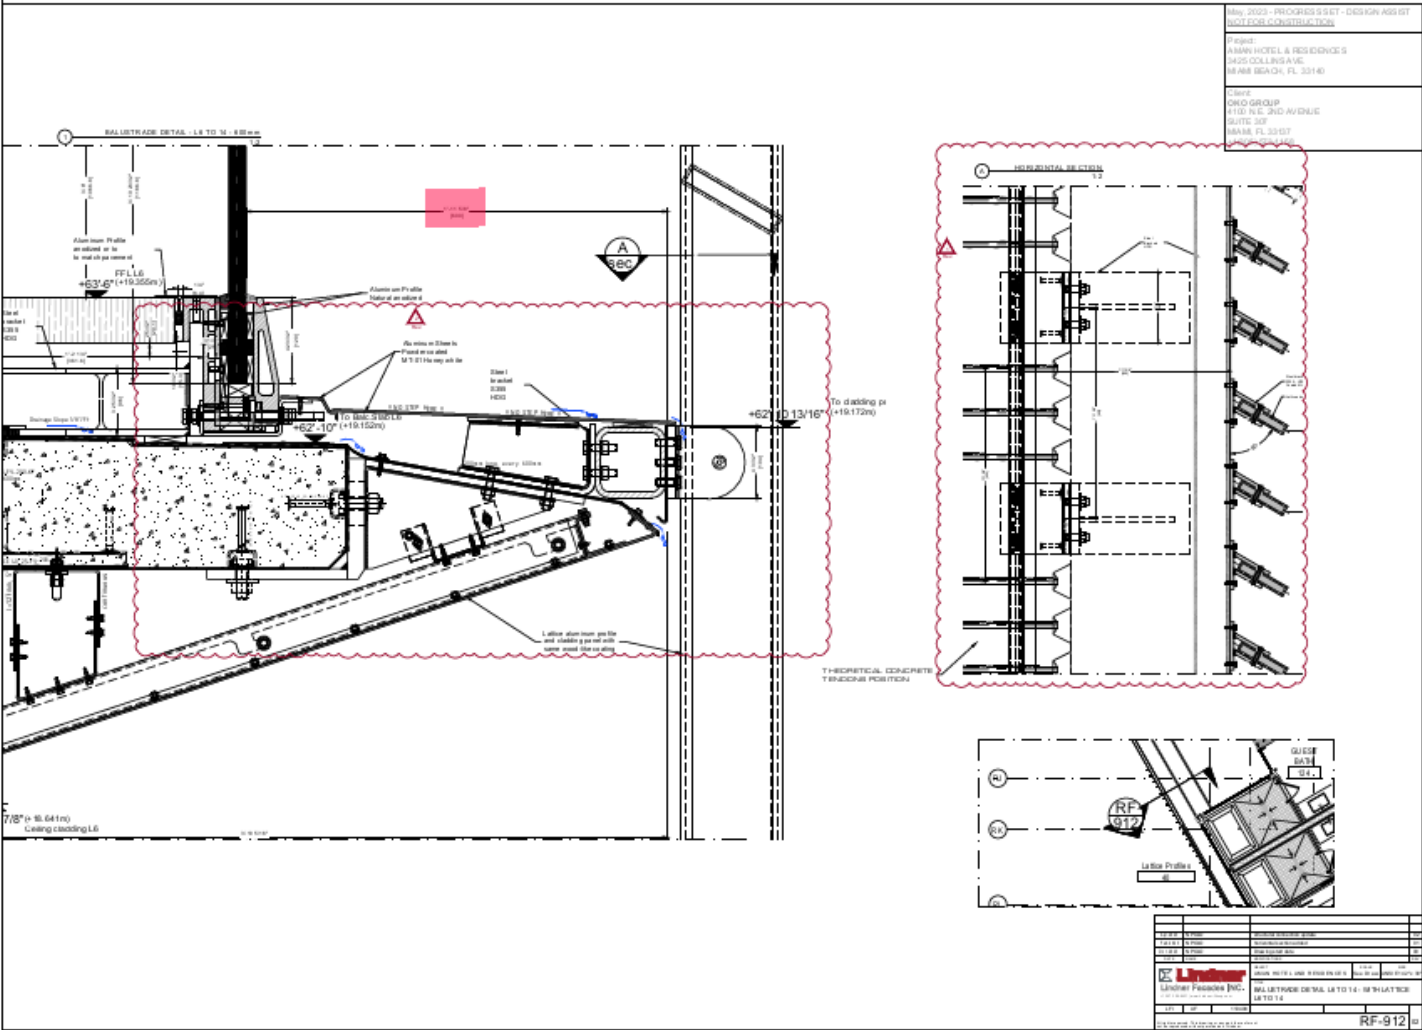
Engineered Design

1. Approved Design Fails to Meet Structural Integrity Standards

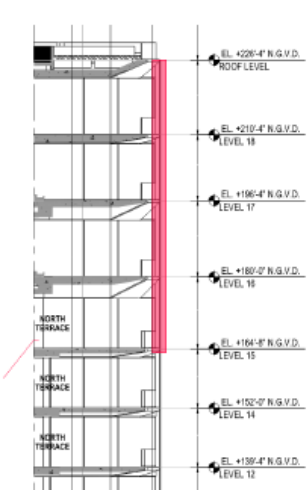
Wind Load Issues with Current Approved Design

$$h_1 := 226 \text{ ft} + 4 \text{ in} - 210 \text{ ft} - 4 \text{ in} = 4876.8 \text{ mm}$$

$$h_2 := 164 \text{ ft} + 8 \text{ in} - 152 \text{ ft} = 3960.8 \text{ mm}$$

Base wind pressure $q_0 := 102 \text{ psf} = 4.88 \text{ kPa}$

form value $c_p := 1.4$

wind pressure 50 yr. $q_{50} := q_0 \cdot 0.6 = 2.93 \text{ kPa}$

windload $w := q_{50} \cdot c_p \cdot 0.7 \cdot 3 \text{ in} = 0.22 \frac{\text{kN}}{\text{m}}$

$$MoE := 70000 \frac{\text{N}}{\text{mm}^2}$$

$$t := 0.5 \text{ in} \quad b := 3 \text{ in}$$

$$I_y := \frac{t^3 \cdot b}{12} = 1.3 \text{ cm}^4$$

$$f_x := \frac{5}{384} \cdot \frac{w \cdot h_2^4}{MoE \cdot I_y} = 695.2709 \text{ mm}$$

$$\sigma_1 := \frac{48 \cdot MoE \cdot f_x \cdot \frac{t}{2}}{5 \cdot h_2^2} = 199.04 \frac{\text{N}}{\text{mm}^2}$$

Deformation of the original lattice profile

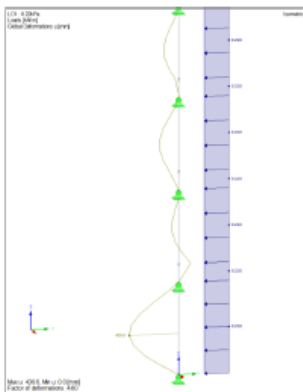
Original Lattice Profile: 3" x 1/2"

considering continuous beam (hinged beam)

$$f_{x,cont,1} := 436.6 \text{ mm} \quad \sim 17"$$

$$f_{x,cont,long,1} := 886.1 \text{ mm} \quad \sim 35"$$

looking at stress levels, this section is largely over-stressed in the upper (longer span) part utilization ratios are up to 248%

in the typical (shorter span) part utilization ratios are 124%, while they raise up to 137% in the first span.
