# SKETCH OF BOUNDARY SURVEY

PROPERTY ADDRESS:  
7801 Atlantic Way  
Miami Beach, Florida 33141-2120

**LEGAL DESCRIPTION:**  
Lot 6, Block 5, of Corrected Plat Altos Del Mar No. 1, according to the Plat thereof, as recorded in Plat Book 31, Page 40, of the Public Records of Miami-Dade County, Florida.  
Lot 6 bounded as follows: Bounded on the North by the dividing line between Lots 5 and 6; Bounded on the South by the Southerly line of Lot 6, said Southerly line also being the Northerly line of 78th Street; Bounded on the West by the Westerly line of Lot 6, said Westerly line also being the Easterly line of Atlantic Way; Bounded on the East by the Erosion Control Line of the Atlantic Ocean, as recorded in Plat Book 105, at Page 62, of the Public Records of Miami-Dade County, Florida.

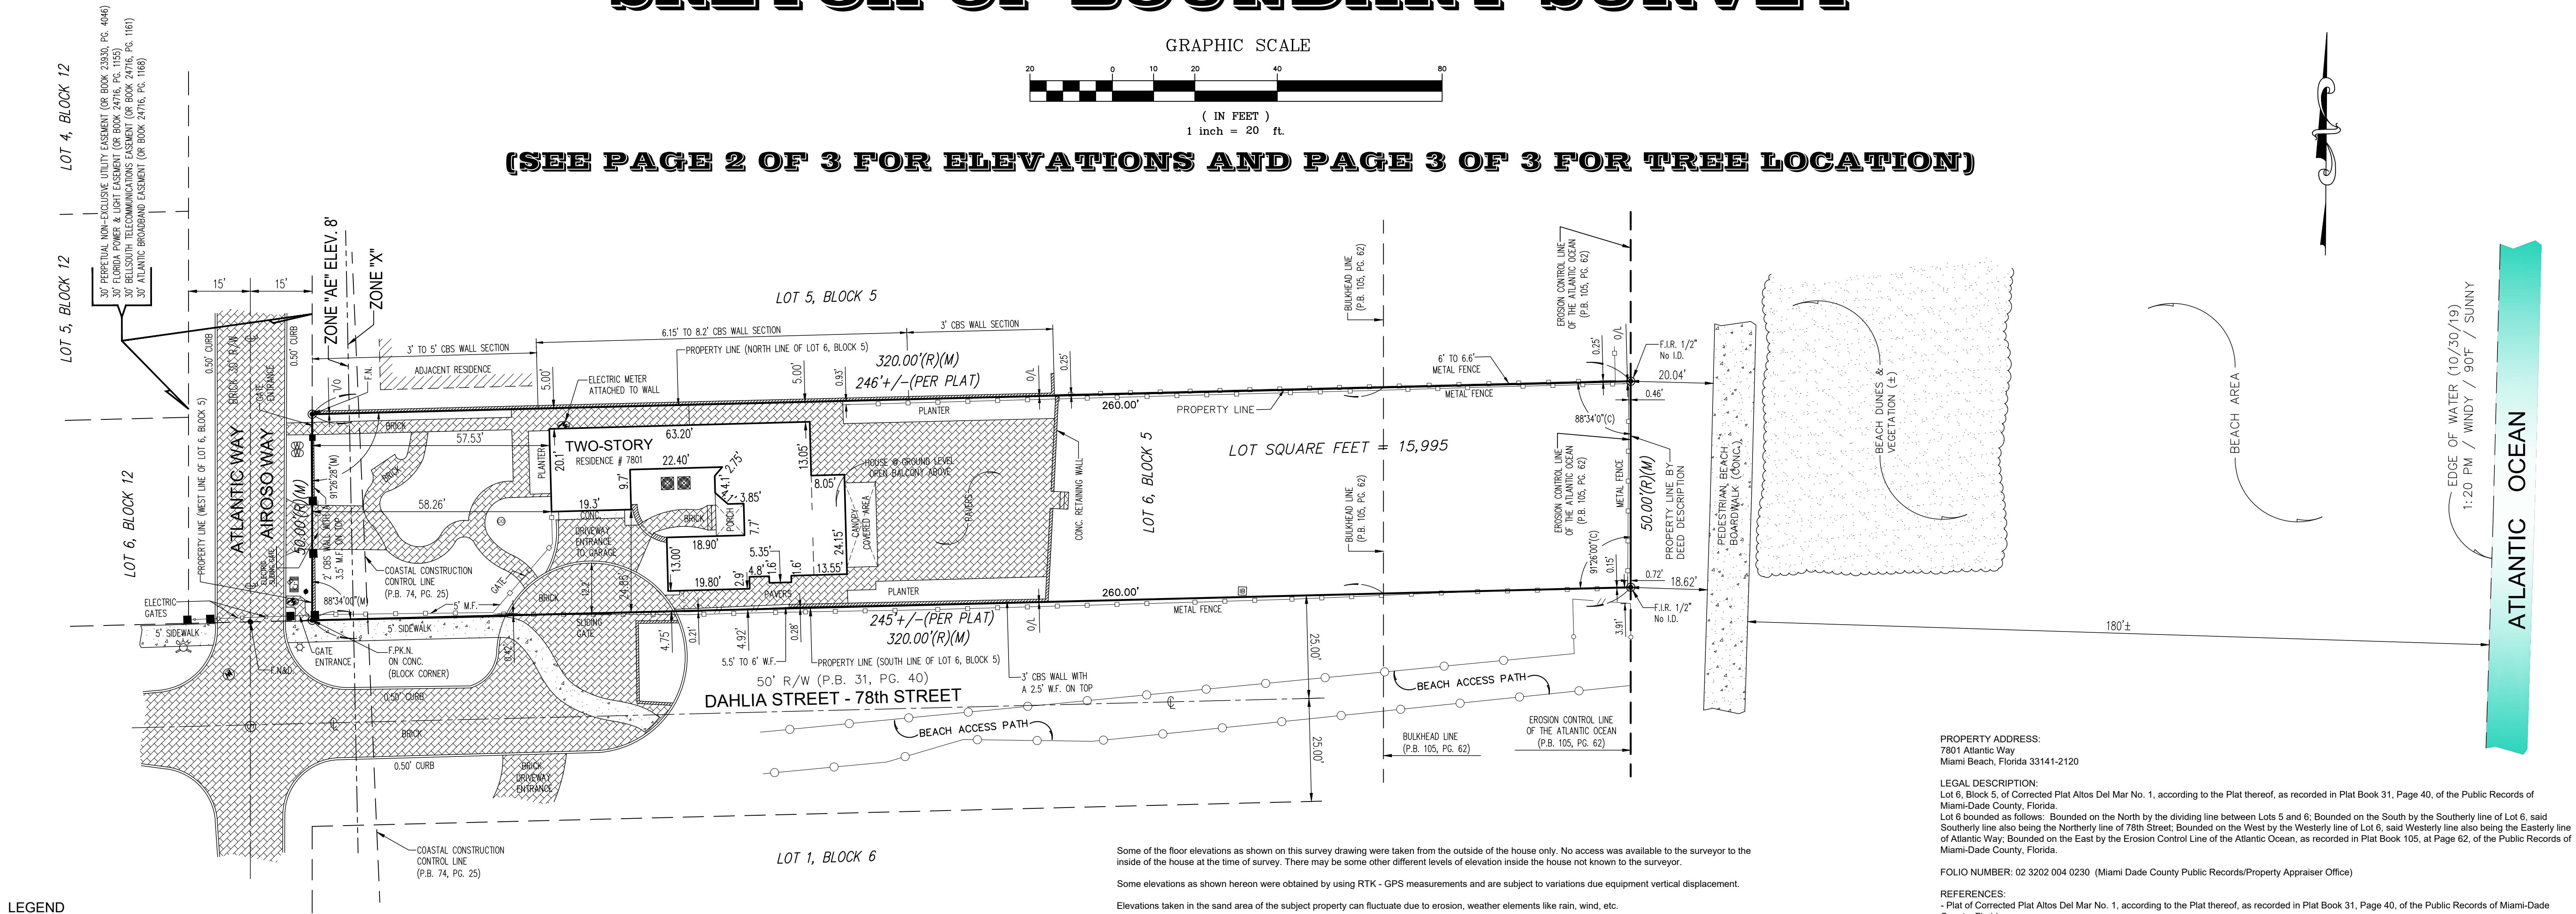
(SEE PAGE 2 OF 3 FOR ELEVATIONS AND PAGE 3 OF 3 FOR TREE LOCATION)

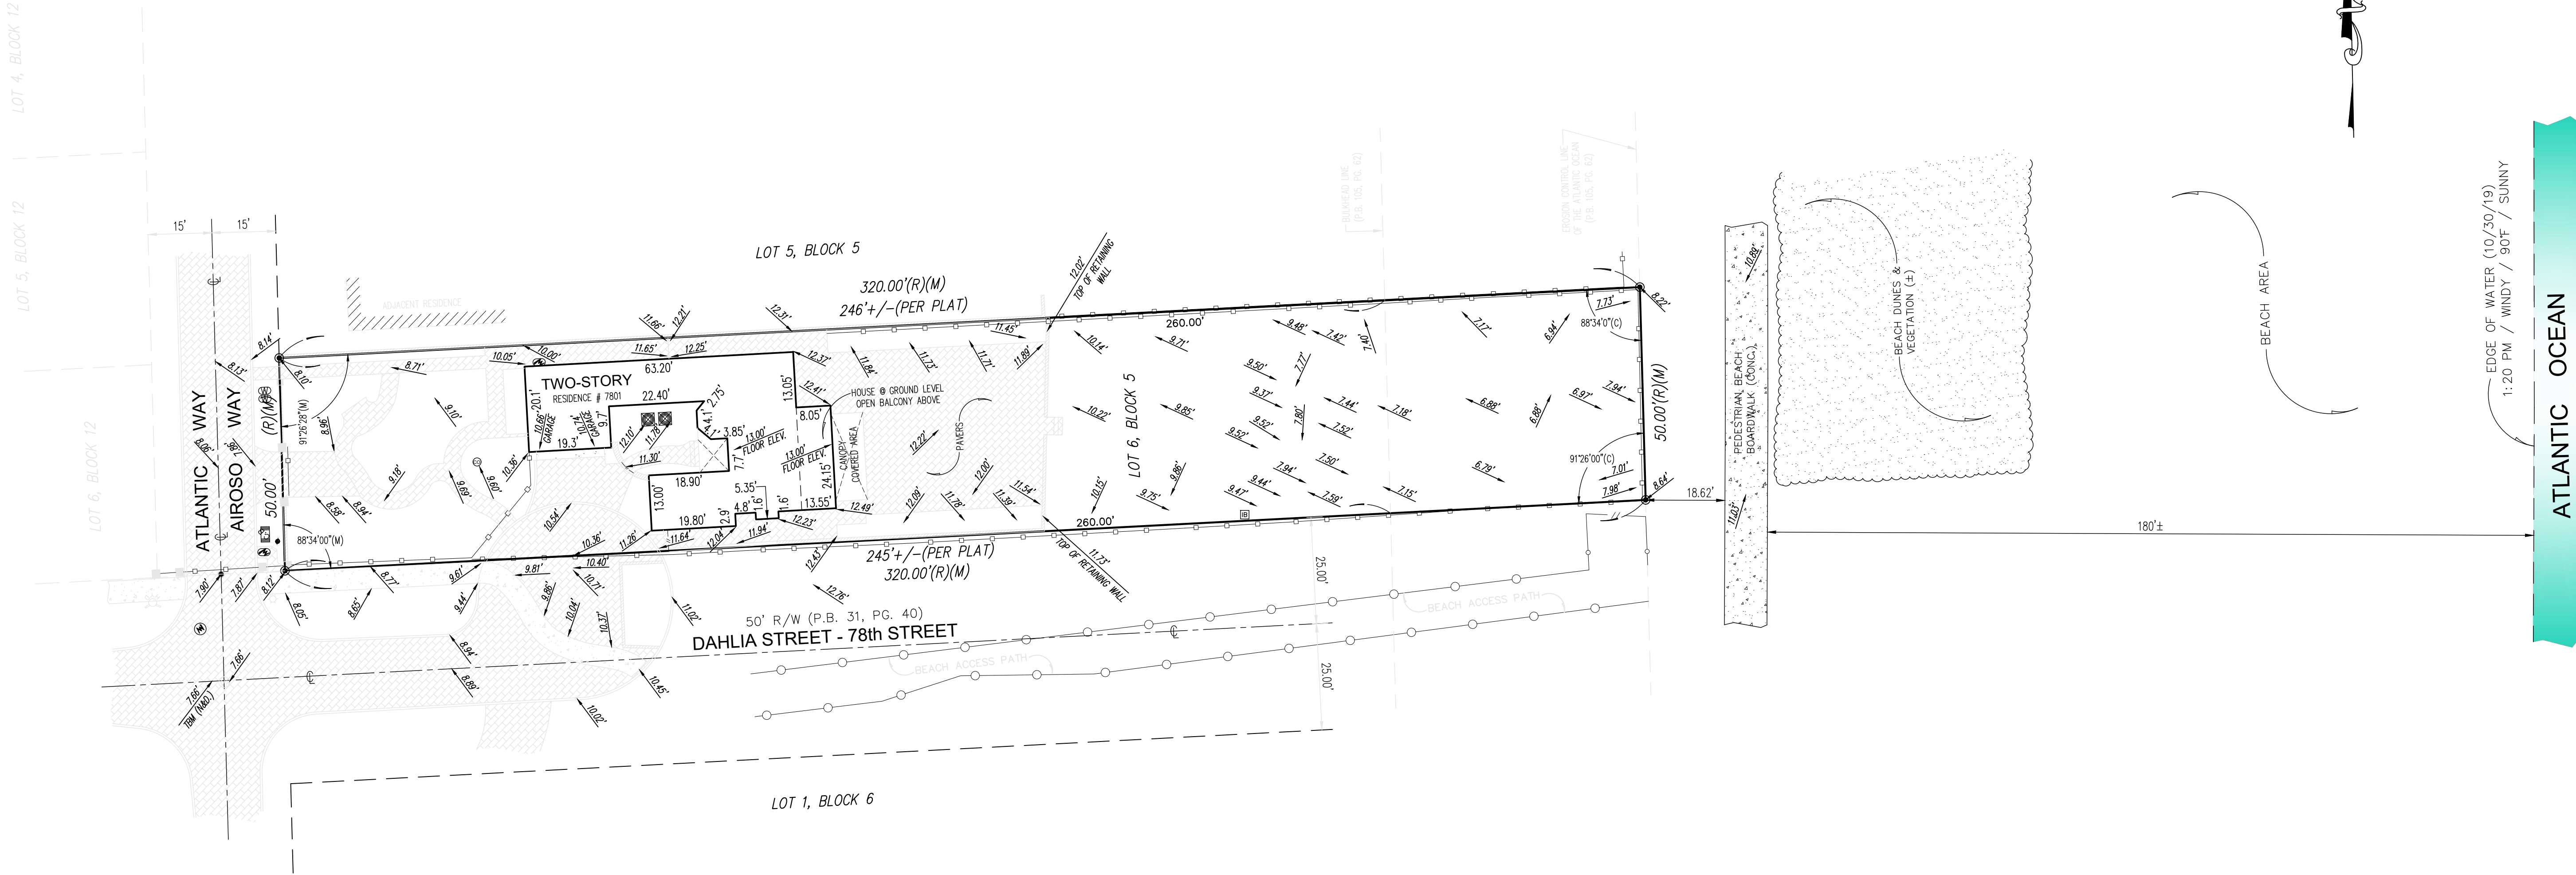
SKETCH OF BOUNDARY SURVEY

(SEE PAGE 1 OF 3 FOR BOUNDARY INFORMATION AND PAGE 3 OF 3 FOR TREE LOCATION)

Some of the floor elevations as shown on this survey drawing were taken from the outside of the house only. No access was available to the surveyor to the inside of the house at the time of survey. There may be some other different levels of elevation inside the house not known to the surveyor.

Some elevations as shown hereon were obtained by using RTK - GPS measurements and are subject to variations due equipment vertical displacement.

Elevations taken in the sand area of the subject property can fluctuate due to erosion, weather elements like rain, wind, etc.

Elevations as shown hereon were not updated at the time of the updated survey work on May 23rd, 2022 under Job Number 19-5113D and was not part of the scope of work provided to the client.

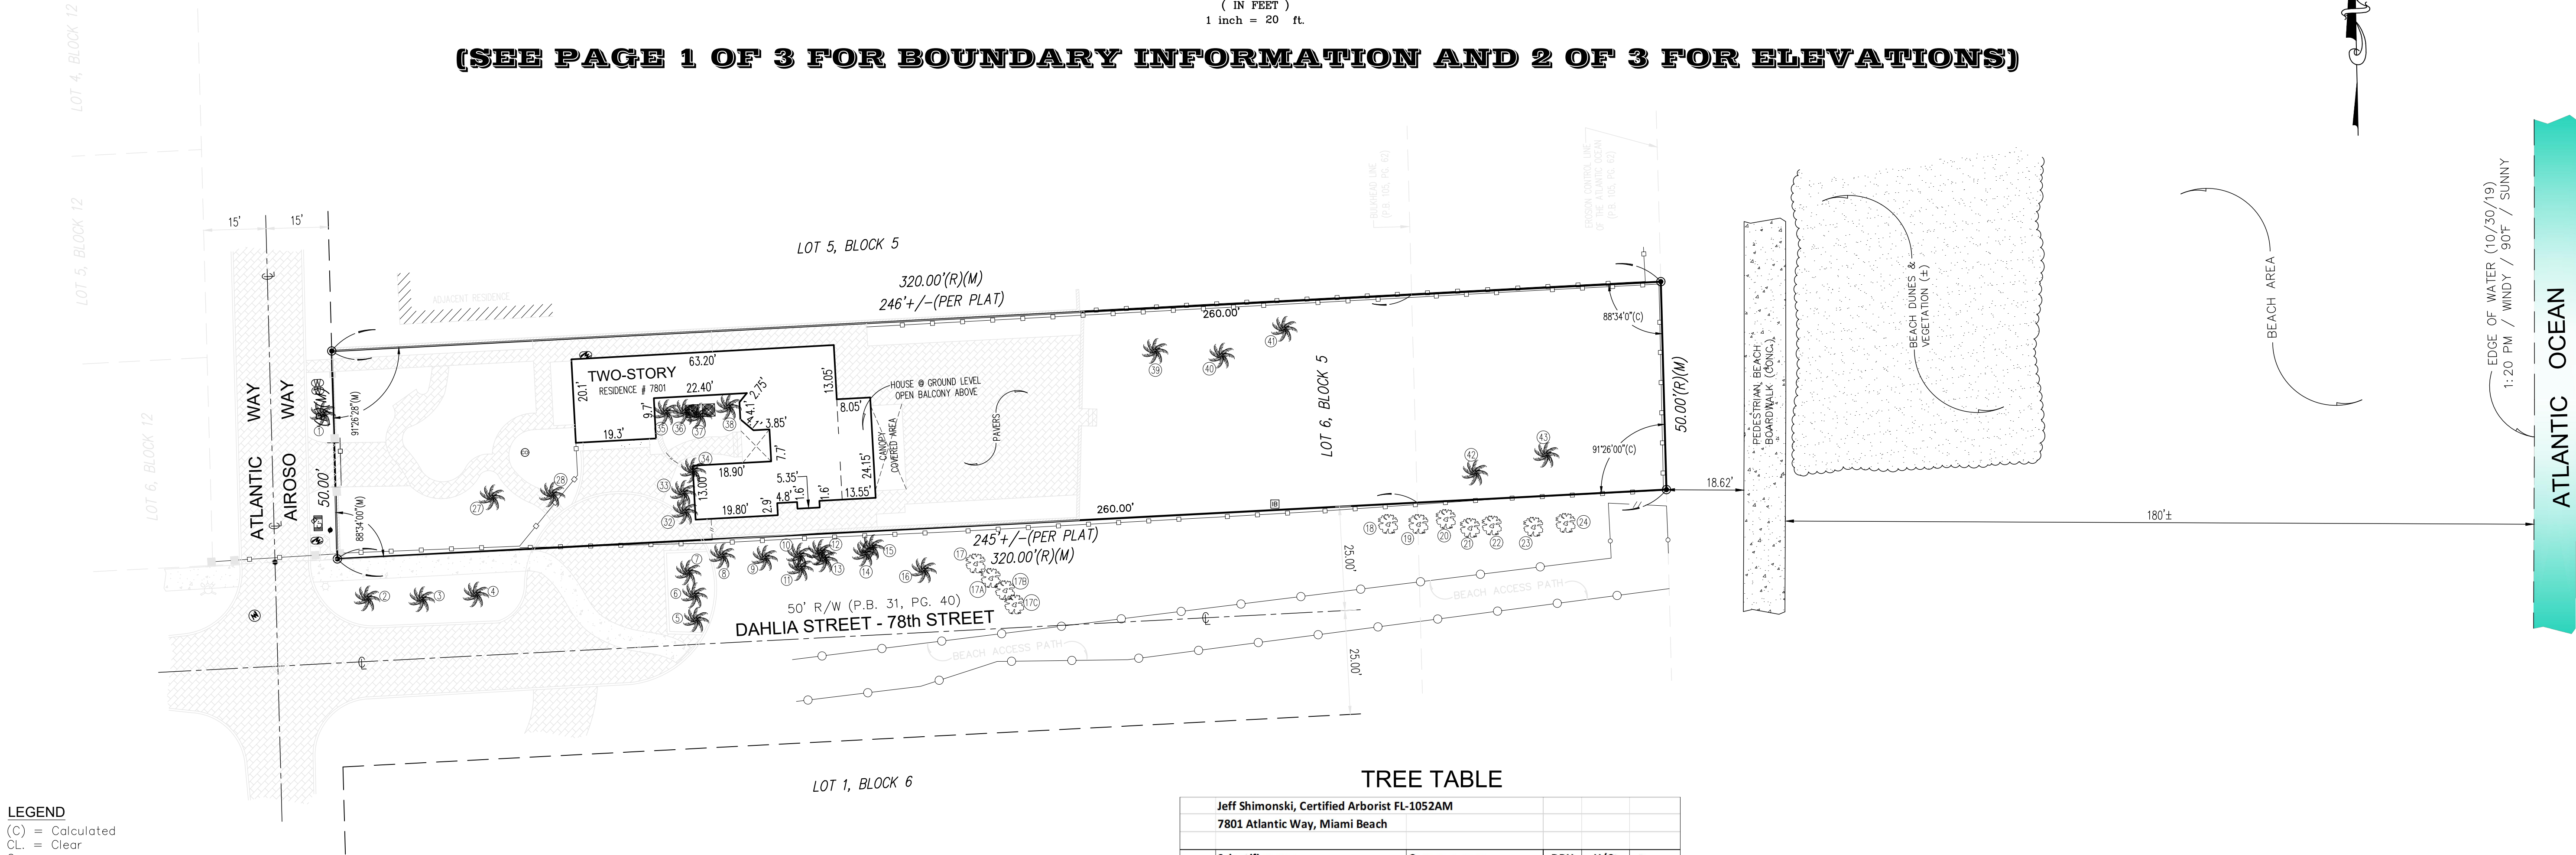
SKETCH OF BOUNDARY SURVEY

(SEE PAGE 1 OF 3 FOR BOUNDARY INFORMATION AND 2 OF 3 FOR ELEVATIONS)

Only the trees inside the subject property were revised at the time of the updated survey on May 23rd, 2022 under Job Number 19-5113D. Trees outside the subject property were not updated and was not part of the scope of work provided to the client.
