# 235 Washington Avenue

HPB25-0645

Historic Preservation Board

March 17, 2026

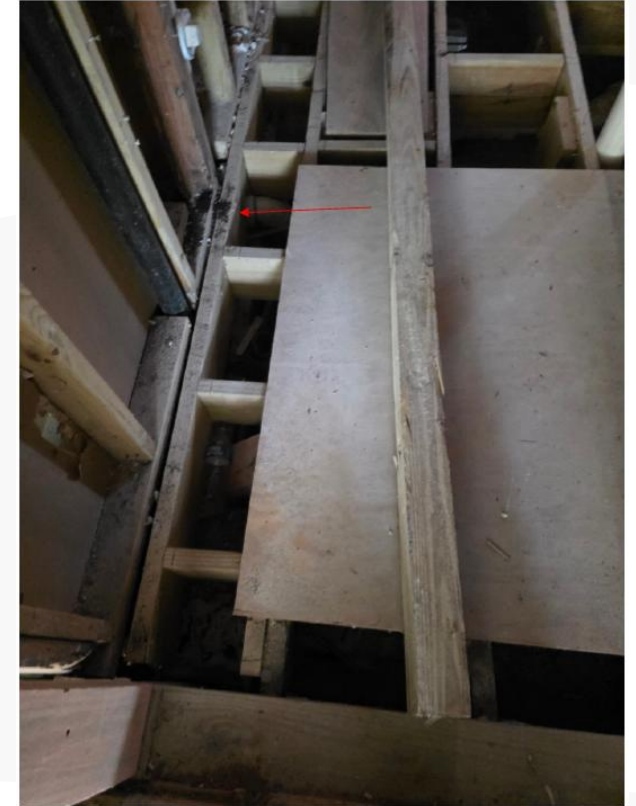
Termite dropping and stud damage

Termite dropping and stud damage

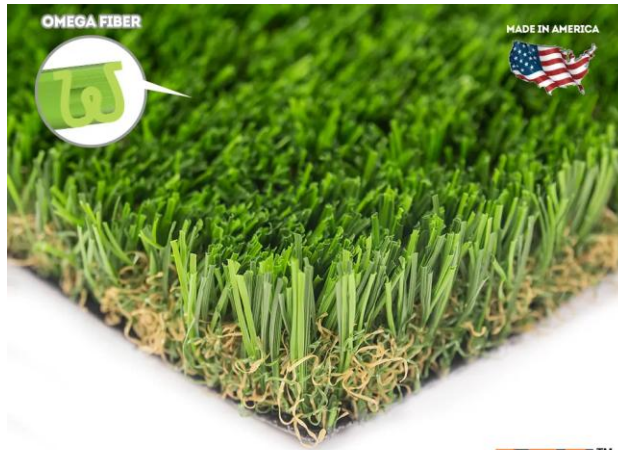
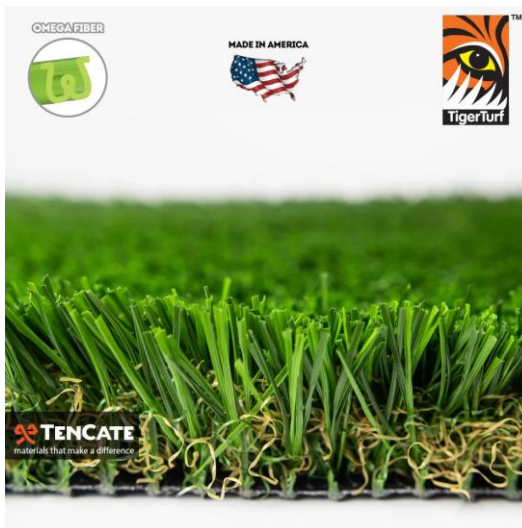
# TigerTurf Everglade Spring Pro

- Multi-tone blend of field and lime green fibers with a brown thatch layer creates a natural grass appearance that integrates seamlessly into the campus environment
- Maintains a uniform and visually consistent open-space surface despite intensive daily student use, avoiding the deterioration and patchiness typical of natural sod in high-traffic school settings
- Permeable system supports on-site drainage and prevents standing water, ensuring the recreation area remains functional without creating runoff or maintenance concerns

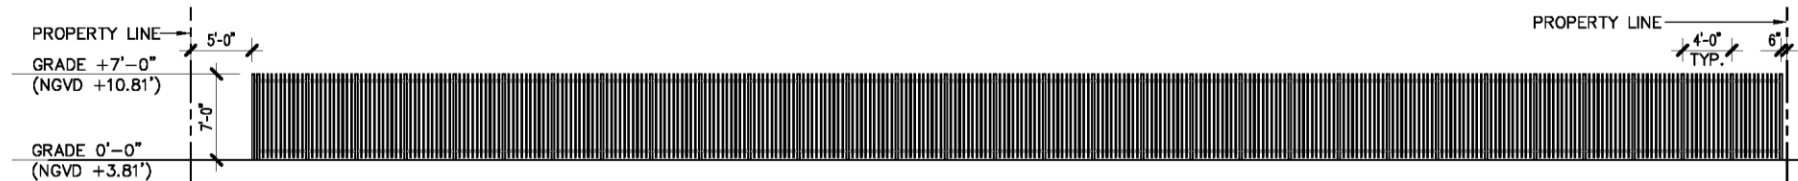
3 South Elev (Adj. Property) 3/32" = 1'-0"  
G1.12 7' High Aluminum Fence

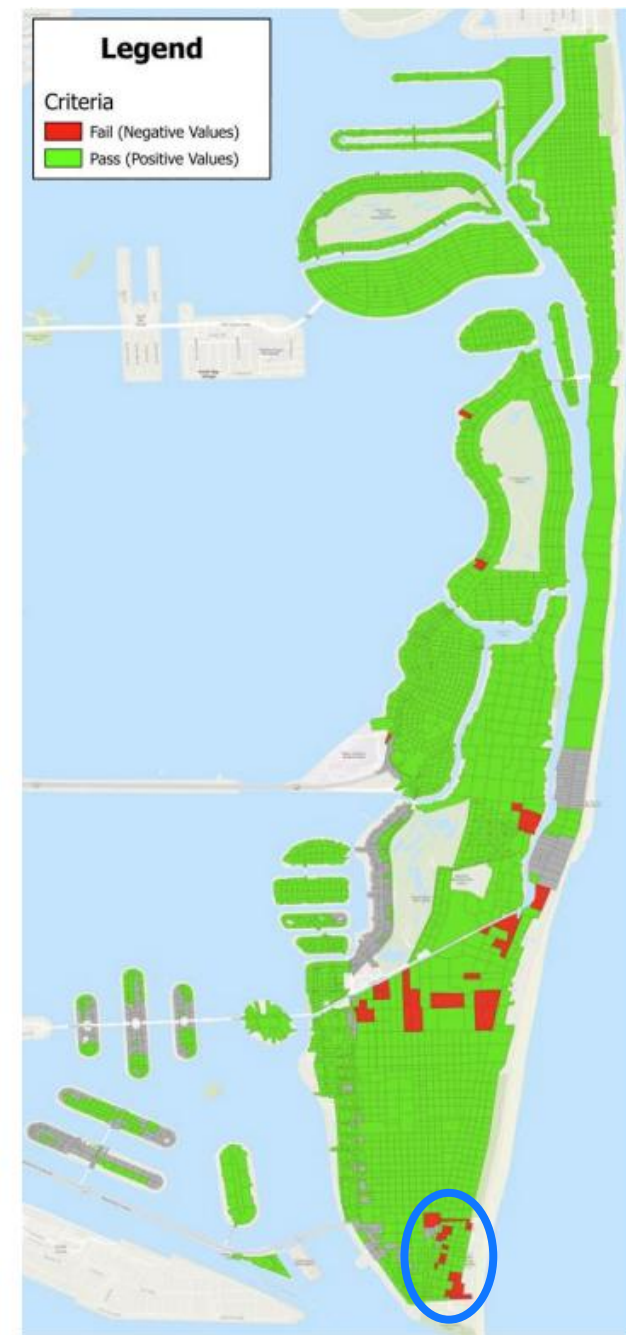
Figure 10, 2024 SWMP LOS Compliance Map

Figure 10 of the City's 2024 Stormwater Master Plan (LOS Compliance Map) indicates that the subject property is located in close proximity to areas identified as failing the adopted stormwater Level of Service standard, reflecting limited available capacity within the surrounding public drainage system during design storm events.

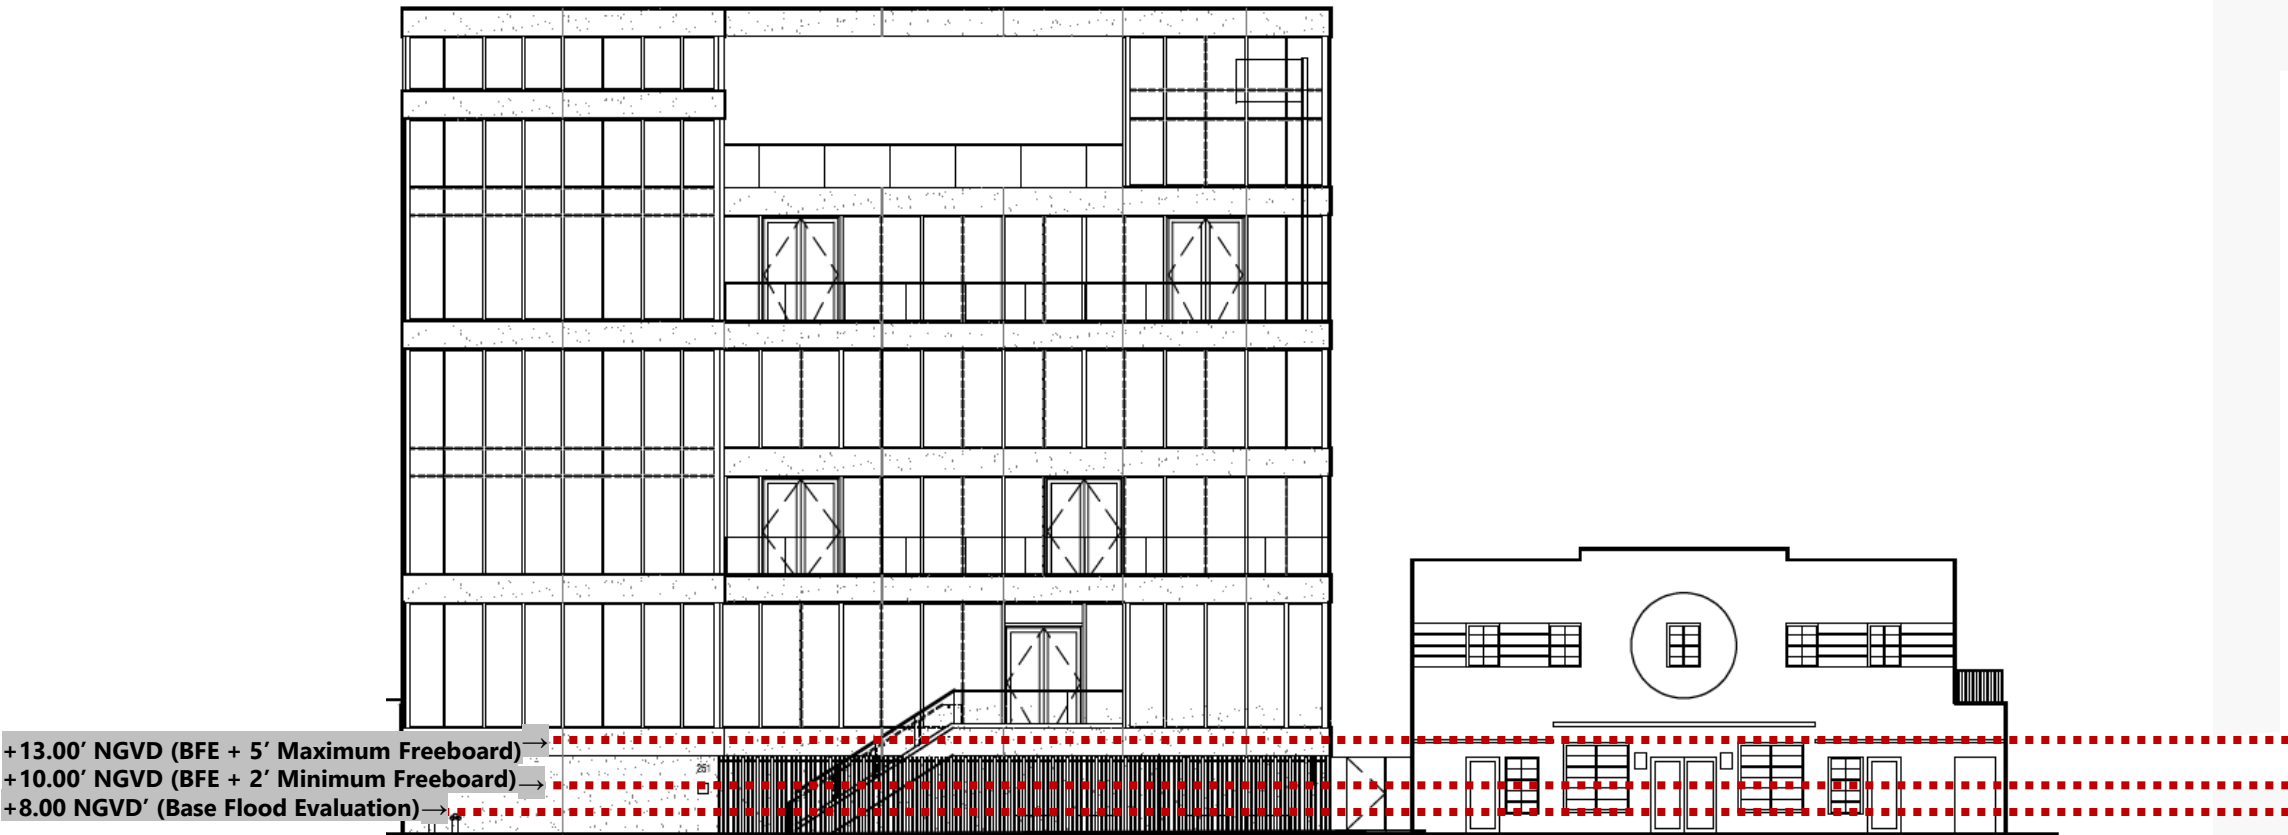
# Existing Elevation Profile

- The existing first floor finished floor elevation is at **6.1' NGVD**.
- The structure is below the flood elevation, as the FEMA maps establish the elevation at **8.00' NGVD**.
- New construction is built at **10.00' NGVD** (8.00' BFE + 2.00' Freeboard).

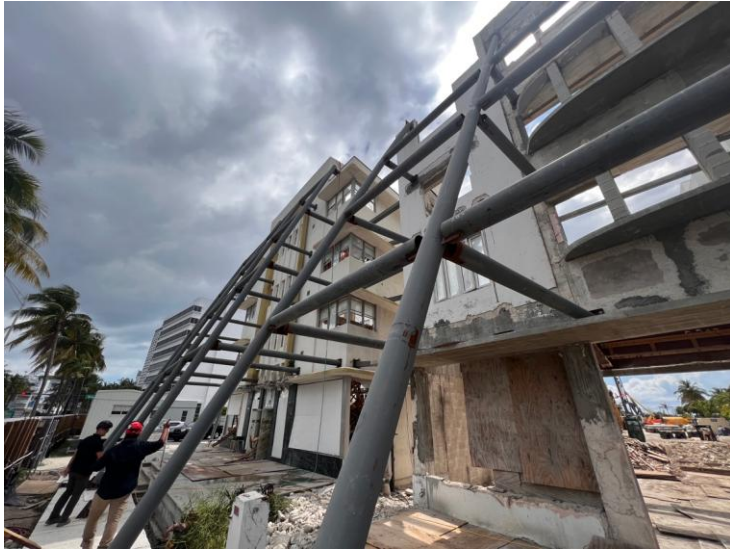
**Richmond and South Seas Bracing**

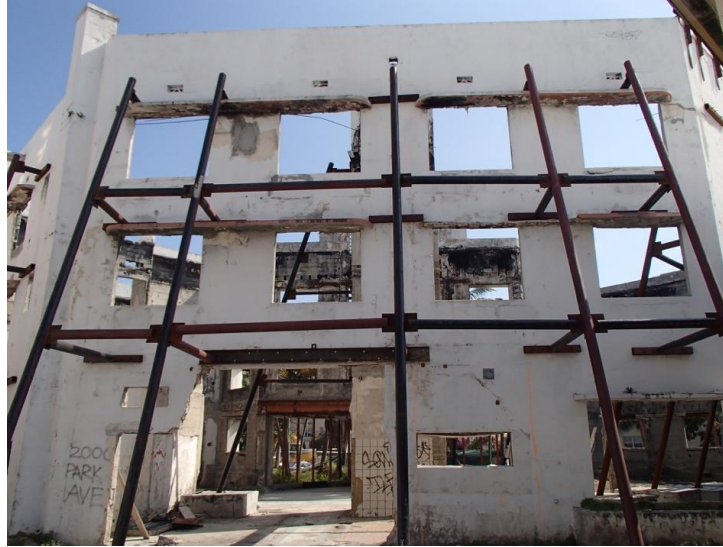
**Collins Park Bracing**

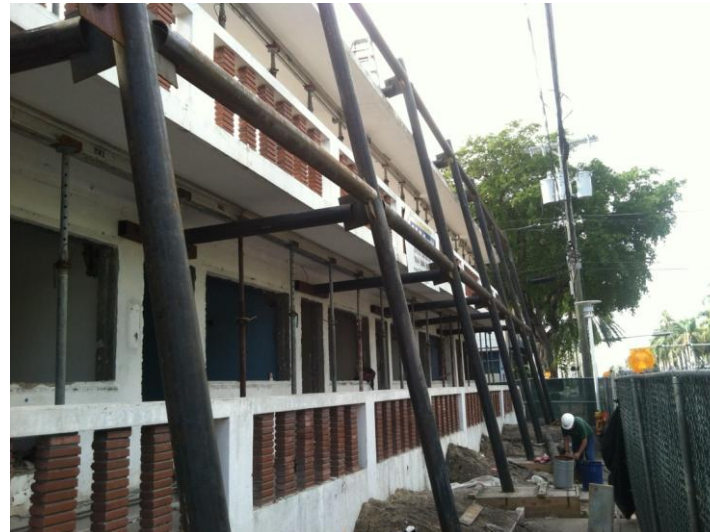
**Kaskades Bracing**

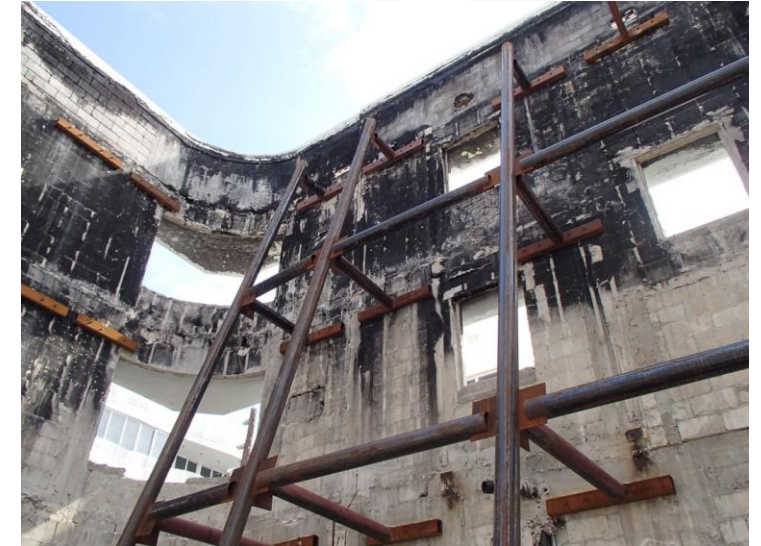
**Collins Park Bracing**

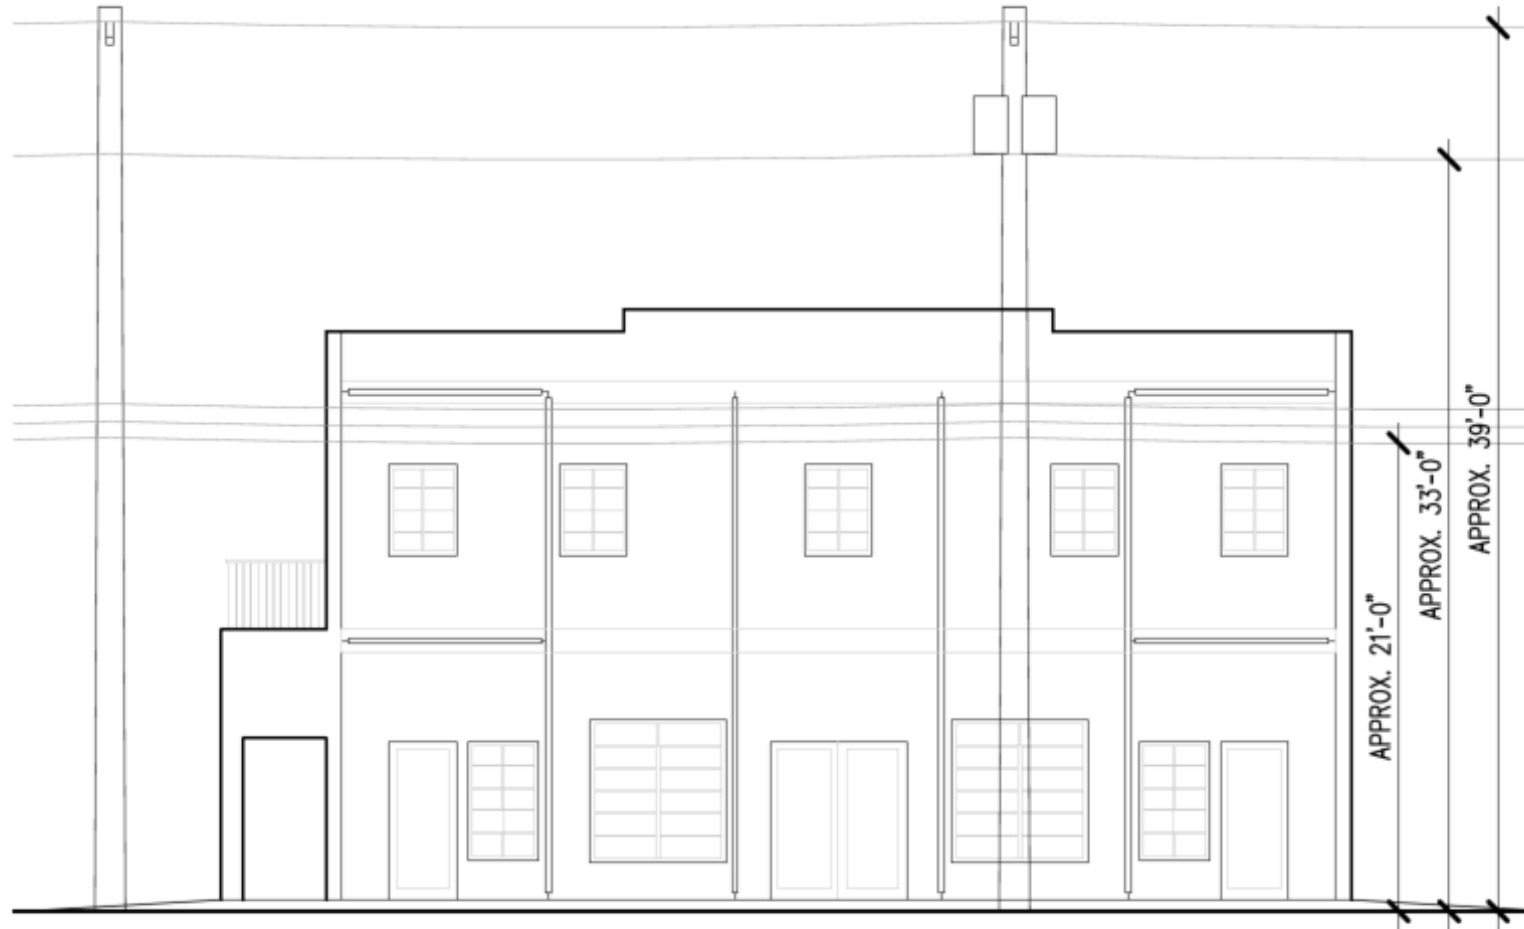
Site Elevation (West)

# Power Line Safety Requirements Restrict Rear Demolition
