# HISTORIC RESOURCES REPORT

**7801 Atlantic Way  
Miami Beach, Florida**

March 15, 2023

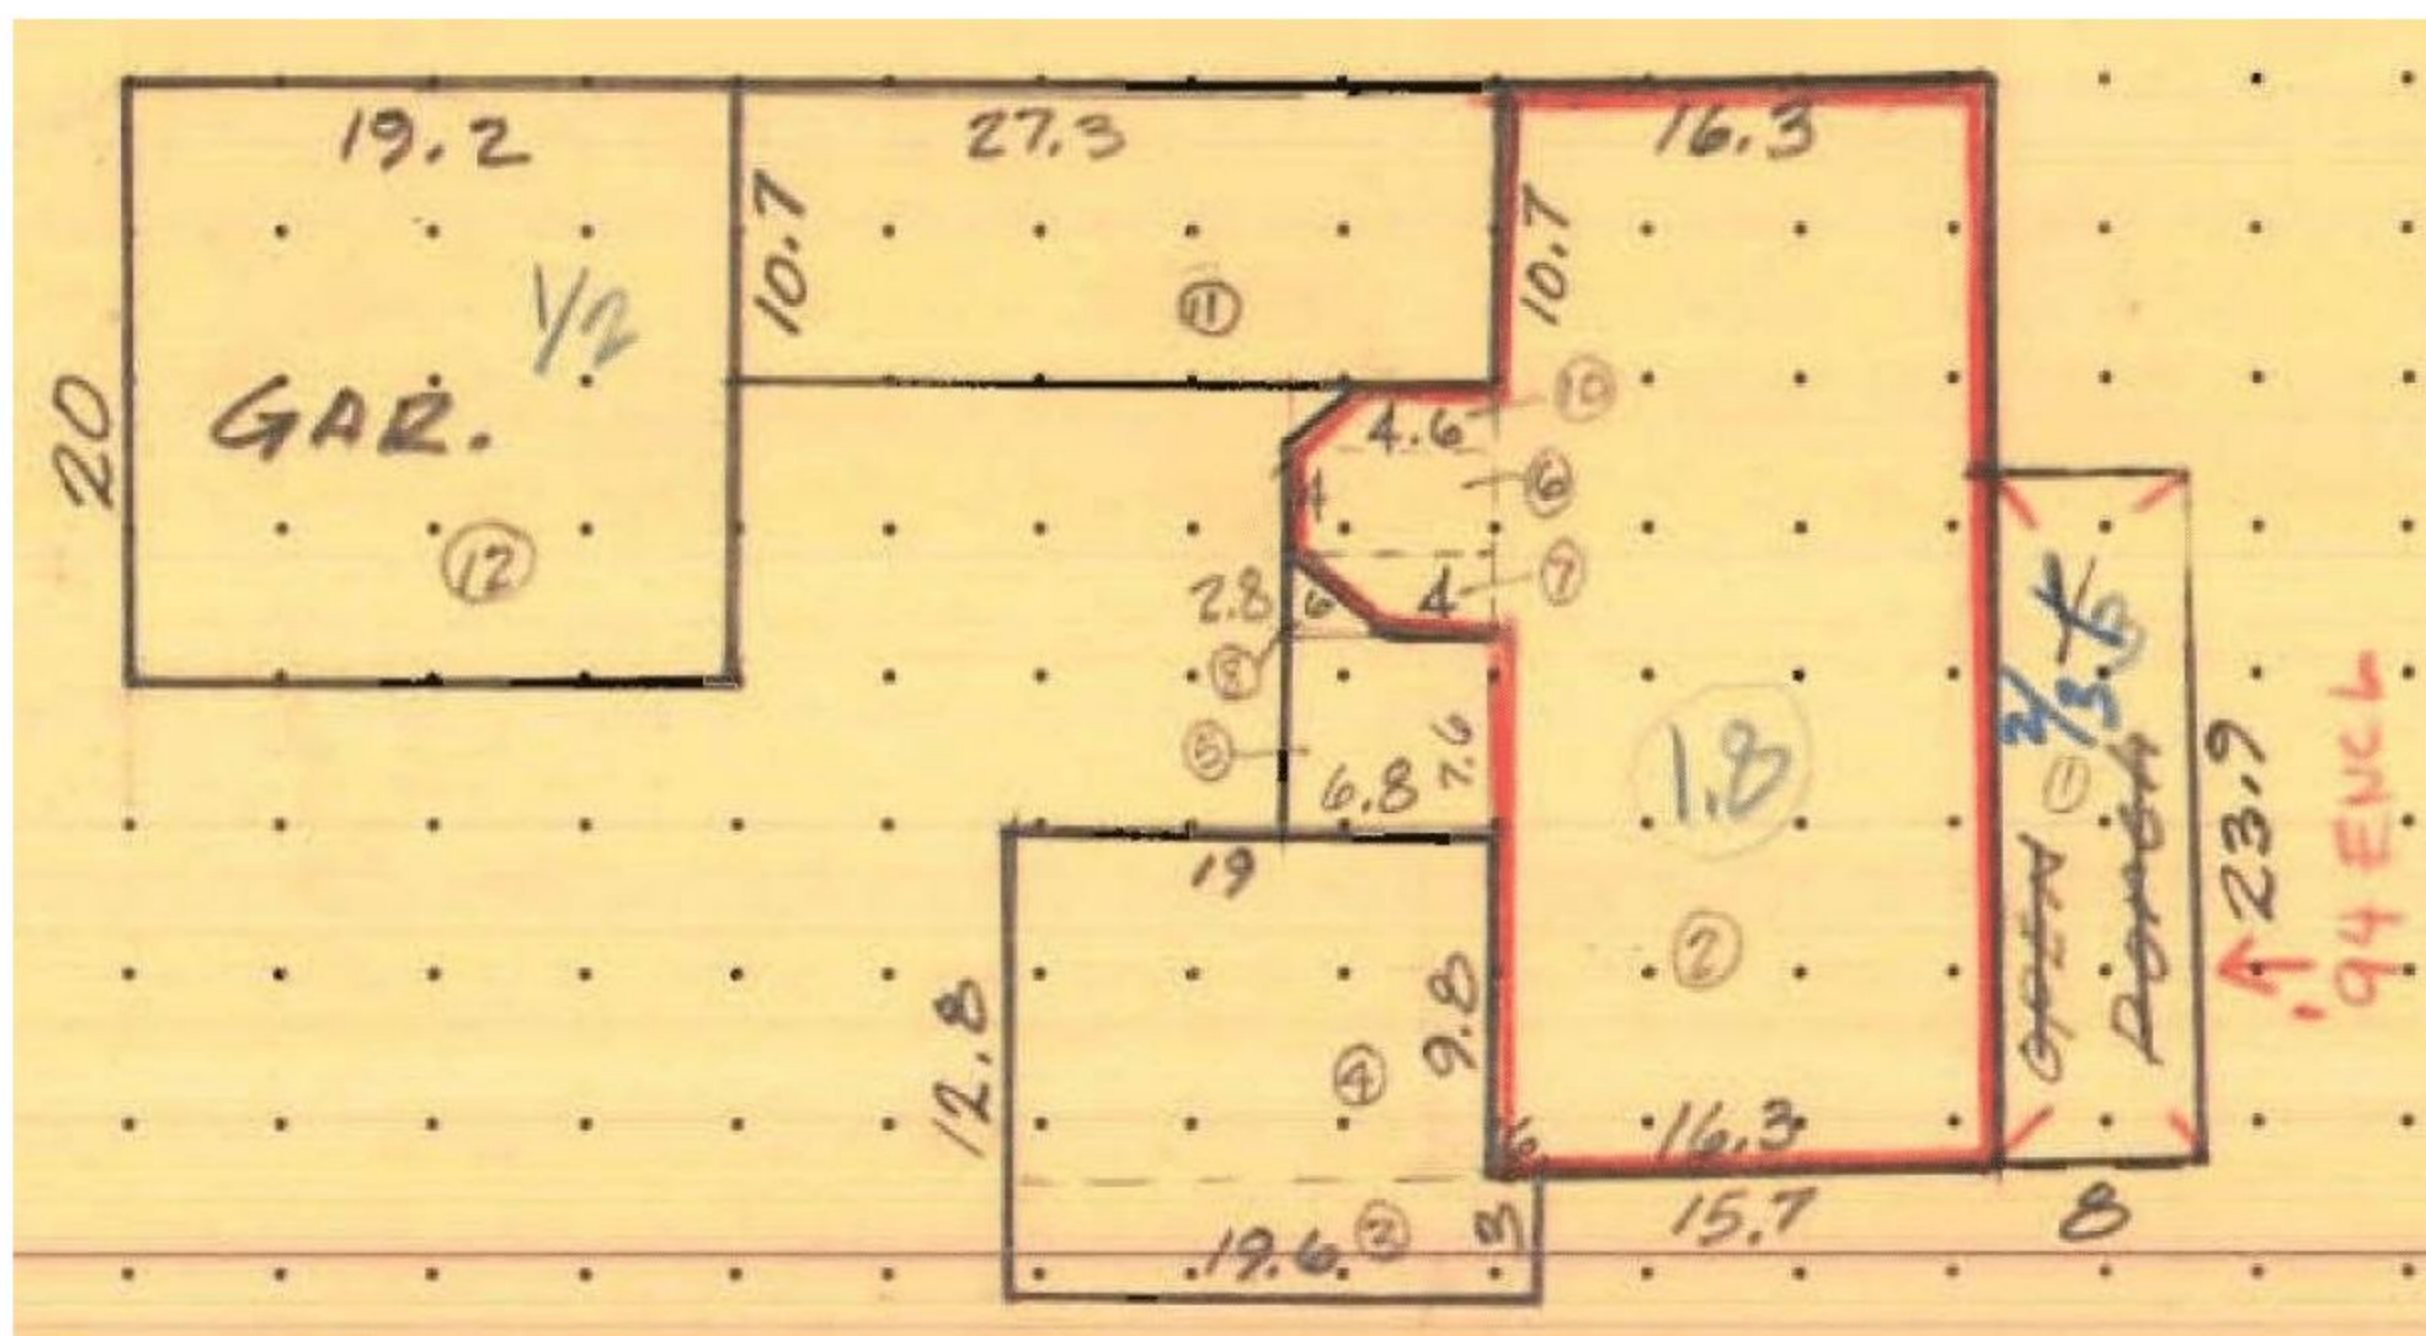
Figure 41 . Diagram of footprint of 7801 Atlantic Way indicating enclosure of east porch, 1994.  
(Office of the Property Appraiser, Miami-Dade County)

Other than maintenance, fencing, and the conversion to sewer from the original septic tank, there were no significant changes to the property from the time of its construction until 1994. In that year, the living area was enlarged by the enclosure of an open porch on the east elevation. (Figure 41, Figure 42) Other work included a new shingle roof, new kitchen, new electric service, plumbing repairs, new windows, new tile floors, new central air conditioning and replacement of some doors. (Figure 43) Also in 1994, a permit was issued for granite repair for a cracked overhead slab (location not specified).

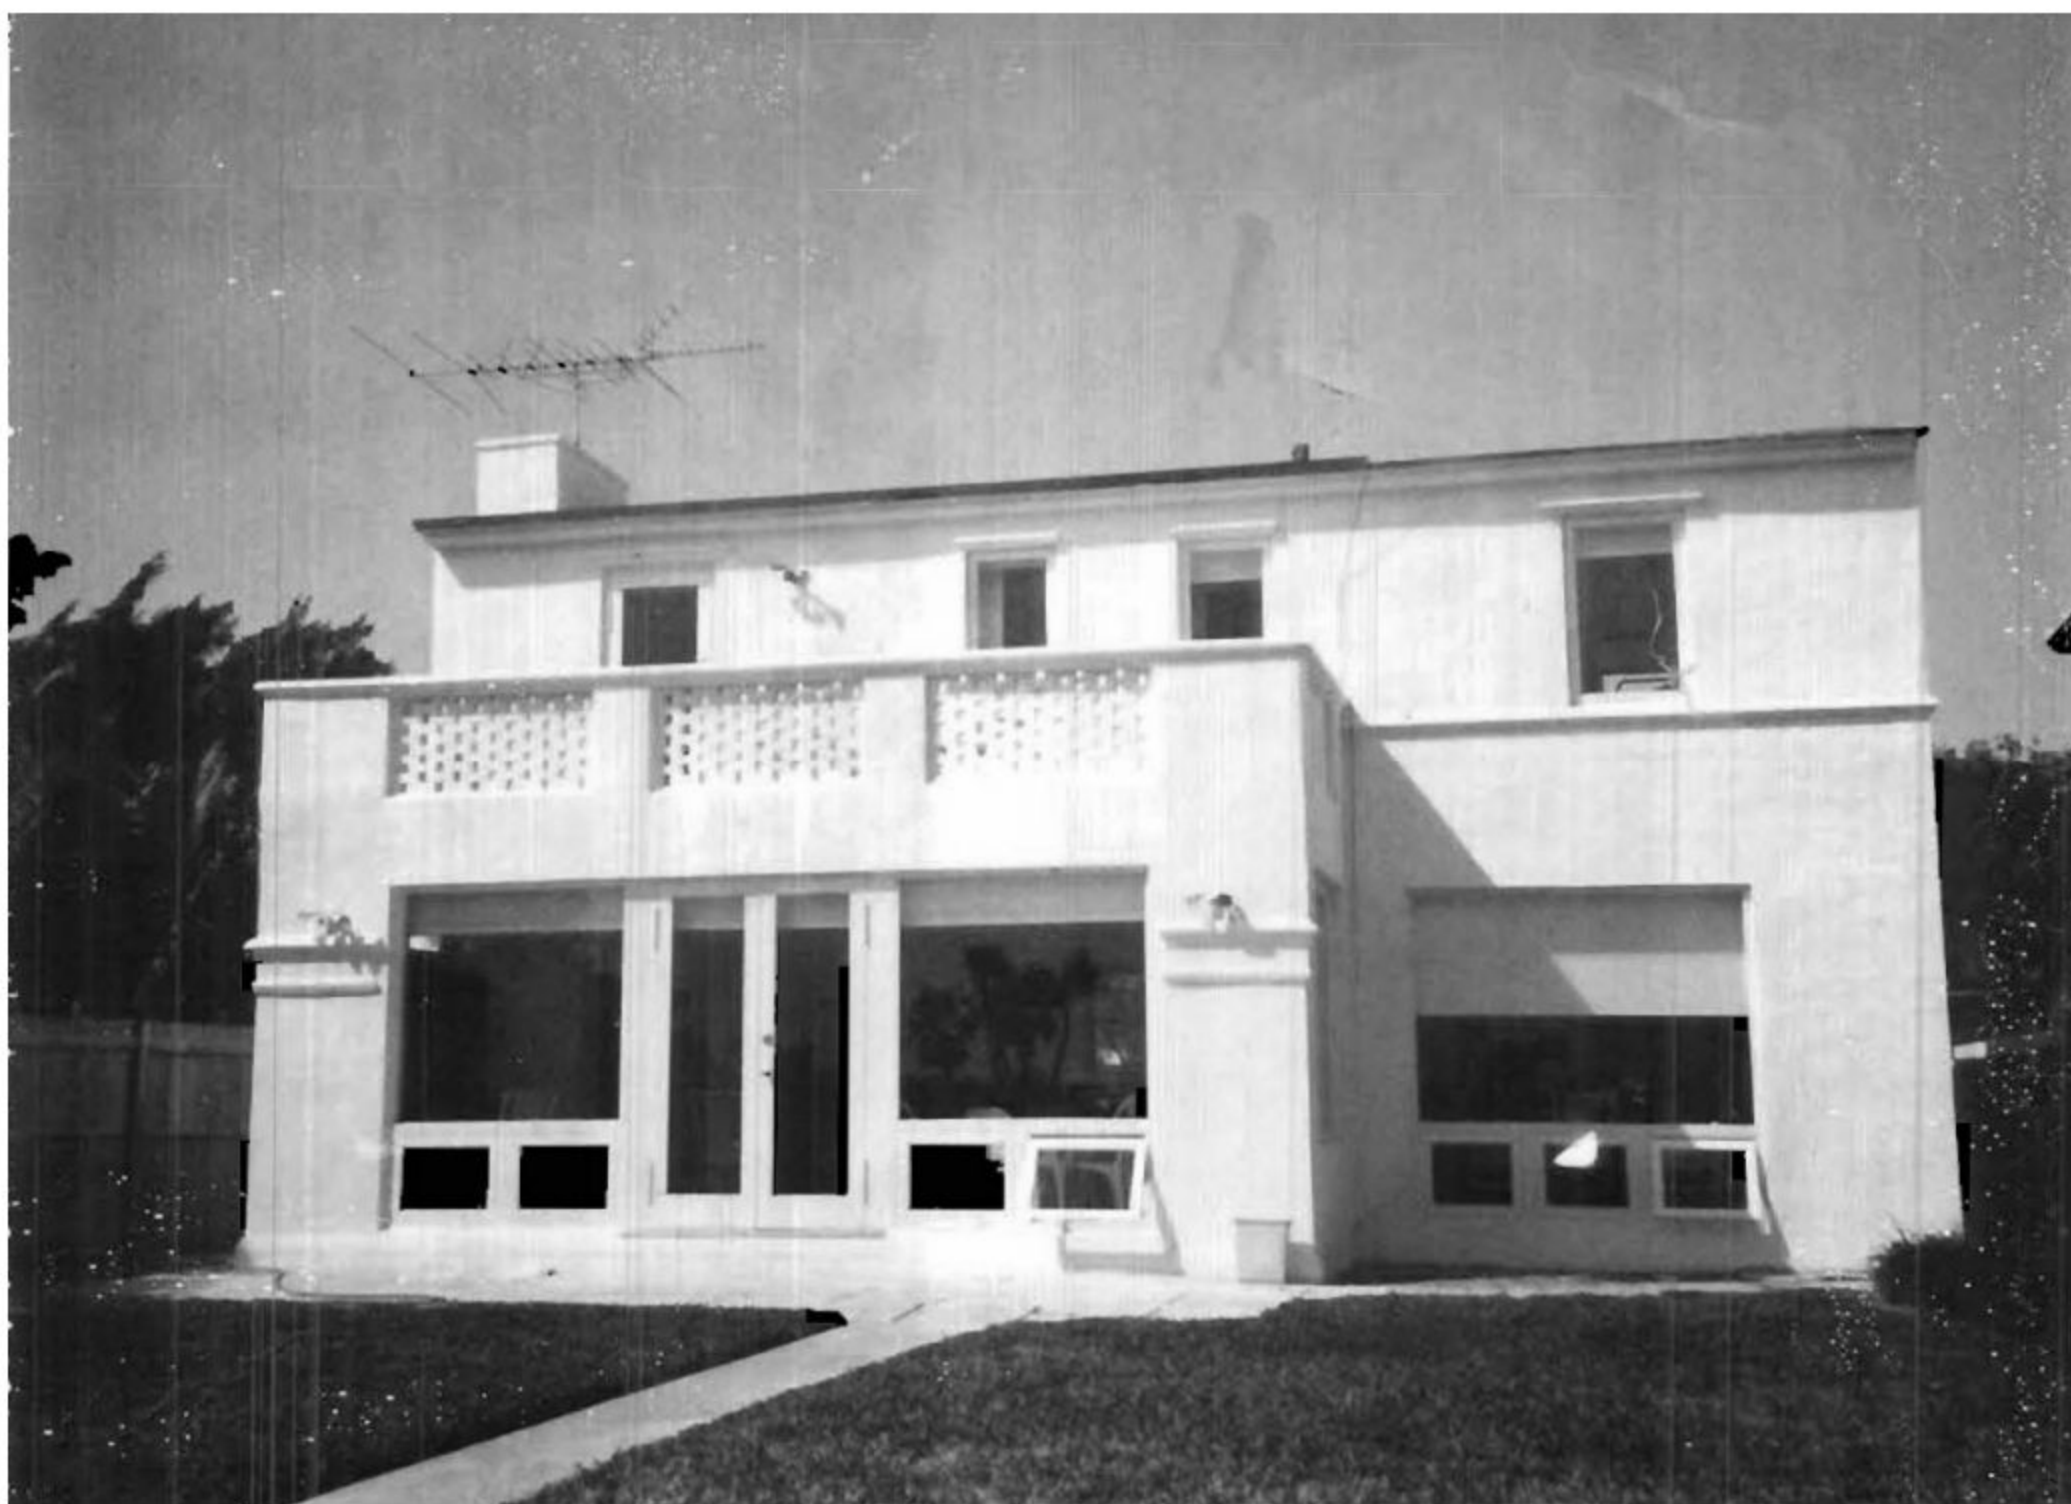
*Figure 42. View of east elevation showing enclosed porch, February 1995.  
(Office of the Property Appraiser, Miami-Dade County)*

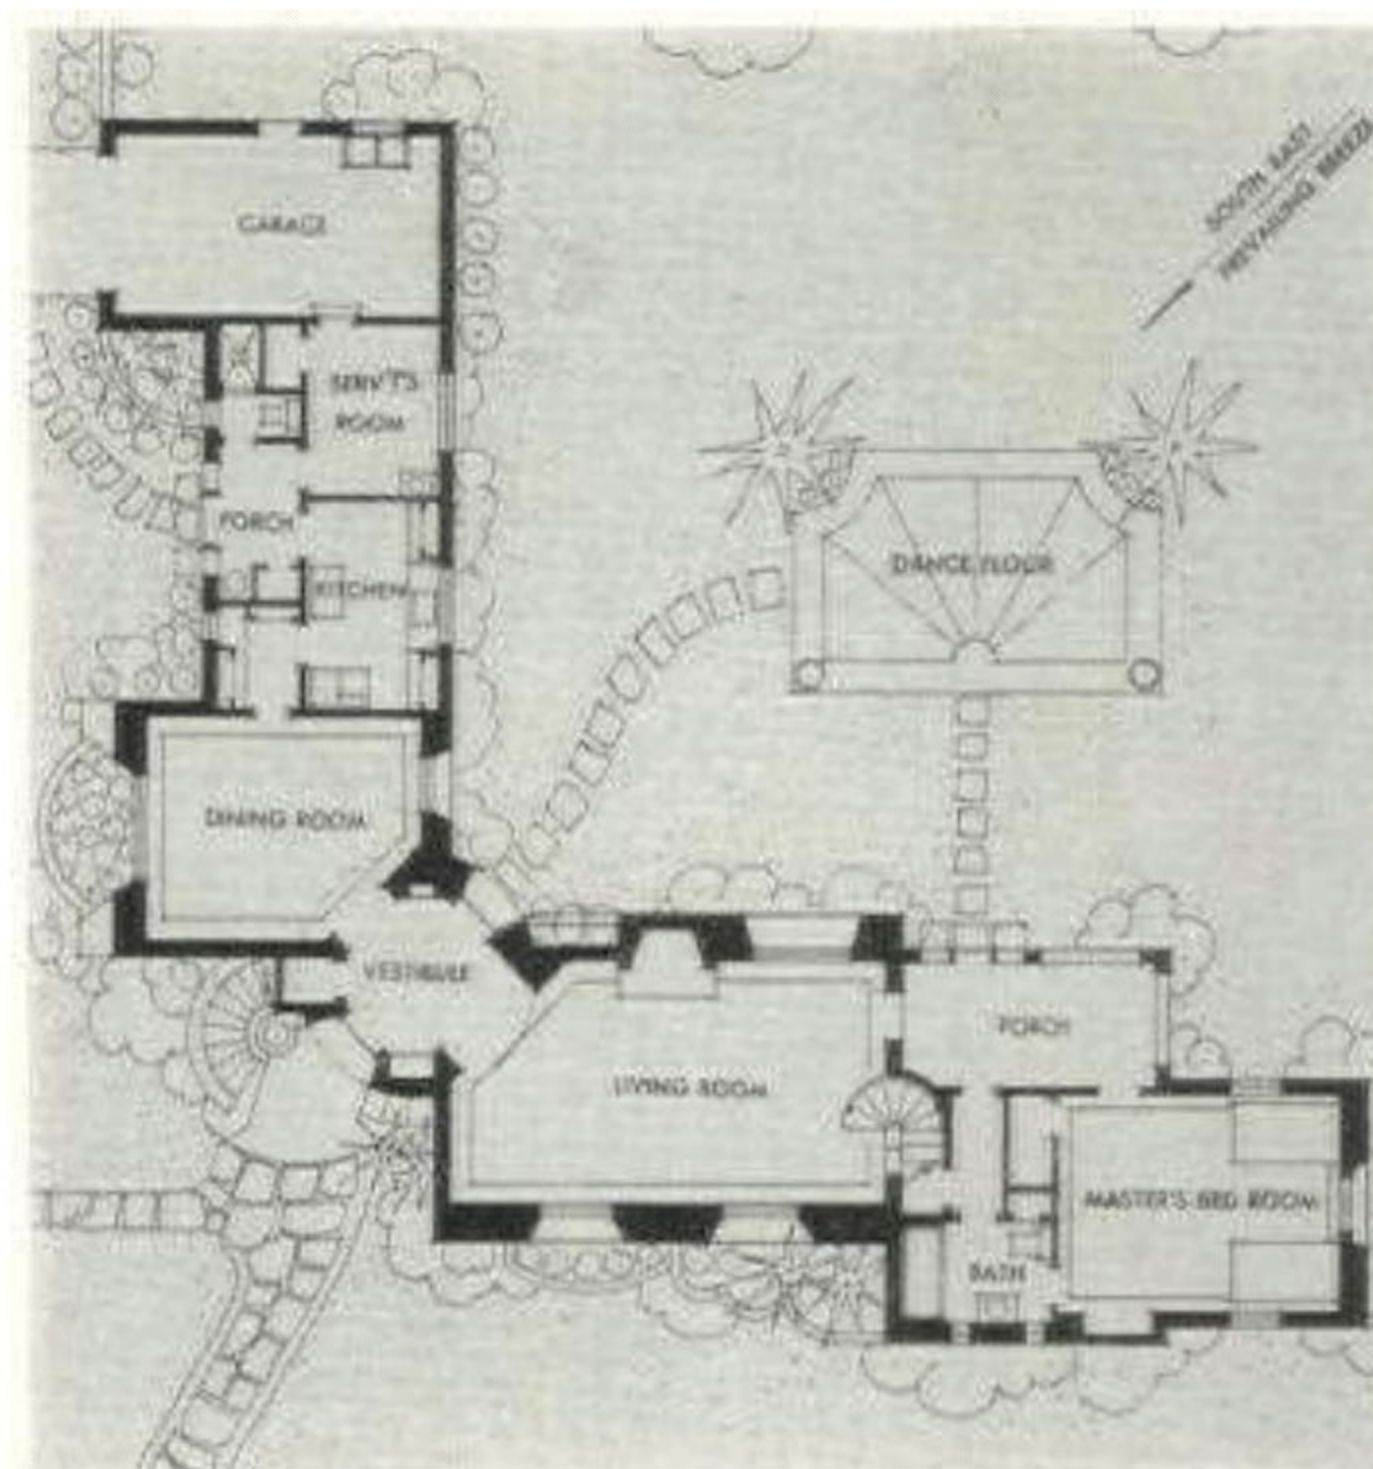
Figure 61. Plan of the L-shaped Knapp House with central tower, 1933.  
(House & Garden, p. 53)

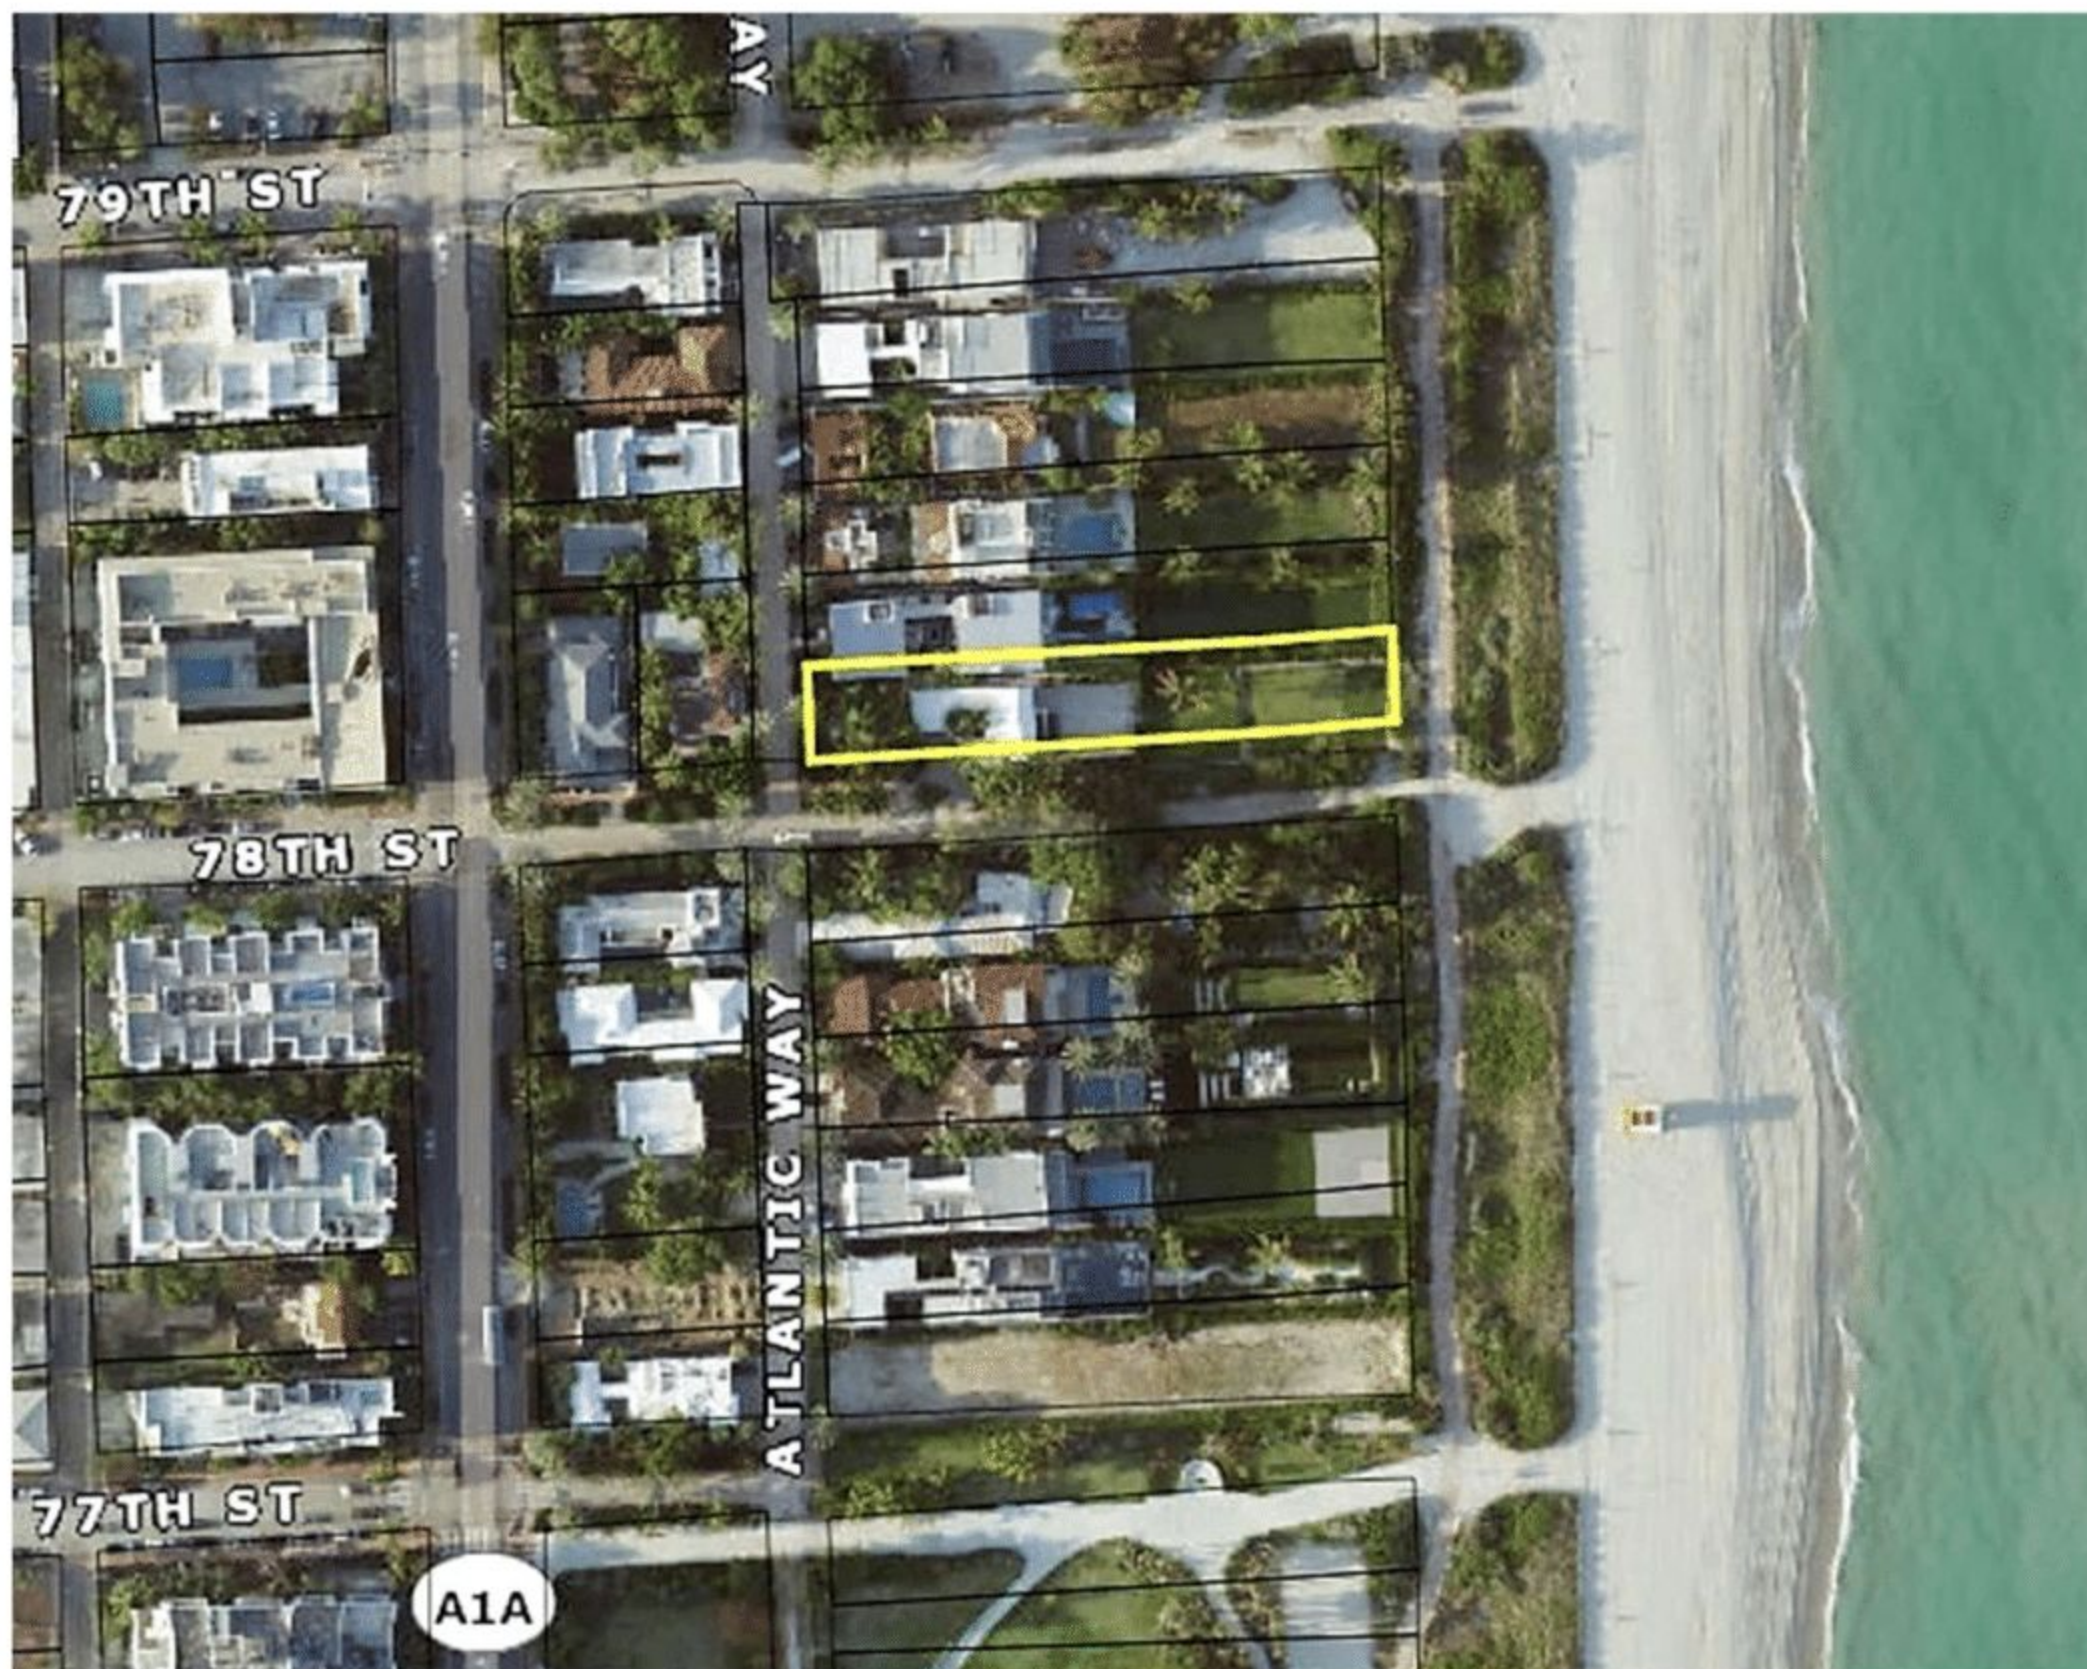
*Figure 62. Tax parcel map showing 7801 Atlantic Way property lines, 2021.  
(Miami-Dade County Property Appraiser)*

The residence at 7801 Atlantic Way is situated on the northeast corner of Atlantic Way and 78<sup>th</sup> Street in Miami Beach, Florida. (Figure 62) Directly to the north and south of the site are residences constructed from the early- to mid- 20<sup>th</sup> century and in the early 21<sup>st</sup> century.

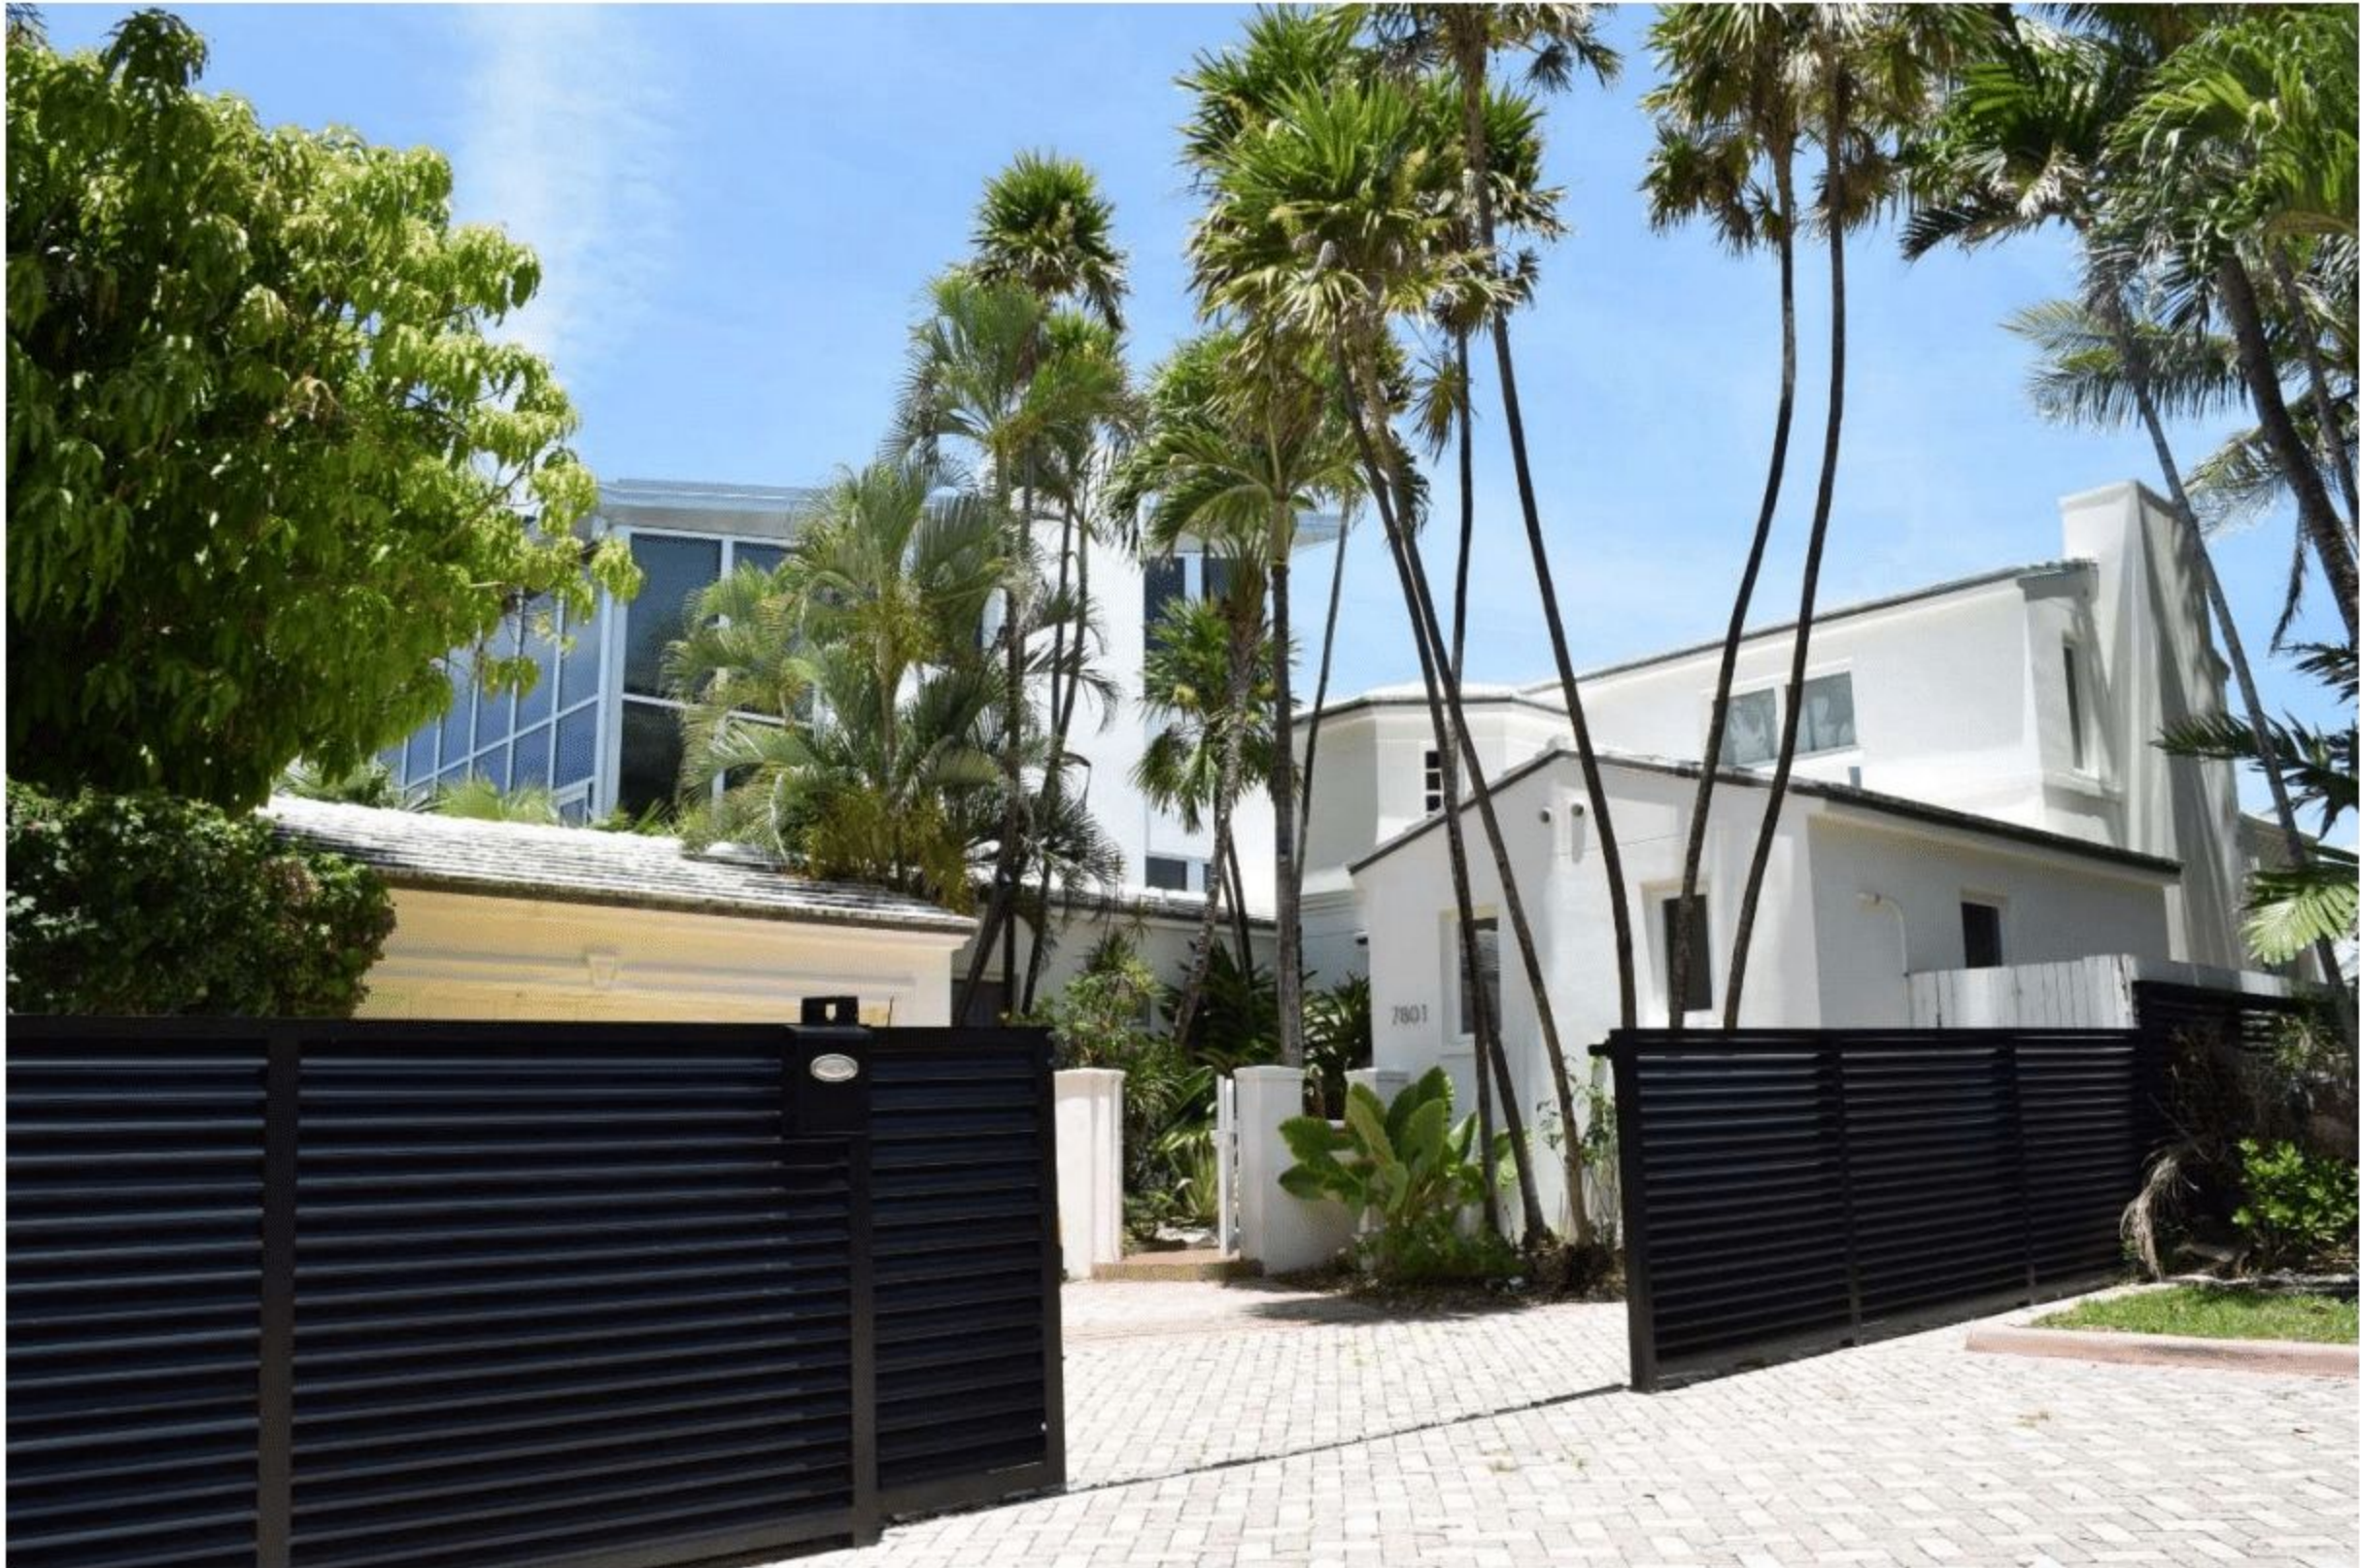
*Figure 73. 7801 Atlantic Way, Miami Beach, May 2021.*

The building at 7801 Atlantic Way is a stucco-clad one- and two-story irregularly-shaped residence with Mediterranean-Revival styling. (Figure 73) The two-story portion of the residence is oriented north-south and has a low-pitched side gable roof. One-story gable-roofed wings project west from the northwest and southwest corners of the two-story block, forming a J-shape. The northern wing, which is longer than the southern wing, is connected to a south-facing double garage. A one-story enclosed porch at the east elevation has a flat roof that serves as a 2<sup>nd</sup> story veranda.

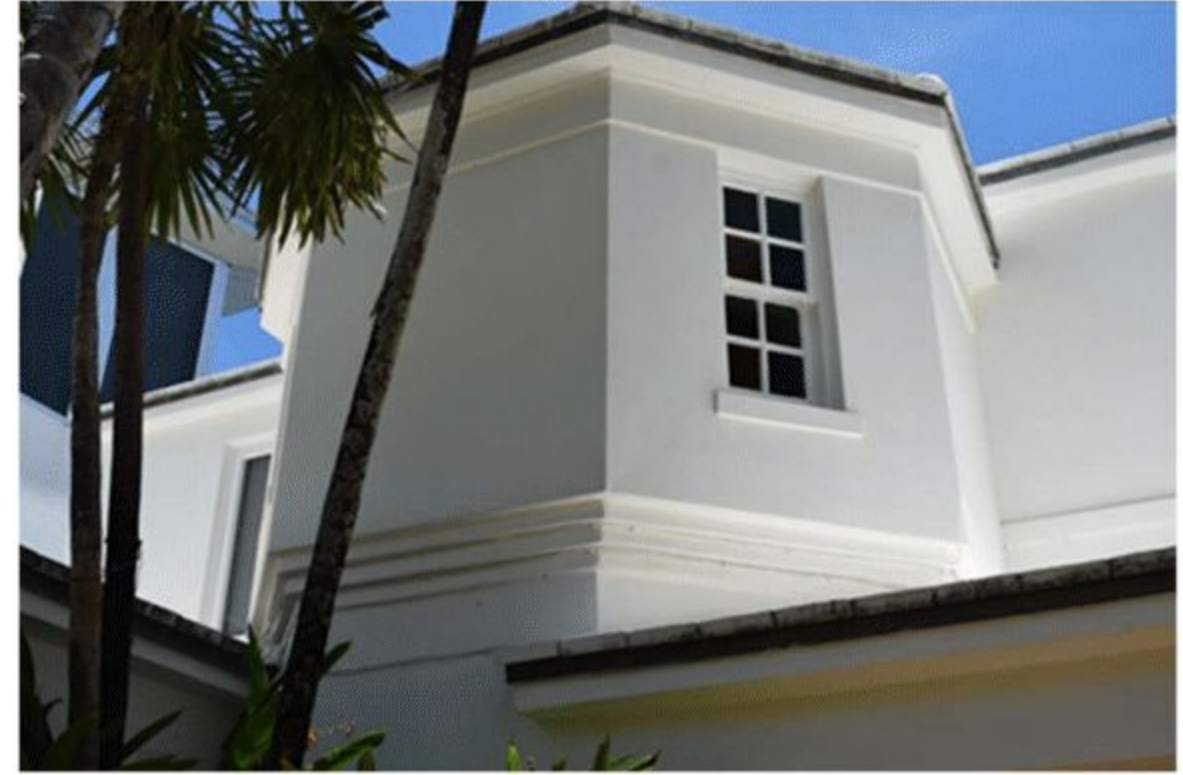
*Figure 75. Detail of octagonal stair tower with cornice and corbelled detailing, May 2021.*

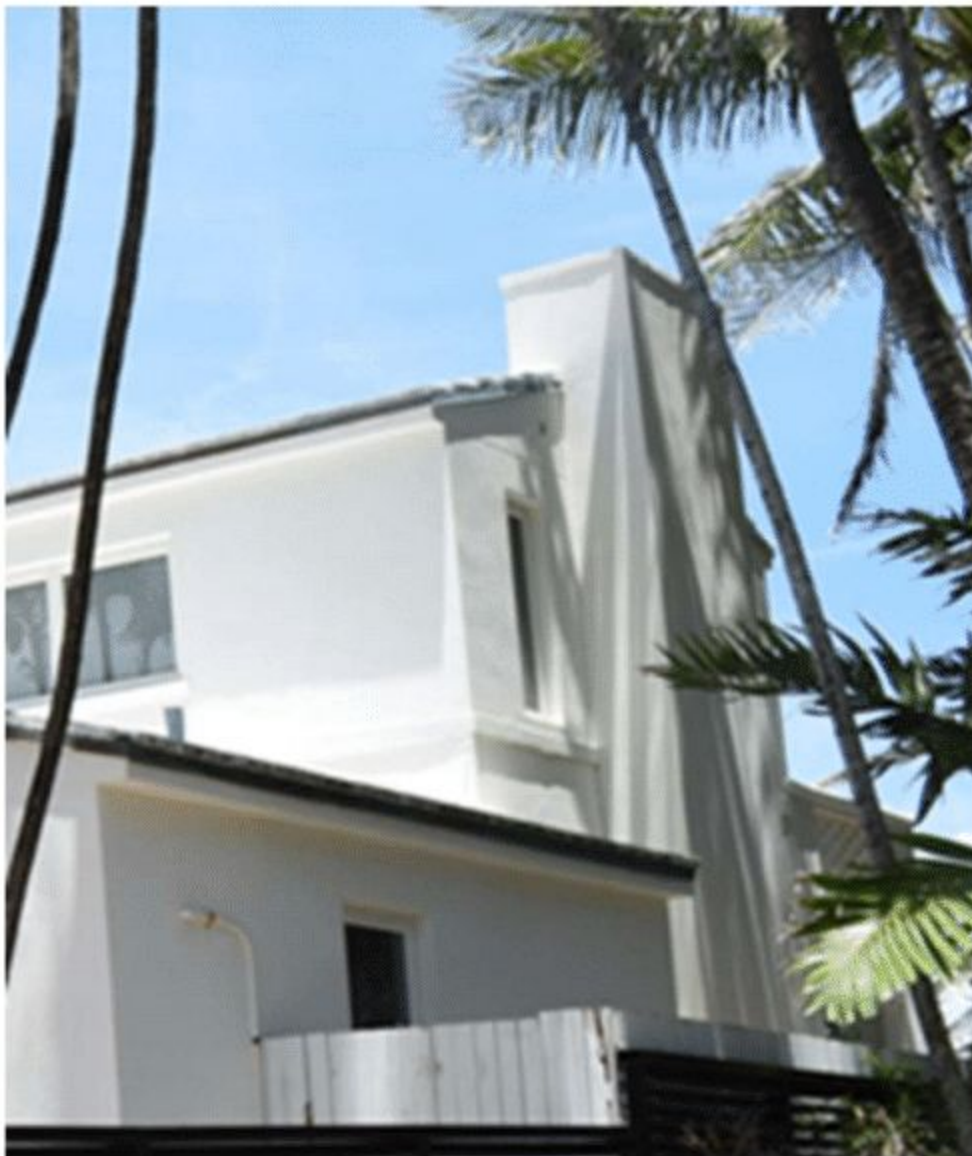
*Figure 80. View of south elevation of southern wing, May 2021.*

The westernmost bay of the south elevation is a double garage with a segmented, paneled garage door. (Figure 78) Wood trim around the door features a centered “keystone” detail. (Figure 80) Windows at the wings and two-story portion of the residence are obscured by foliage. (Figure 79) A chimney projects slightly from the center of the south elevation gable end of the two-story block. (Figure 80)

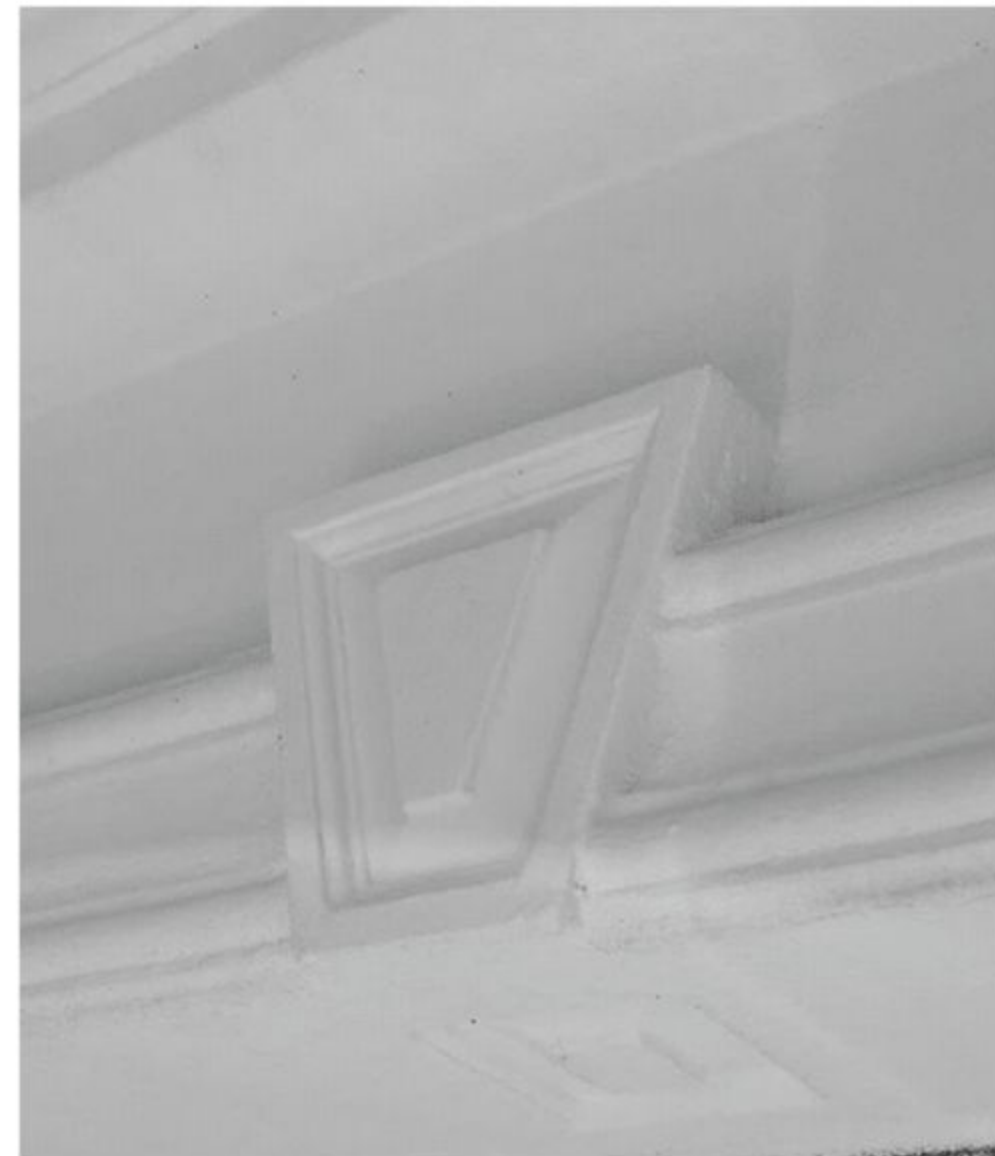
*Figure 81. Detail of keystone at garage door, May 2021.*

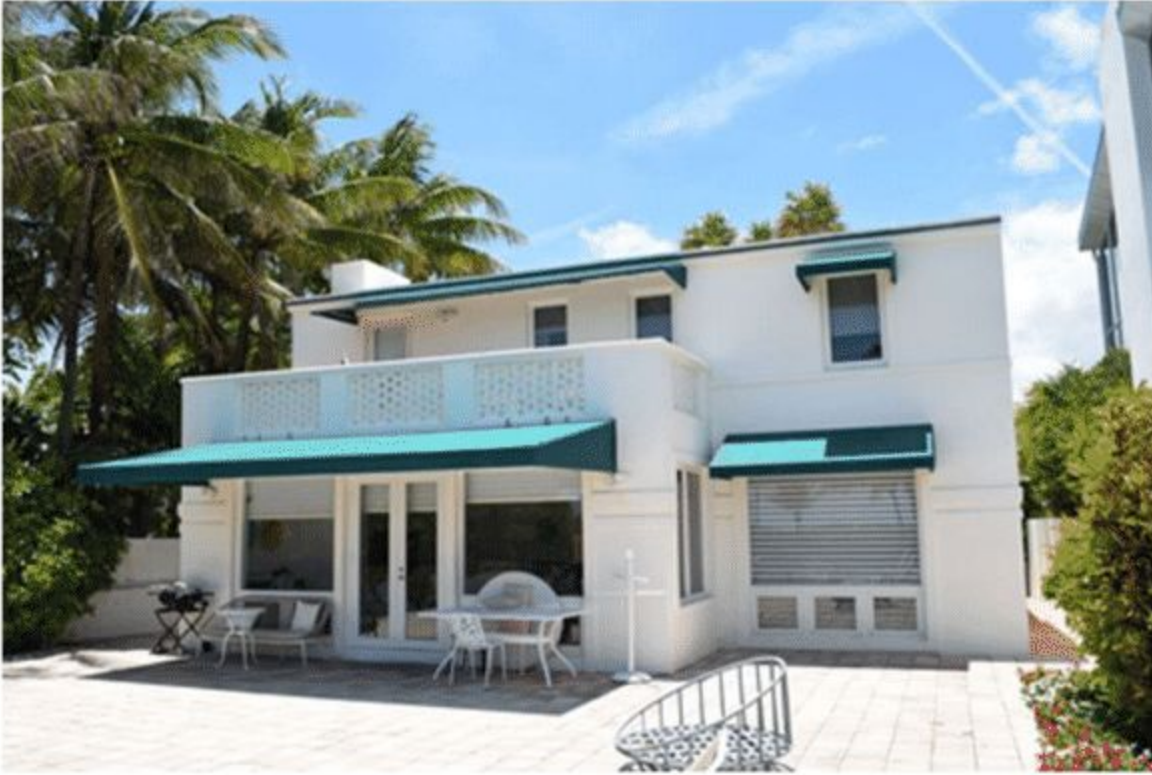
Figure 82. View of east elevation with one-story enclosed porch, May 2021.

The two-story east elevation has an attached one-story enclosed porch that spans two-thirds of the width of the elevation. (Figure 82) It features picture and slider windows and a pair of single-light doors. The veranda on the roof of the porch is enclosed by knee walls with sections of rectangular breeze block. (Figure 83) The two-story block features picture and casement windows, and a door at the second level leads to the veranda. The windows and doors on this elevation appear to be replacement. Paired horizontal moldings are situated approximately six feet above grade (Figure 84), and a belt course is situated below the second story windows. (Figure 85)

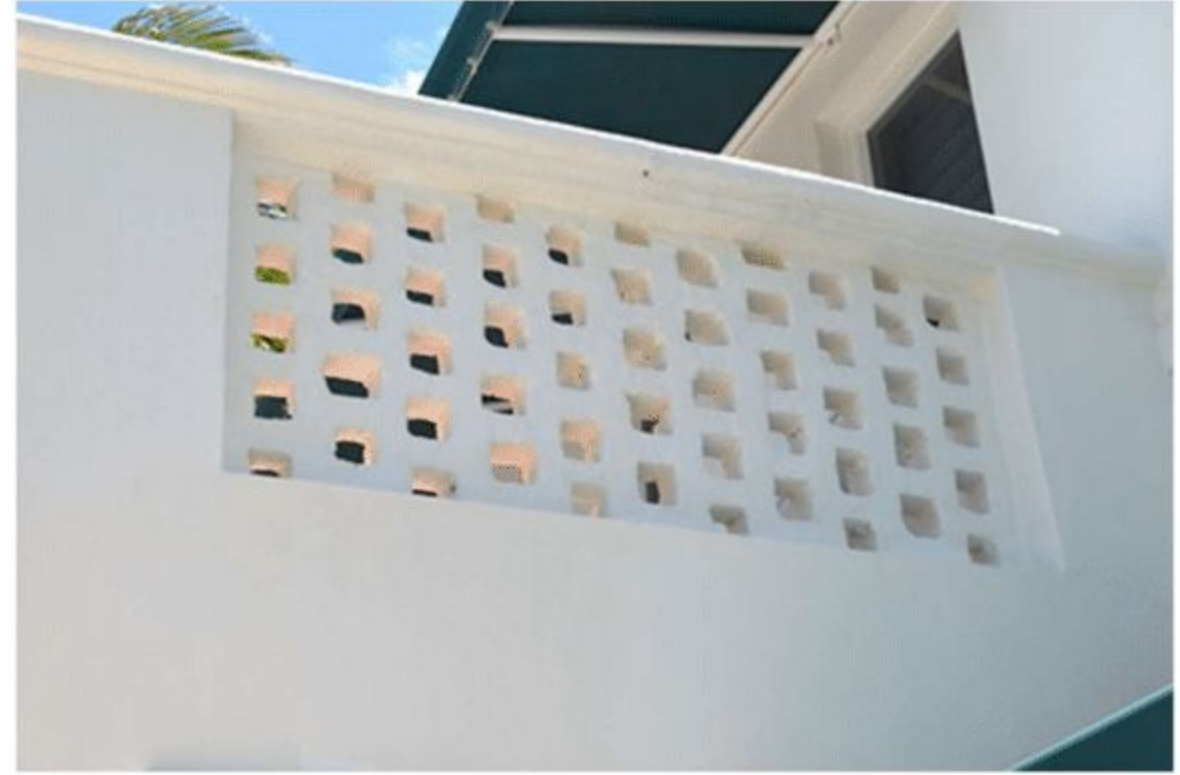
Figure 83. Detail of breezeblock at veranda, May 2021.
