# HISTORIC RESOURCES REPORT

**7801 Atlantic Way  
Miami Beach, Florida**

March 15, 2023

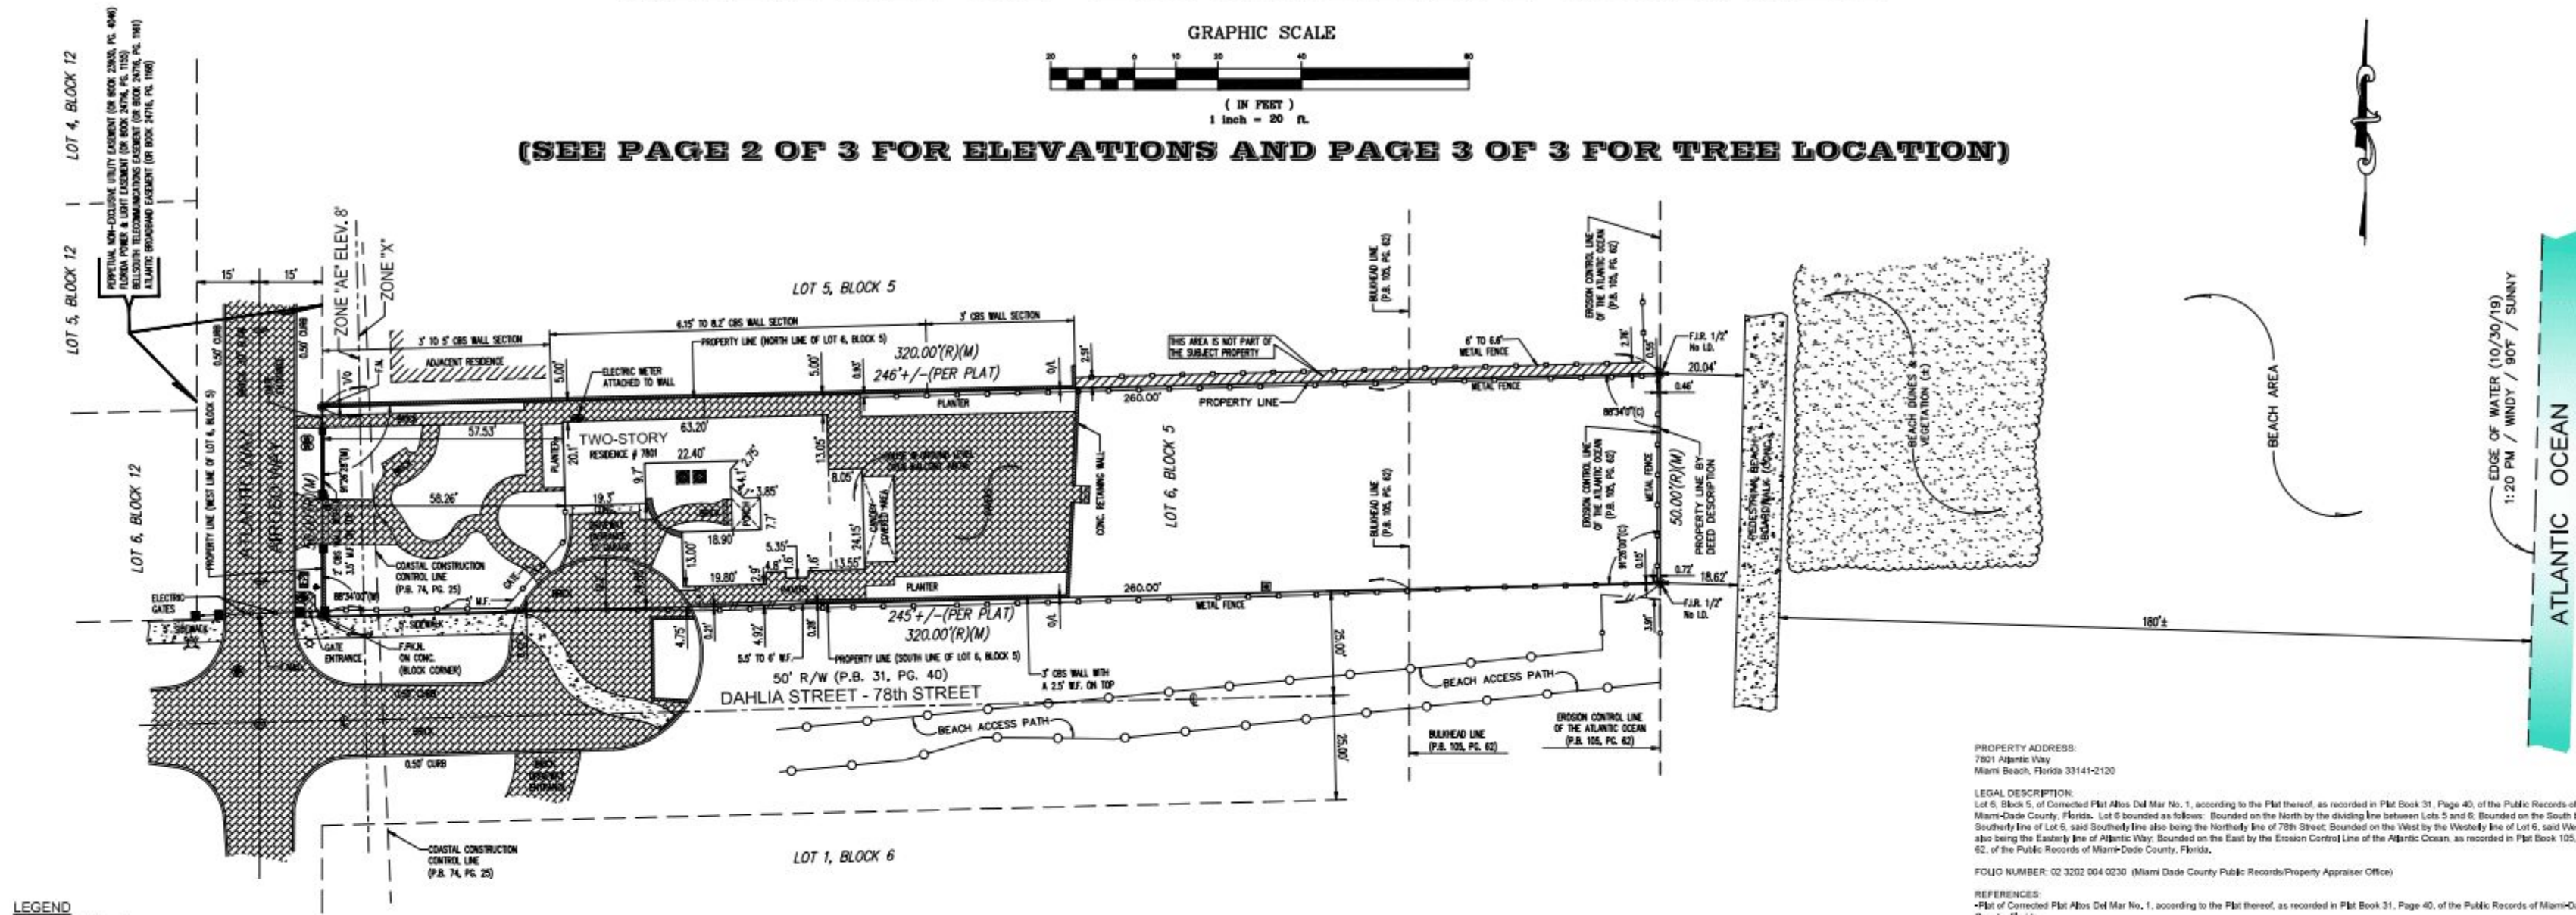
**SURVEYOR'S NOTES:**  
All distances as shown are based on the US Survey foot.  
At the time of Survey, The National Flood Insurance Rate Map for Florida, Community Panel No. 120651 (City of Miami Beach) 12066 C, 0326 L, FIRM Date 08/11/2009 and Revised with an effective date of 08/11/2009, published by the United States Department of Housing and Urban Development, delineates the existing dwelling structure located within the described parcel of land to be situated outside the Special Flood Hazard Area designated by the Federal Emergency Management Agency (FEMA). The existing residence lies within Zone "X", areas determined to be outside the 0.2% annual chance floodplain. Subject lands cross more than one Flood Zone and a portion of the lot abutting the Westerly boundary line lies within Flood Hazard Zone "AE", Base Flood Elevation 8 feet. The Base Flood Elevation "AE" 8' refers to NGVD Datum (1929).
