# SKETCH OF BOUNDARY SURVEY

PROPERTY ADDRESS:  
7801 Atlantic Way  
Miami Beach, Florida 33141-2120

LAST REVISION  
05/23/2022  
JN 19-5113-D

SHEET:  
**1**  
OF 3

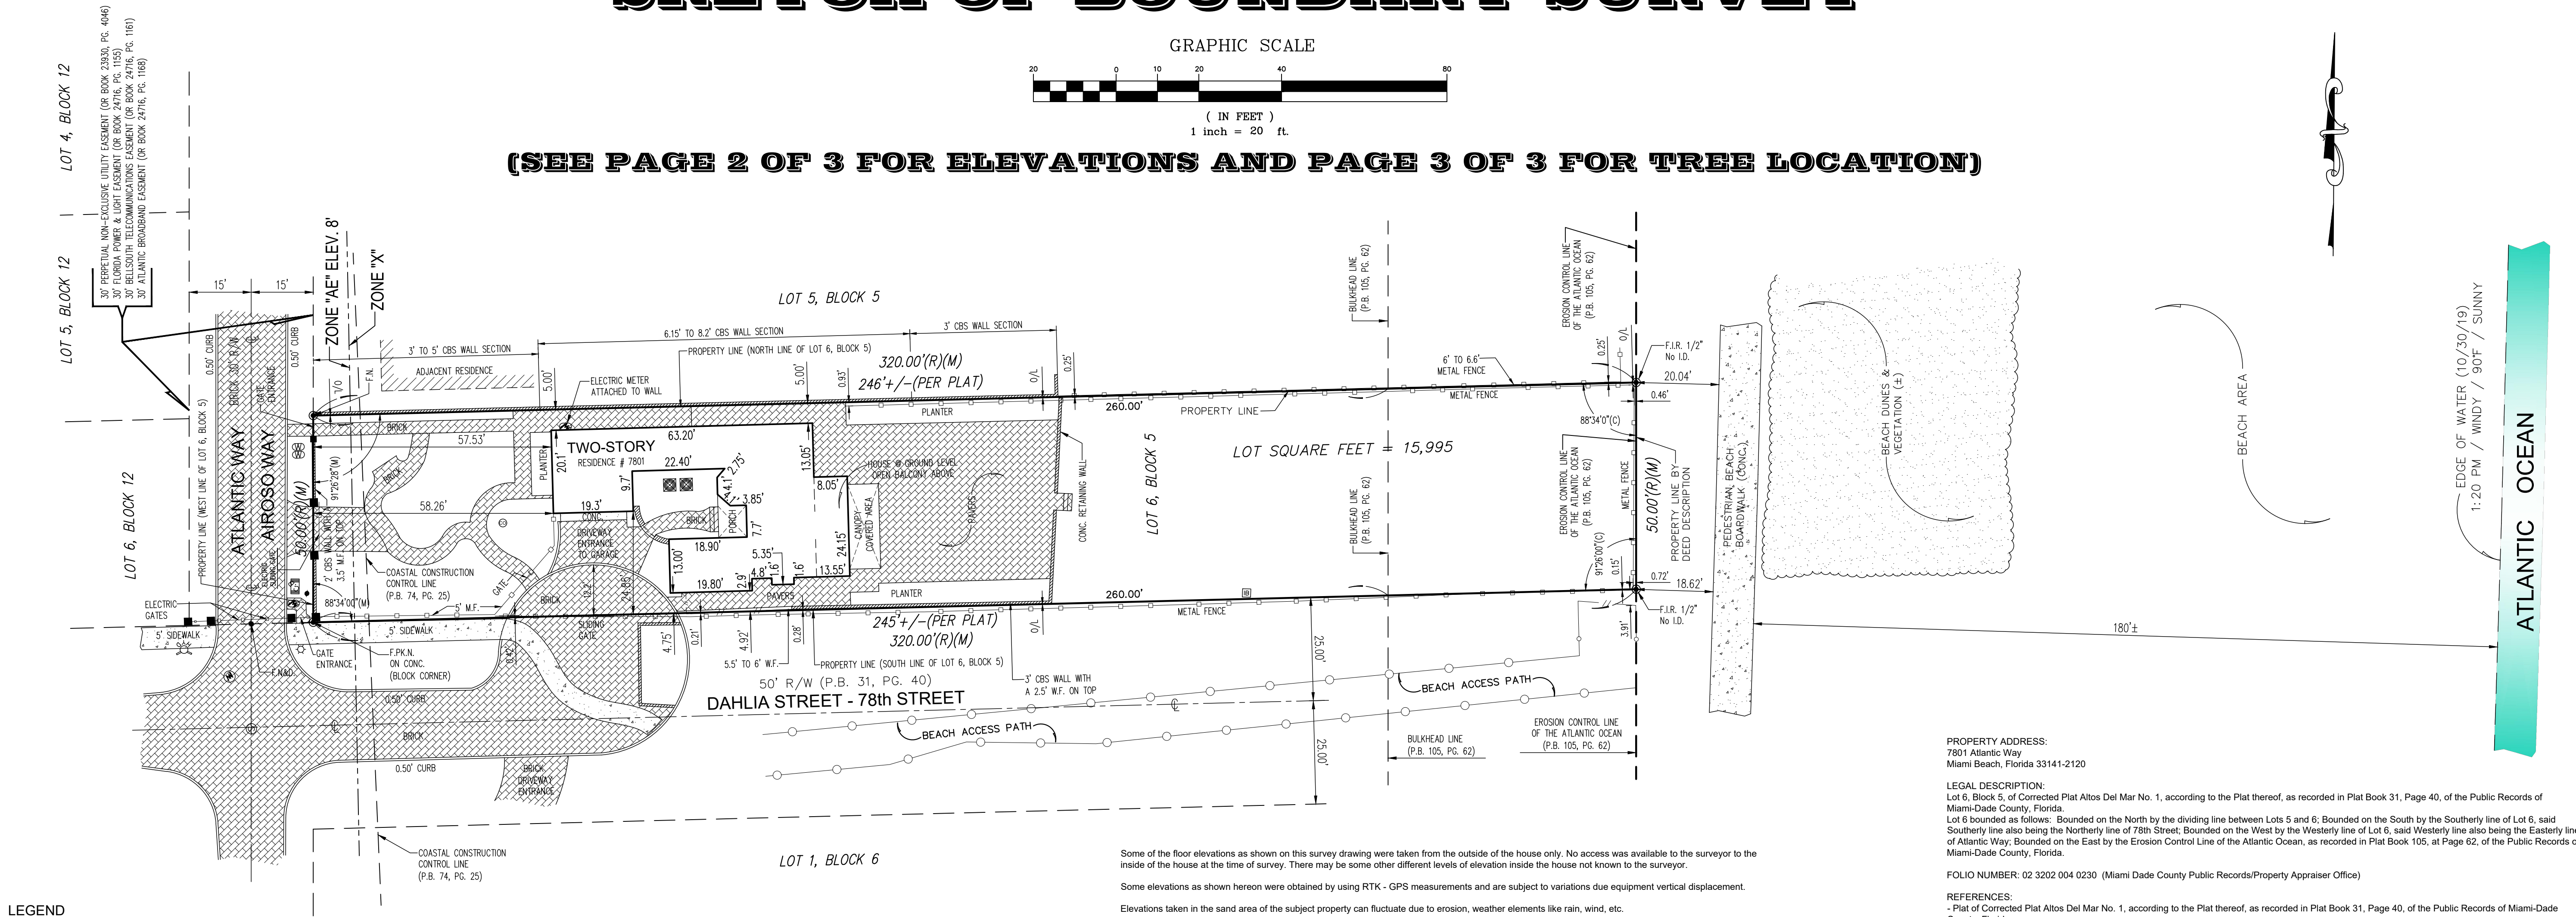
(SEE PAGE 2 OF 3 FOR ELEVATIONS AND PAGE 3 OF 3 FOR TREE LOCATION)

Survey done by occupation, physical evidence, the recovery of existing property corners, field measurements, calculations, adjacent plats and legal description provided to the surveyor and also from the Miami-Dade County Public Records/Property Appraiser Office and no claims as to ownership are made or implied.

Distances from property lines to fences or walls may slightly varies due to their irregularity, width and composition. Fences or walls not always travel on a straight line and in most cases meander through trees, hedges, vines and heavy landscaping usually located along boundary lines, therefore the resultant of said dimensions as shown hereon may vary slightly within 0.30' to 0.50' of a foot more or less.

Obstructed property corners are witnessed by improvements.
