**RE: International Inn – Resilient Review  
Brizaga Project No. 223006.00**

We at Brizaga thank you for the opportunity to provide a Resilient Review of the International Inn, a hotel undergoing rehabilitation located at 2301 Normandy Drive in Miami-Dade County, Florida. This letter will provide you with a comprehensive review of storm surge preparedness and design standards for the proposed development. What follows is a summary of the findings and recommendations to ensure the resilience of the building against potential flooding-based natural disasters.

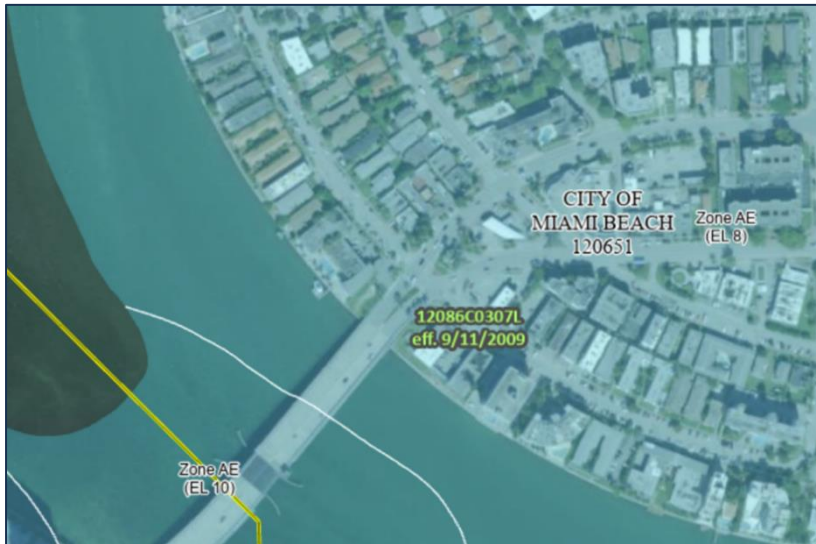
The International Inn's existing Finished Floor Elevation (FFE) of 4.0 feet NAVD places the building at risk of flooding during storm surge events. According to the Flood Insurance Rate Map (FIRM) in the project vicinity, the International Inn is located within the AE flood zone which is part of the Special Flood Hazard Area. This means that the Inn is at a heightened risk of being impacted by a 100-year flood event (or a flood that has a 1% chance of being exceeded in any given year).

**Figure 1.** FEMA Flood Insurance Rate Map (FIRM) in the Project vicinity.

The base flood elevation (BFE) at the International Inn is 8 feet NGVD29, or 6.44 feet NAVD88. This means that the 100-year flood event is expected to cause 2.44 feet of flooding within the interior of the property, if not otherwise mitigated.

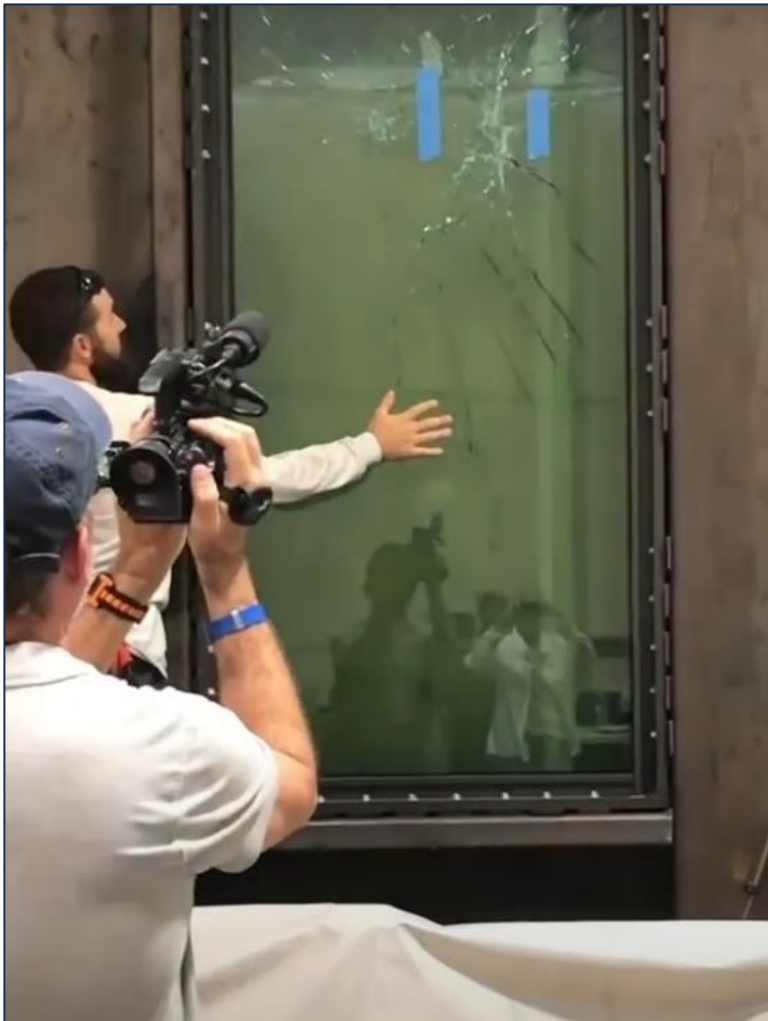
**Figure 2.** A flood glazing system is undergoing shop testing. The glass has been intentionally damaged to simulate potential wind-driven impacts coinciding with flood events.<sup>3</sup> This system may be a viable alternative for the historic atrium.

The atrium building is comprised primarily of glass storefronts with access doors around its perimeter. A flood glazing storefront may be the most appropriate solution due to limited setbacks from the adjacent property to the south. Temporary door barriers may be utilized in conjunction with flood glazing to seal any remaining openings.

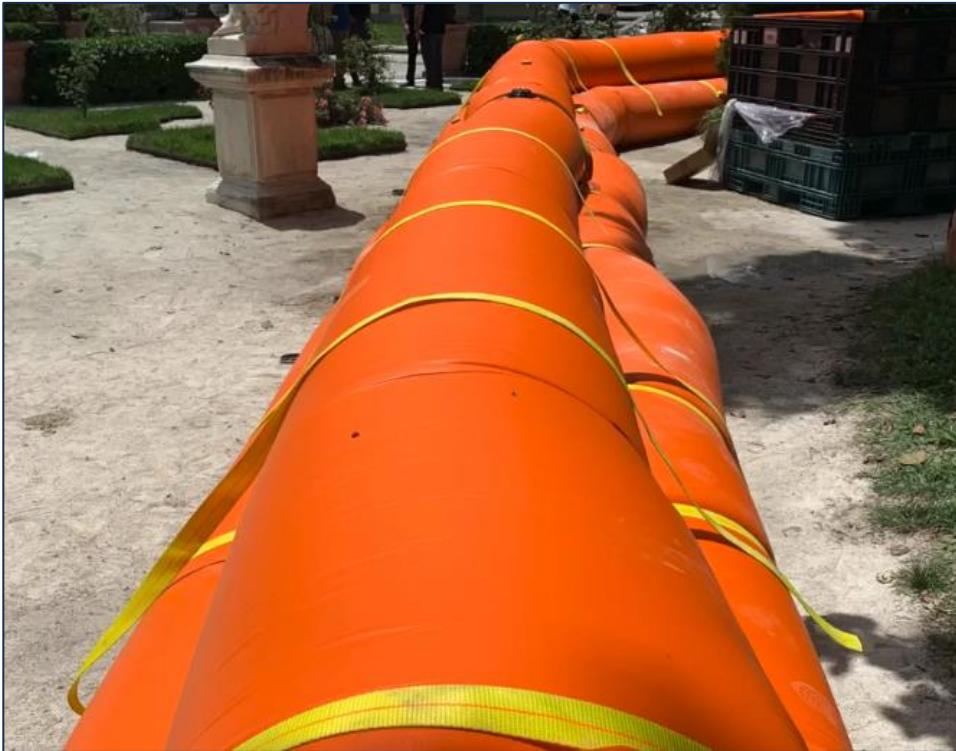
**Figure 3.** A temporary perimeter barrier installed at Vizcaya Museum & Gardens. The system shown is a bladder-style system which is filled with water and anchored to the ground as part of the deployment.<sup>4</sup>

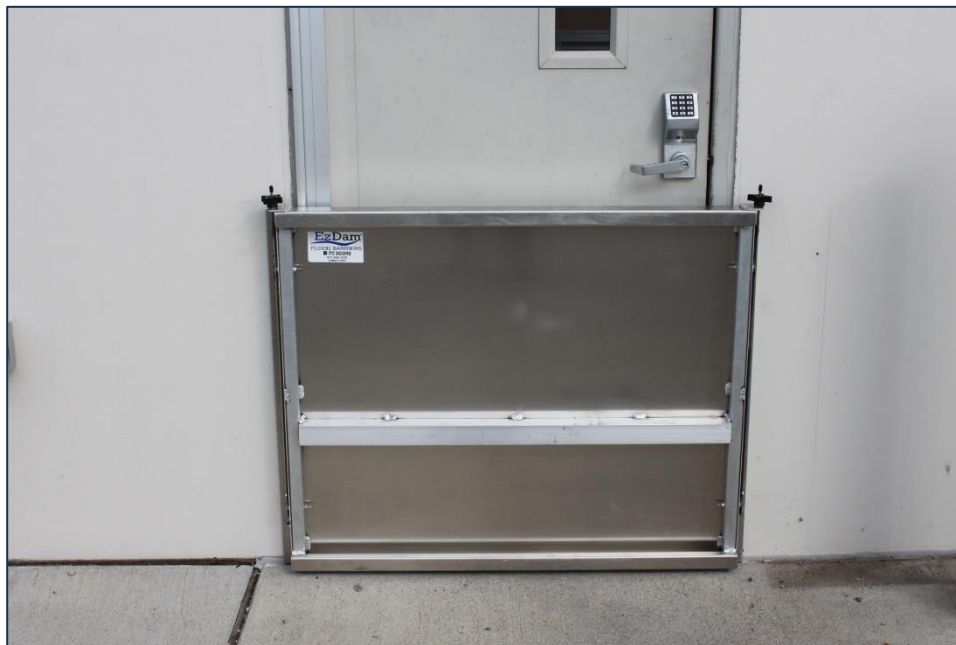
**Figure 4.** A temporary opening barrier deployed in front of a doorway.<sup>5</sup> Permanent components for anchoring the barrier to the building must be installed.

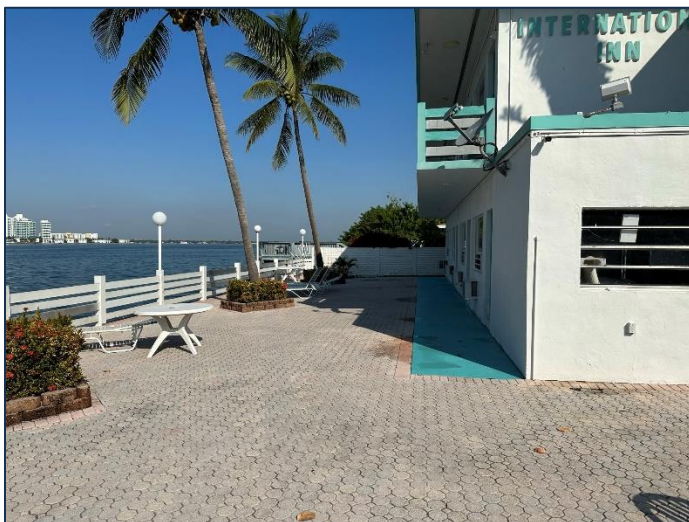
The rooms at the central and north suites are each serviced by their own wall A/C unit which penetrates the exterior wall of the building structure. On the ground level, these units are located approximately 12 to 18 inches above the finished grade. Due to the volume of openings around the exterior of each building, perimeter barriers should be explored to reduce deployment time and minimize the number of mechanical connections needed to fully secure the structures. Perimeter barriers will also permit a higher level of flood protection, as the penetrations for the A/C units on the ground level cannot be sealed.

**Figure 6.** North suites facing the waterfront with A/C units along exterior wall.

If perimeter barriers are not feasible, opening barriers below the level of the A/C wall penetrations should be explored to protect against minor to moderate events. Finishing the interiors within the buildings utilizing flood-resistant building materials beneath the design flood elevation will also mitigate potential damage.

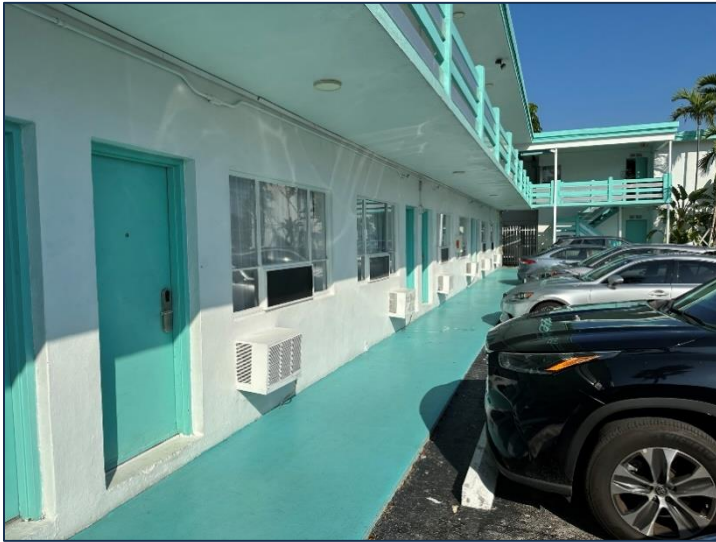
**Figure 7.** The northeastern side of central suites with low A/C units at each ground level room.

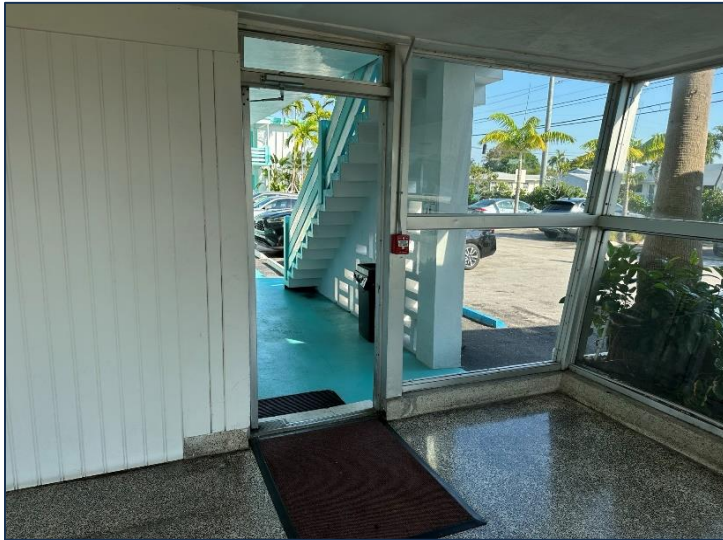
**Figure 9.** Side entry to atrium building from concourse along central suites.

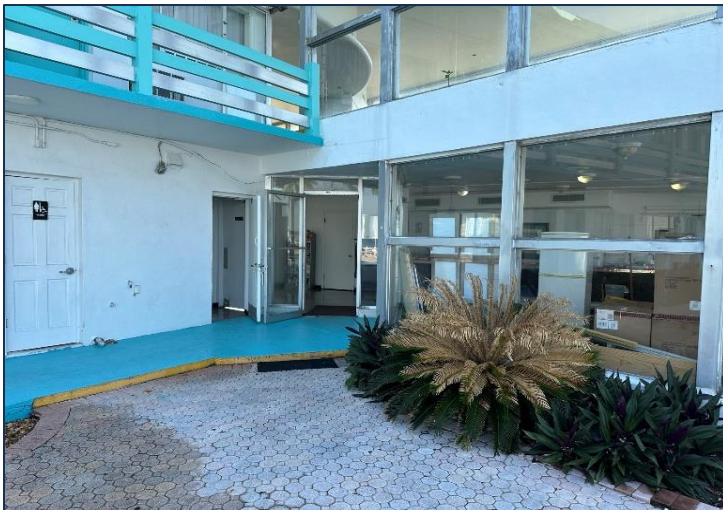
**Figure 10.** Entryway to atrium building from pool deck where atrium building connects to central suites.
